Asbestos Design Data Collection (DDC) 10242019

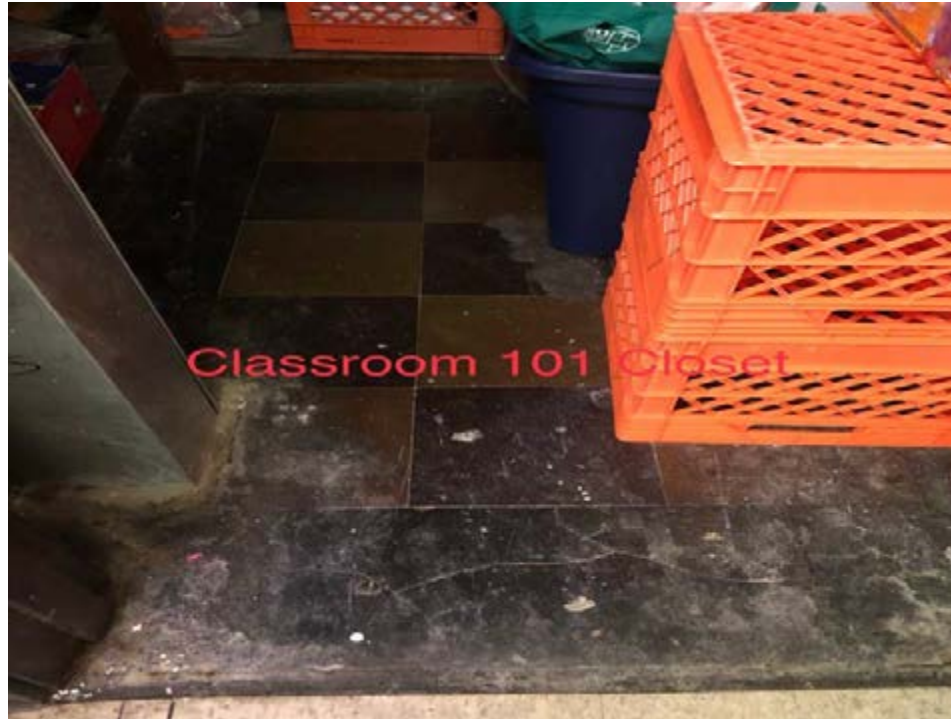
Classroom 101 Closet

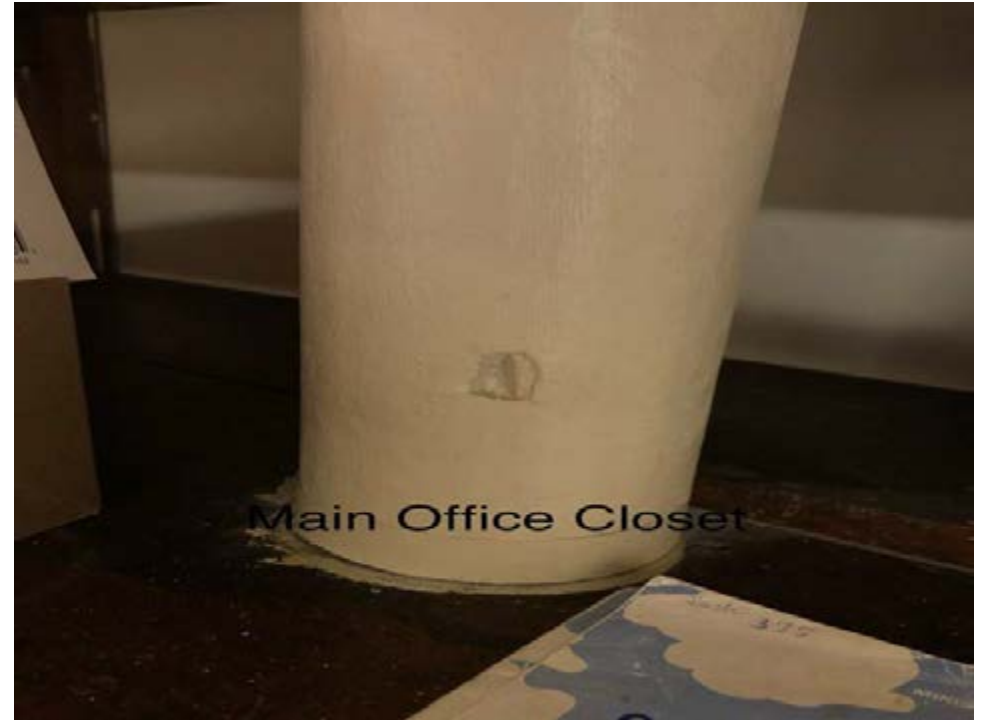
Small indentation damage

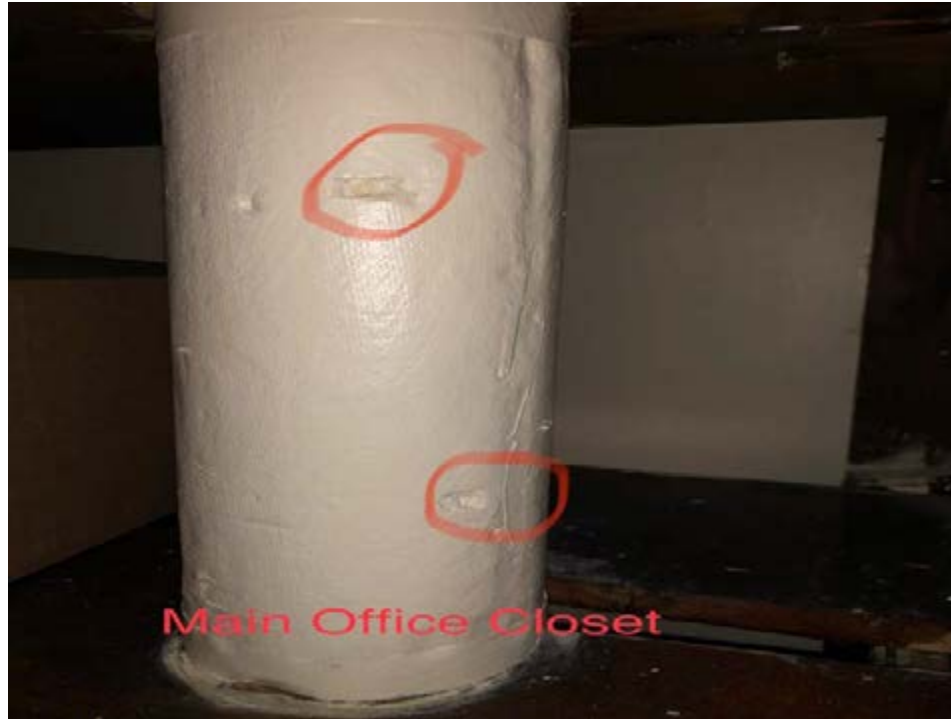
Small indentation damage

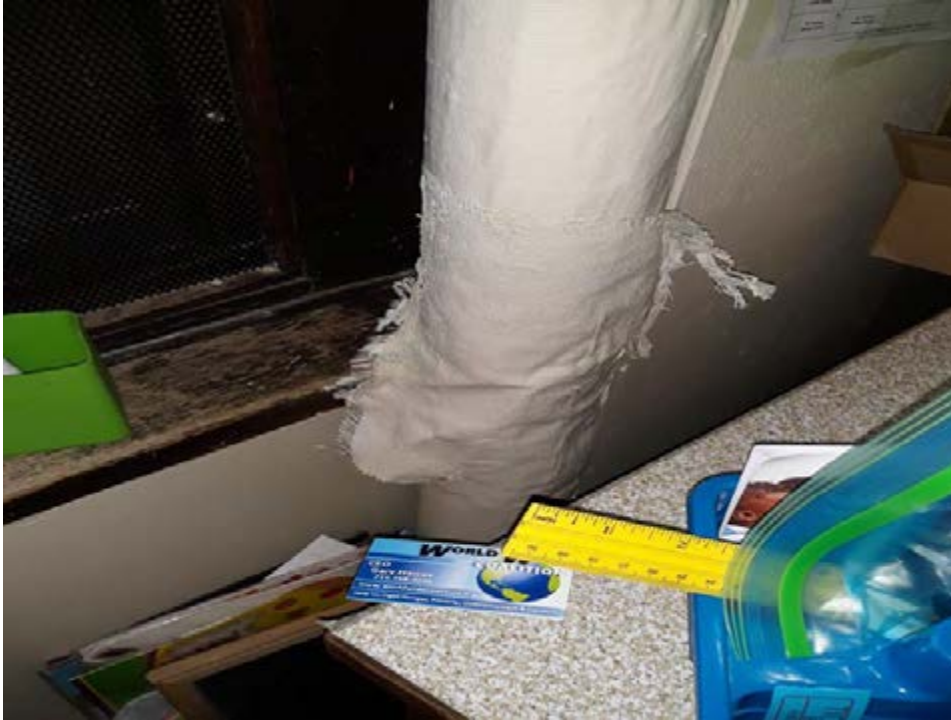
Excessive loose Cloth Needs to Be Trimmed To Prevent Someone Pulling It Of

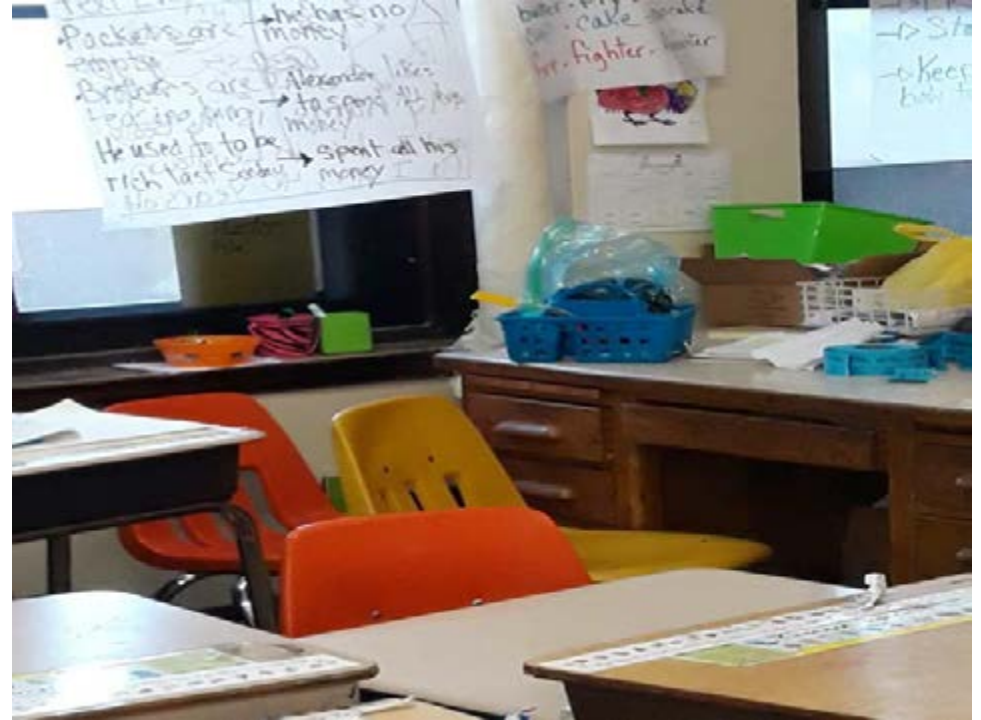
Excessive loose Cloth Needs to Be Trimmed To Prevent Someone Pulling It Of

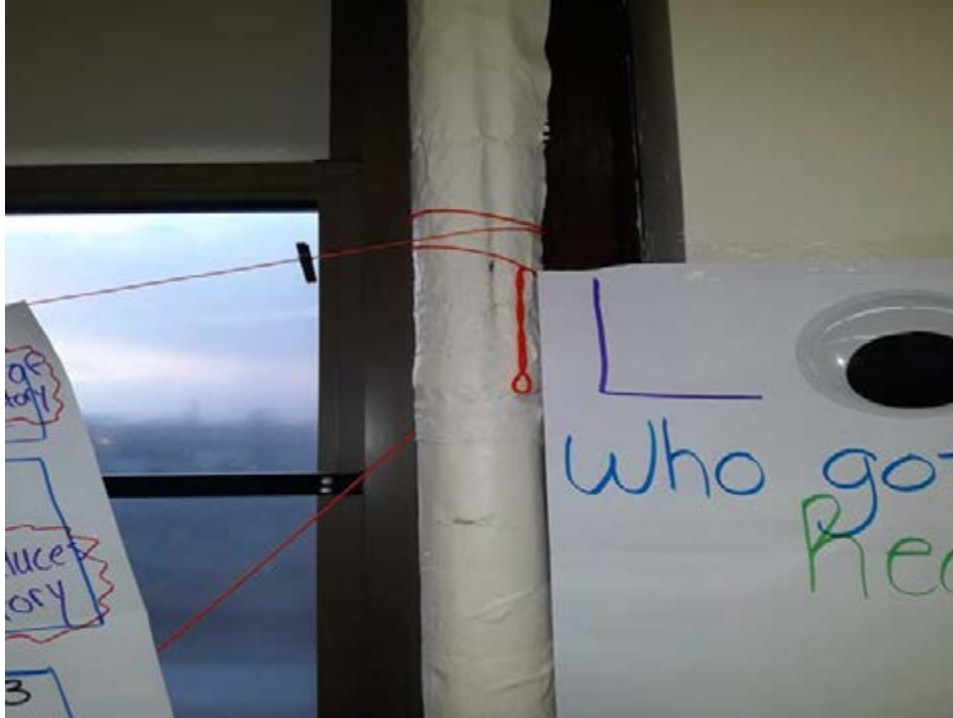
Excessive loose Cloth Needs to Be Trimmed To Prevent Someone Pulling It Of

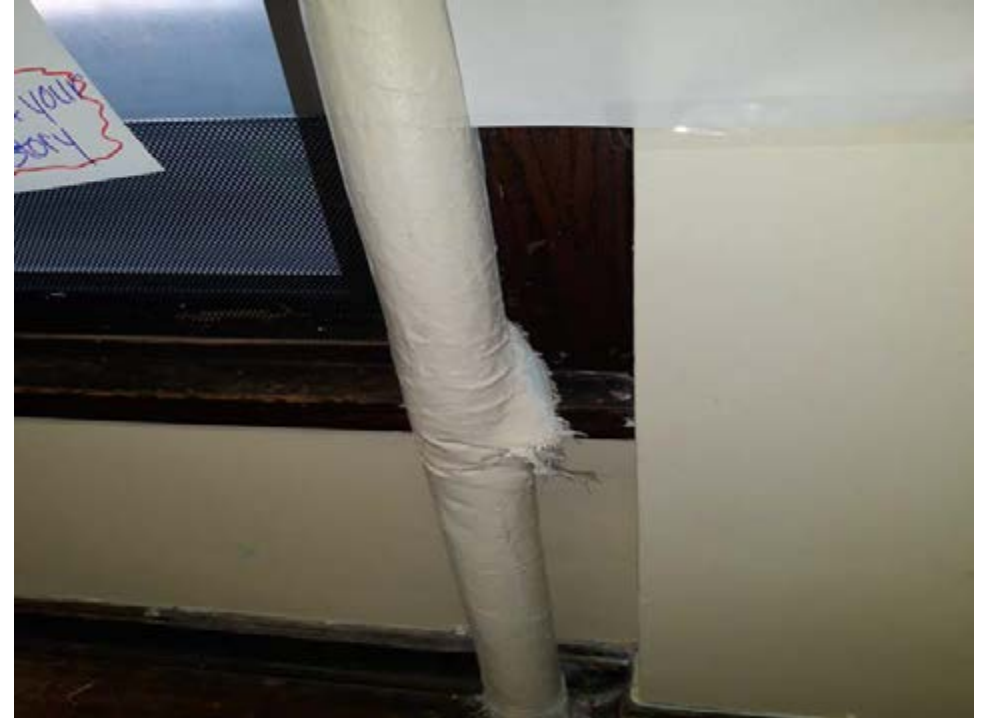
Excessive loose Cloth Needs to Be Trimmed To Prevent Someone Pulling It Of

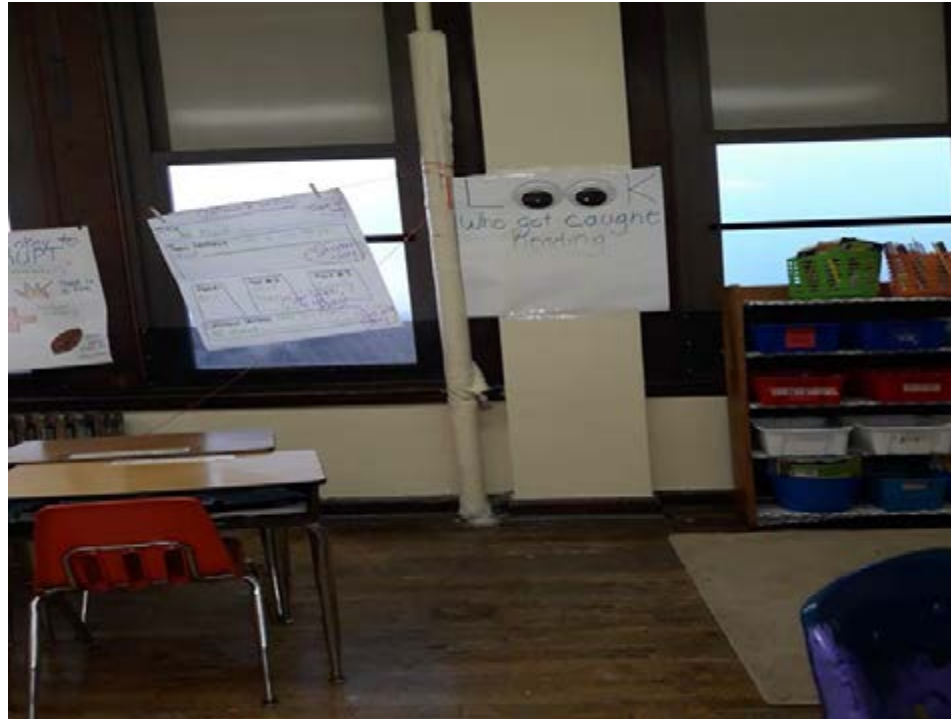
Excessive loose Cloth Needs to Be Trimmed To Prevent Someone Pulling It Of

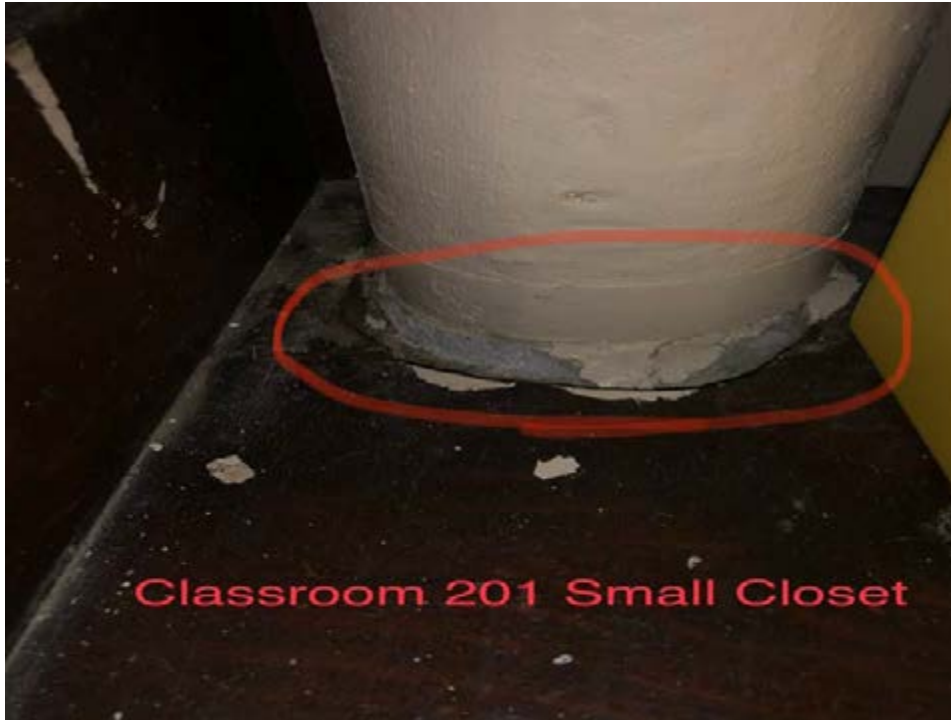
Damaged pipe insulation

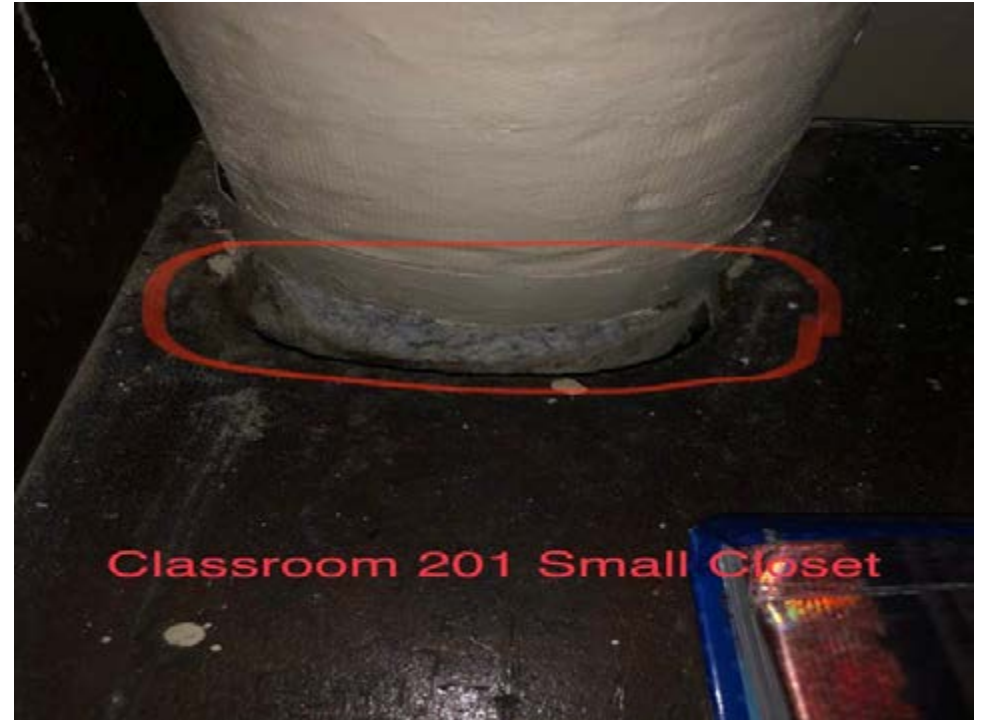
Damaged pipe insulation

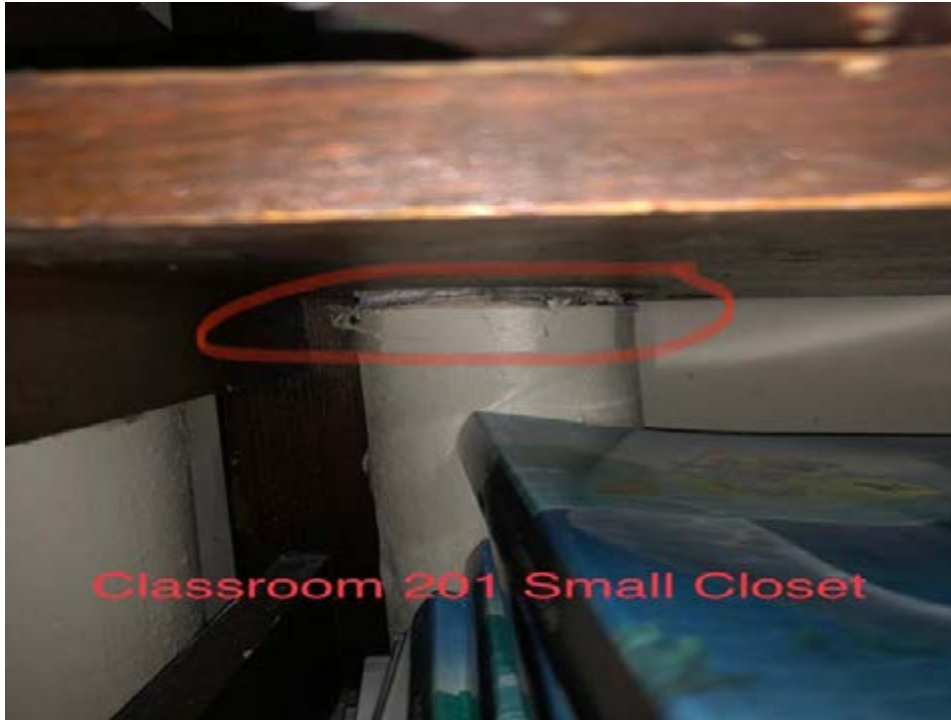
Damaged pipe insulation

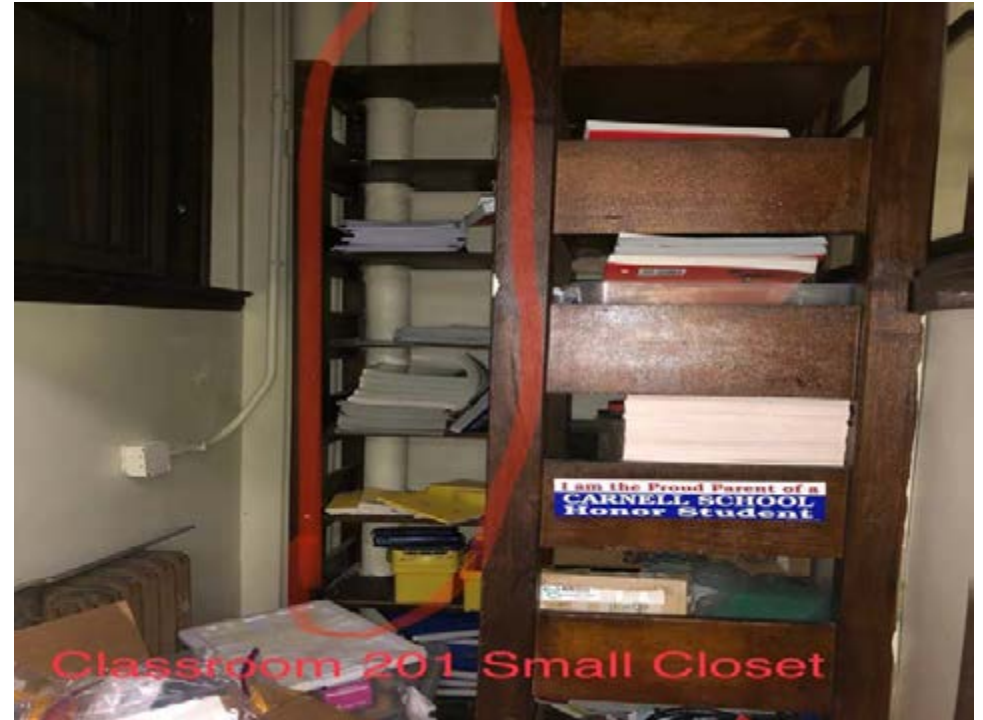
Remove all pipe insulation

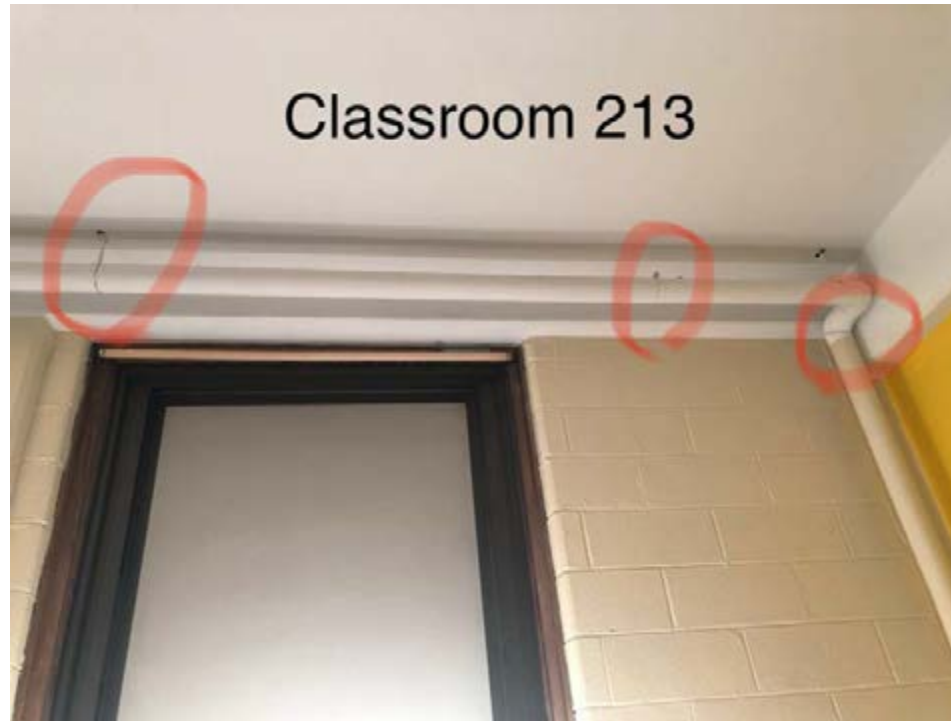
Perspective picture of cracked fitting

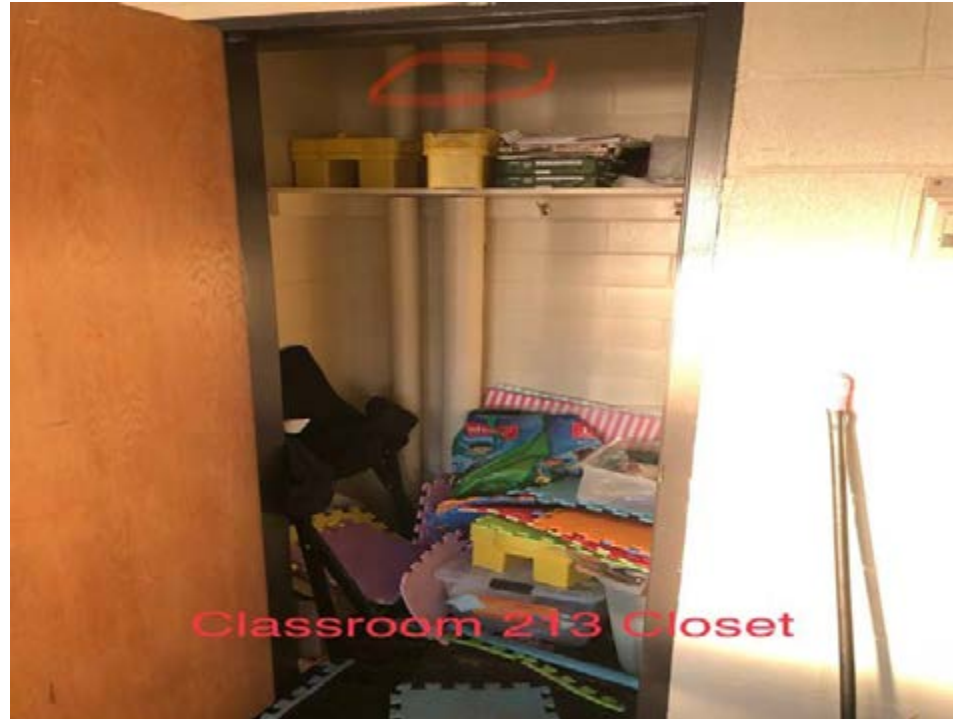
Perspective picture with open seam damage

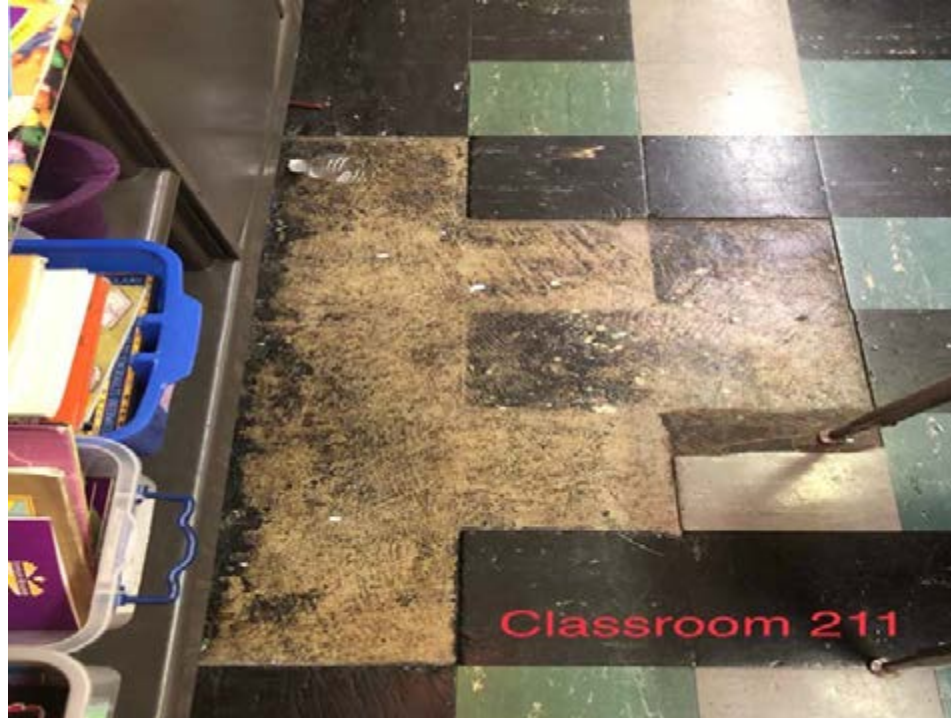
Cracked and missing tiles

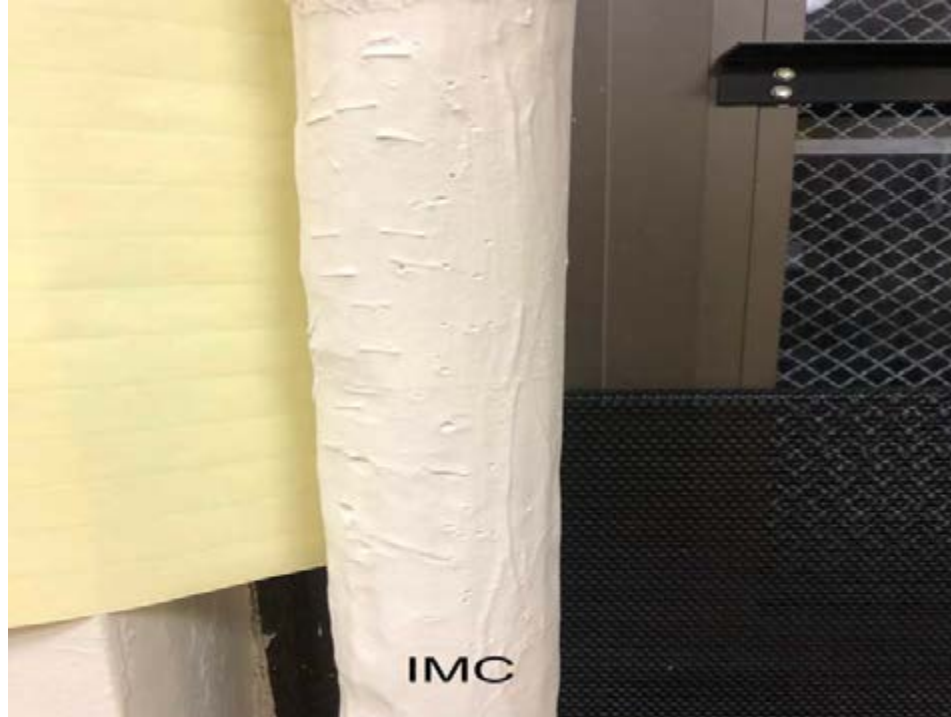
Asbestos Design Data Collection (DDC) 10242019

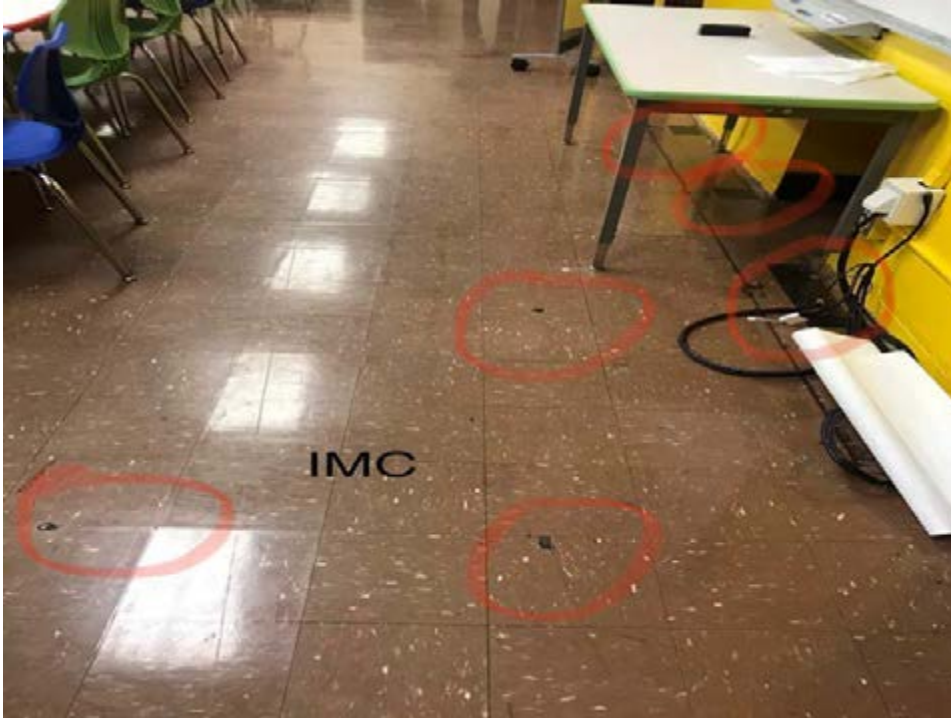
Cracks, dents and missing floor tiles

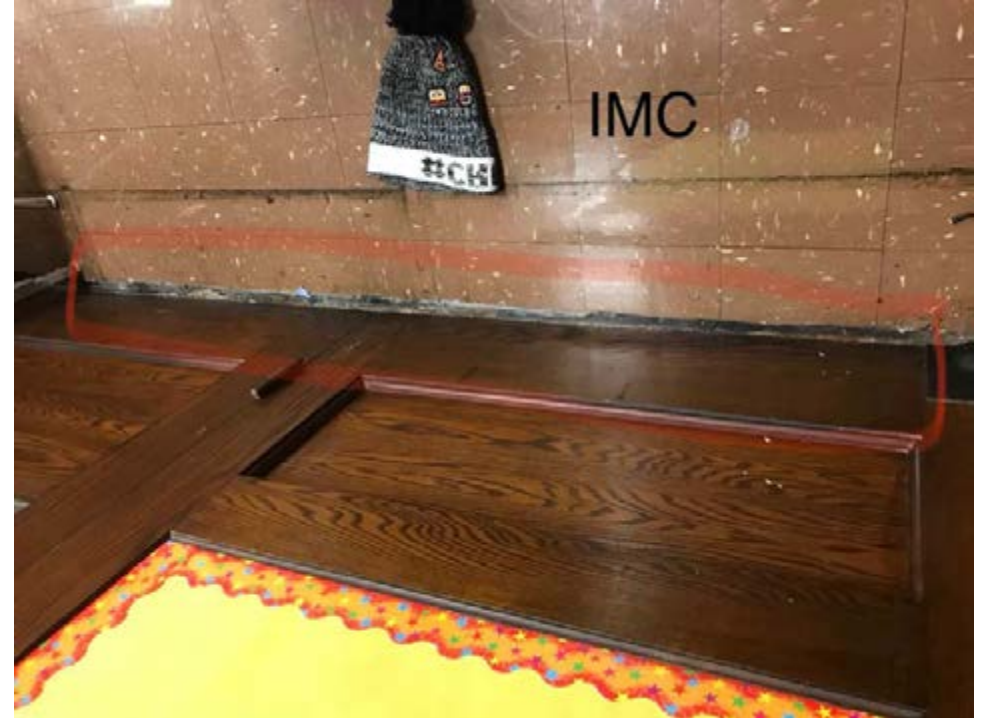
Cracks, dents and missing floor tiles

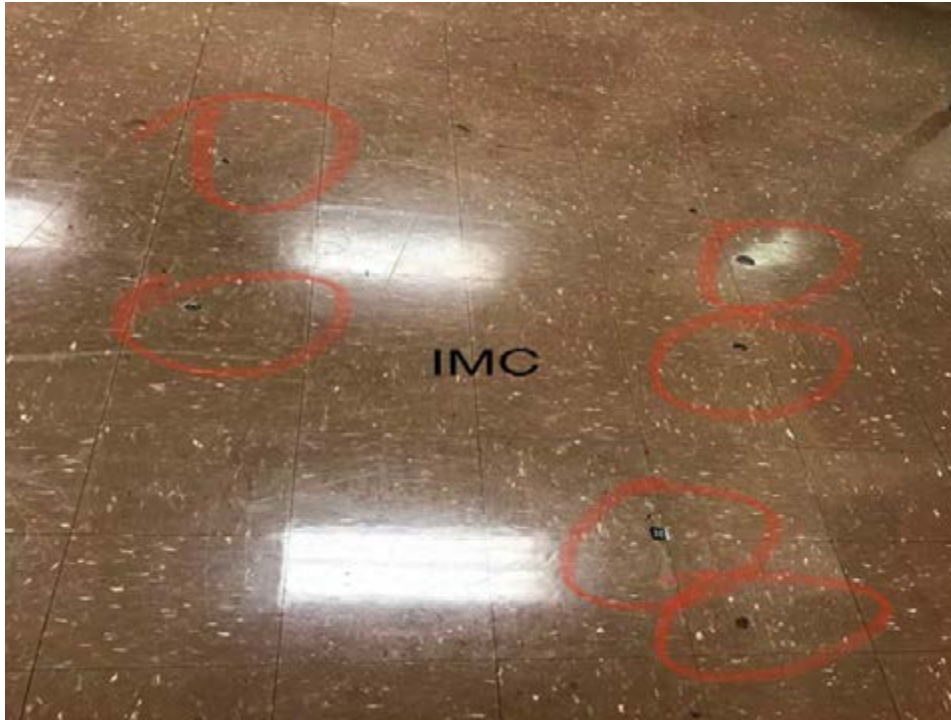
Cracks, dents and missing floor tiles

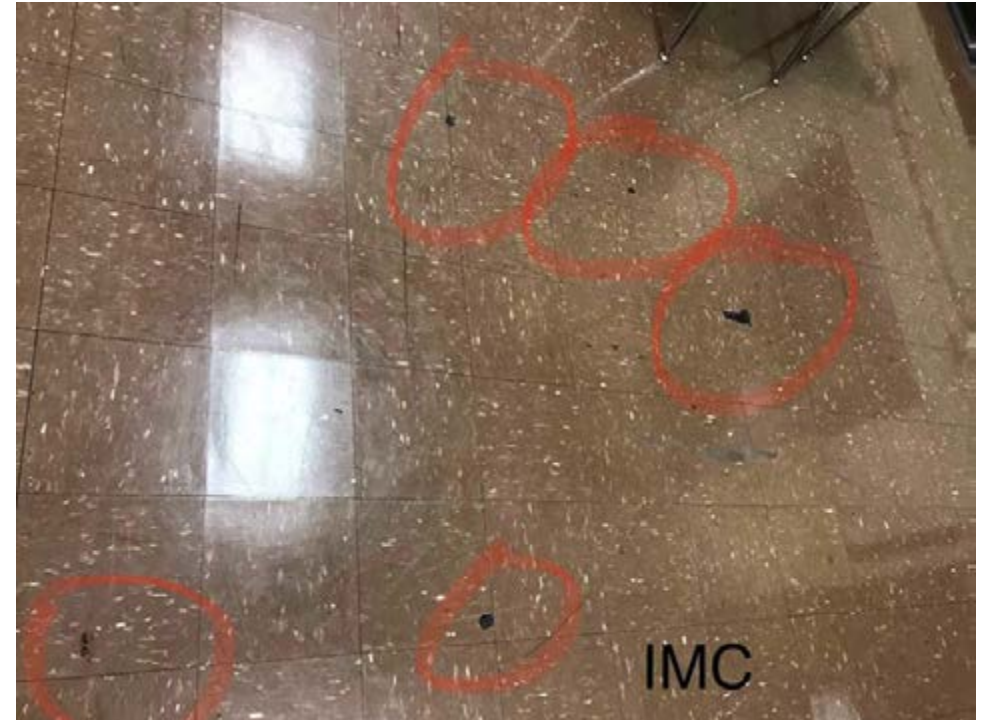
Cracks, dents and missing floor tiles

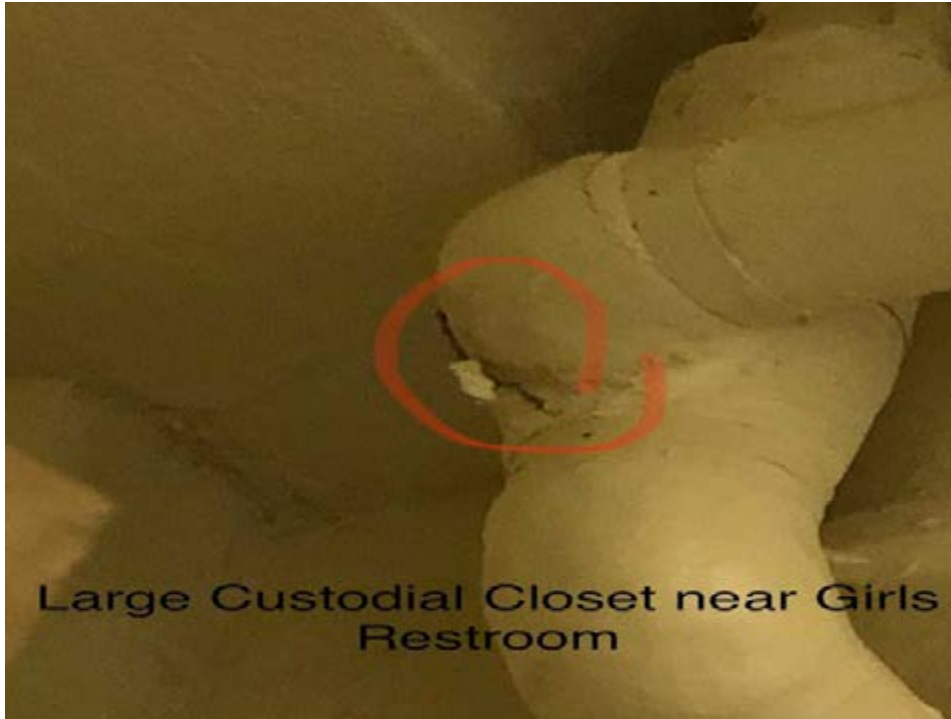
Cracked pipe fitting

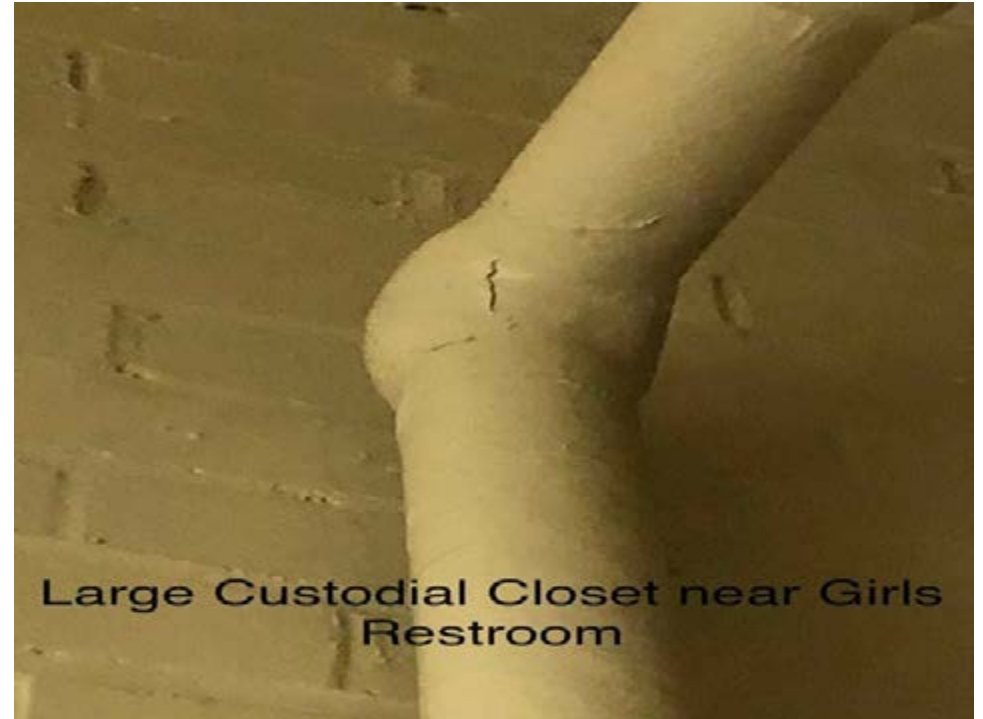
Cracked pipe fitting

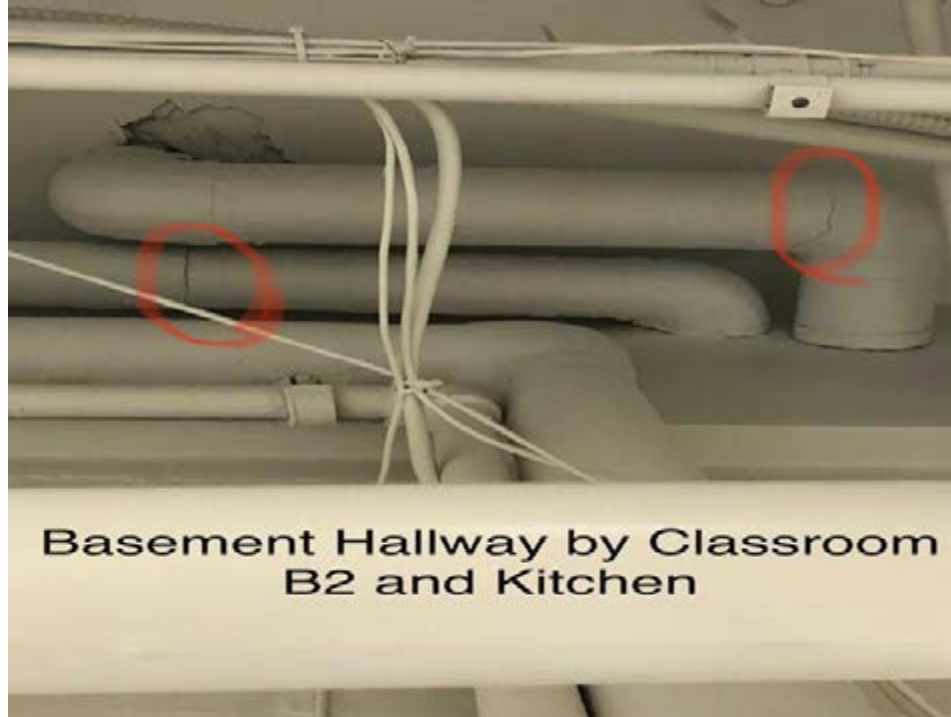
Asbestos Design Data Collection (DDC) 10242019

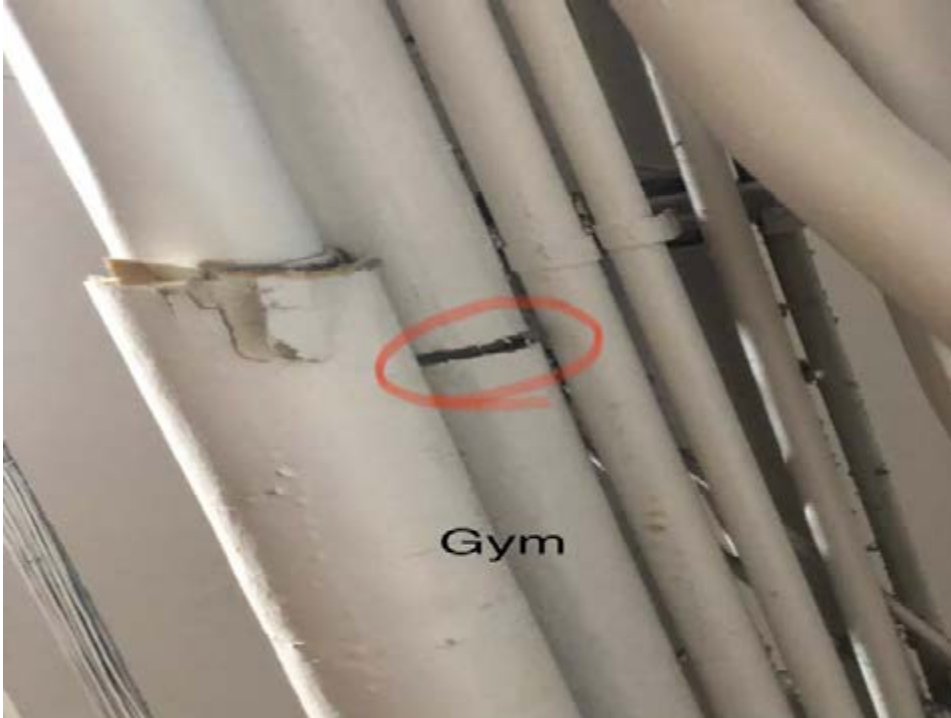
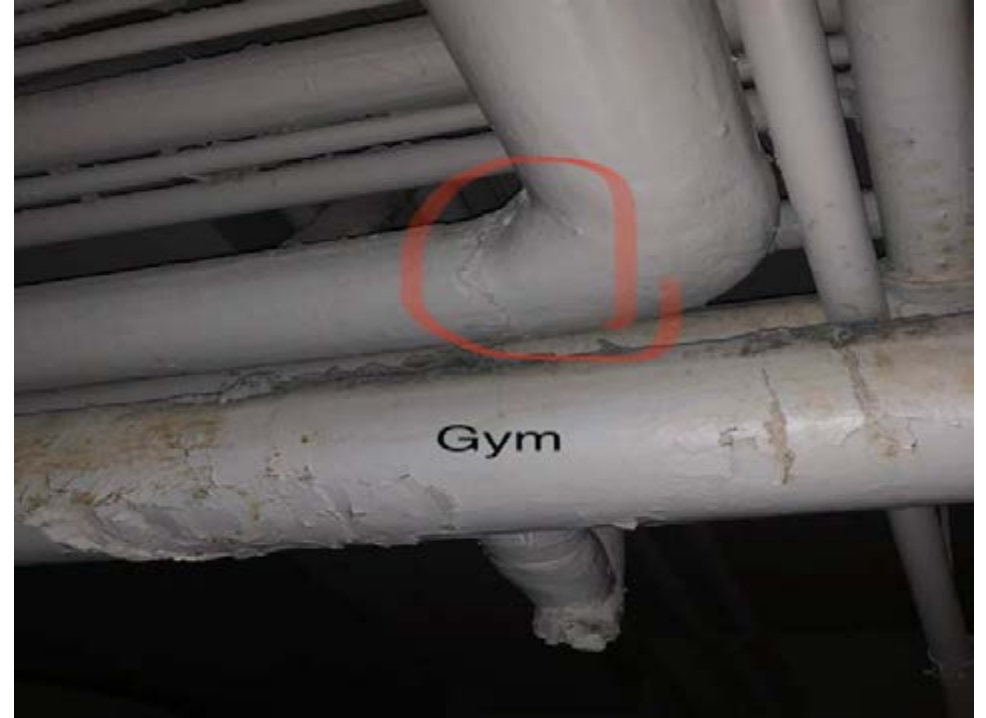
Asbestos Design Data Collection (DDC) 10242019

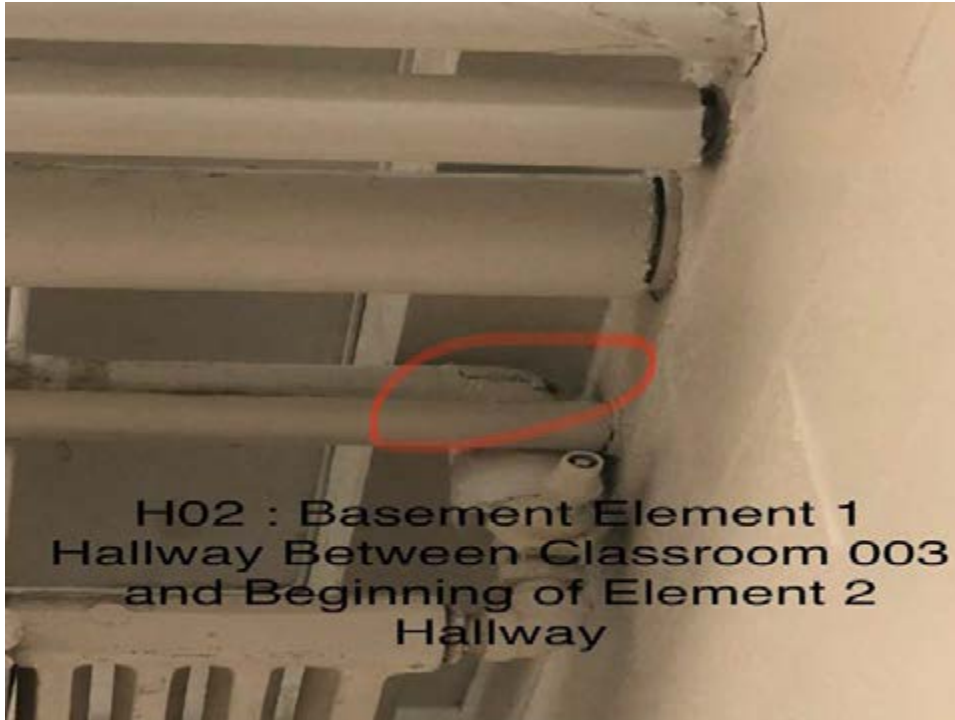
Basement Element 1 Hallway between Classroom 003 and Beginning of Element 2 Hallway

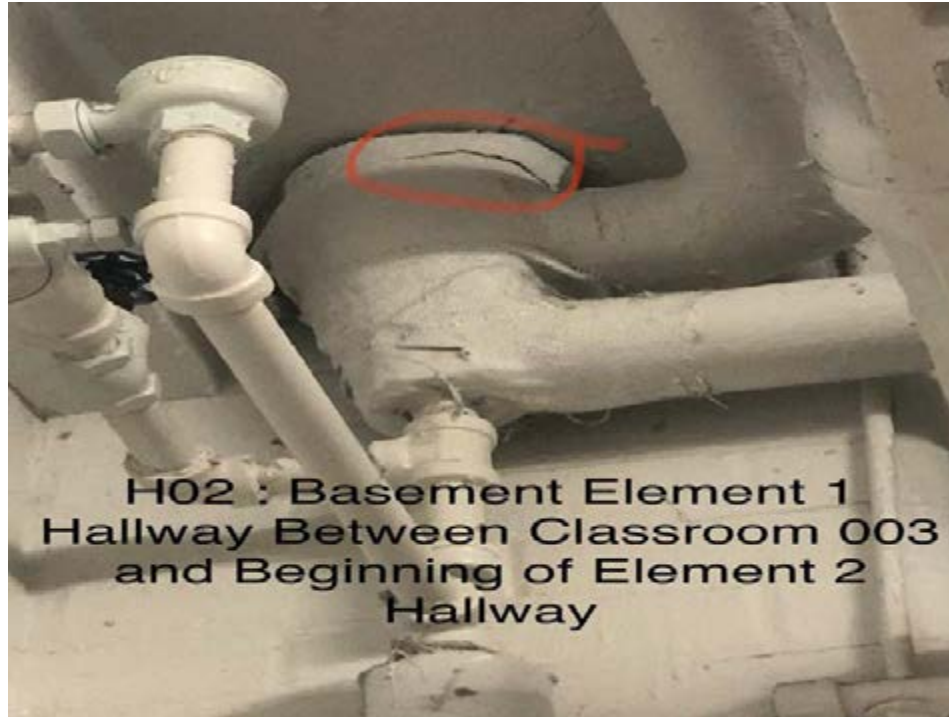
Basement Element 1 Hallway between Classroom 003 and Beginning of Element 2 Hallway

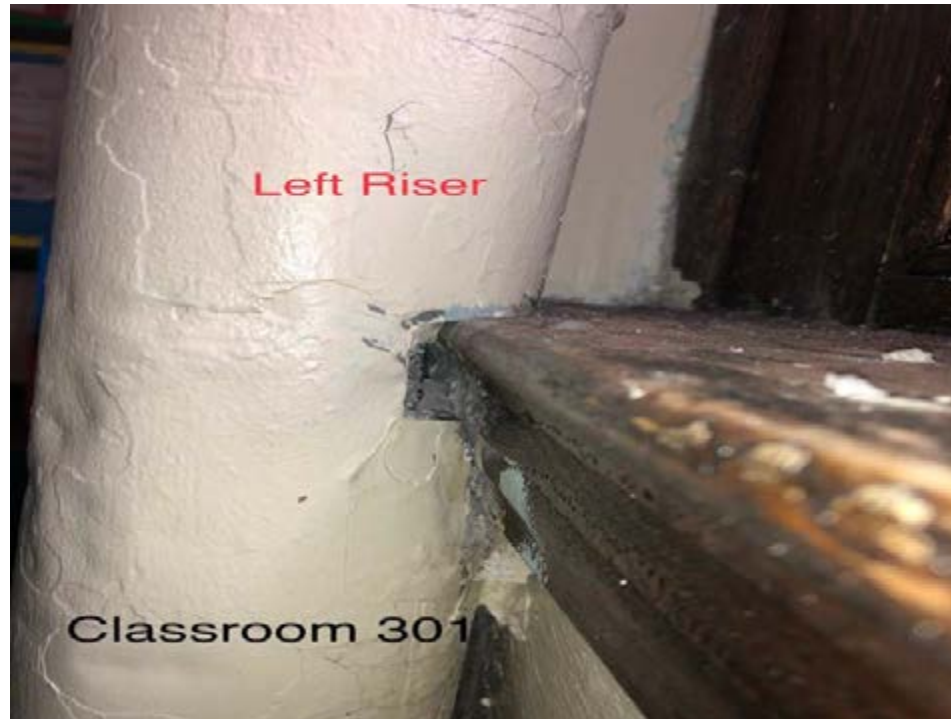
Asbestos Design Data Collection (DDC) 10242019

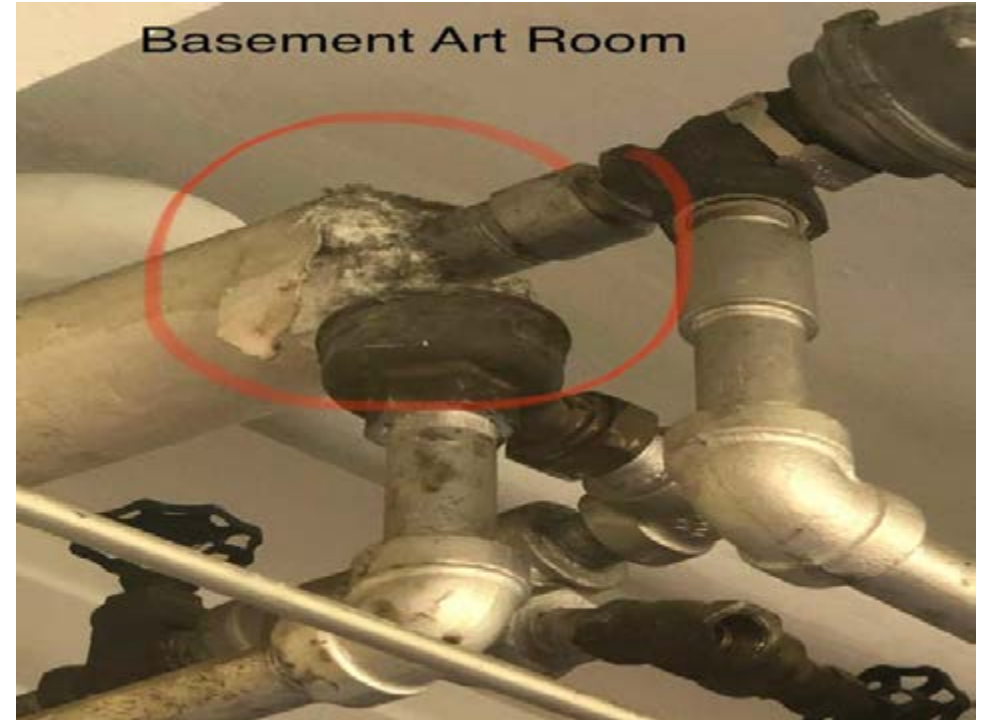
The Imminent hazard. Exposed asbestos mag insulation.

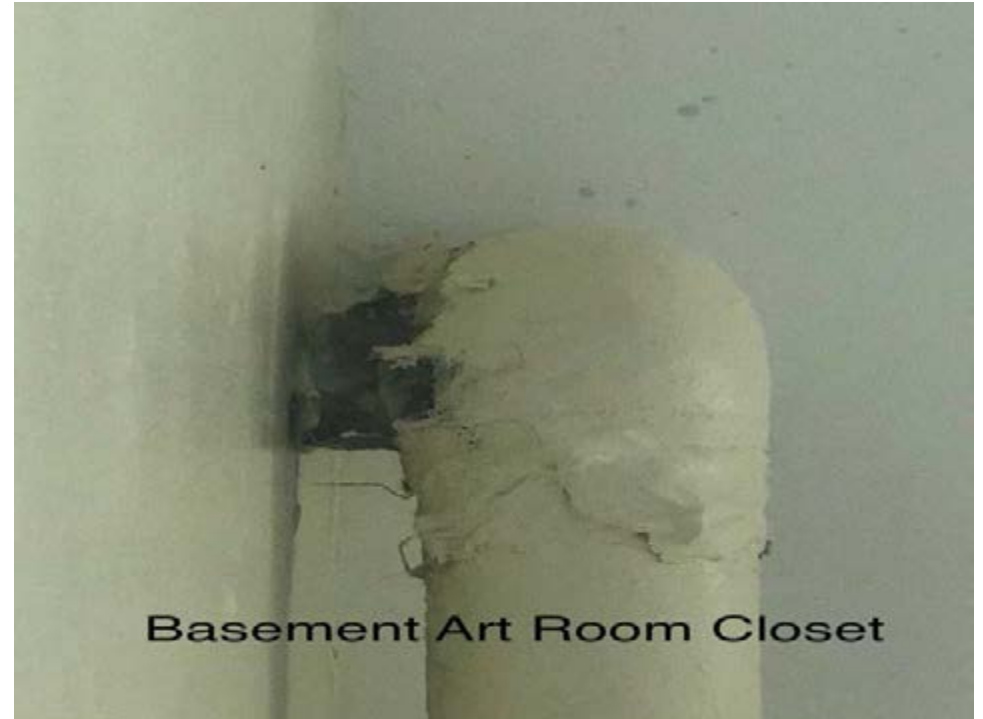
Significantly damaged fitting

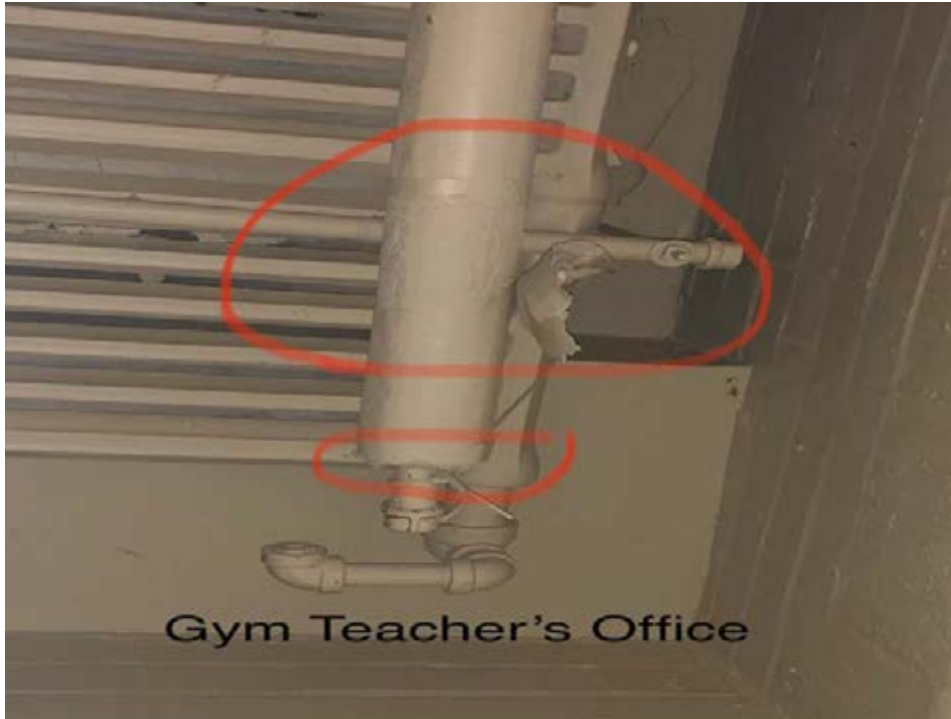
Exposed asbestos mag insulation. This is the imminent hazard

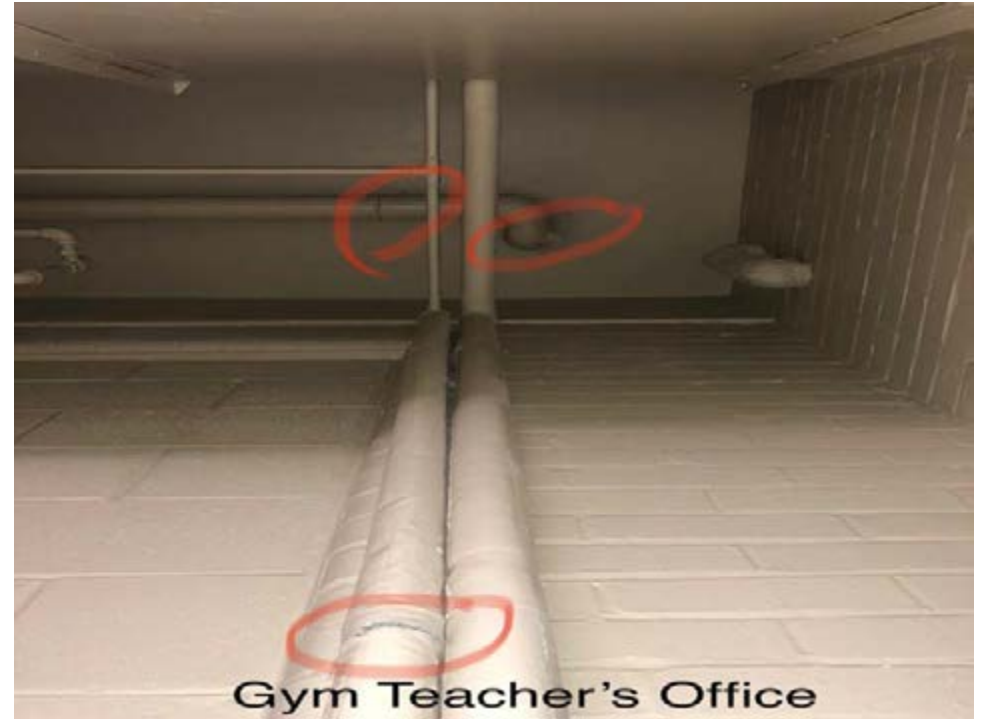
Two open seams and one damaged fitting
