Asbestos Design Data Collection (DDC) 10242019

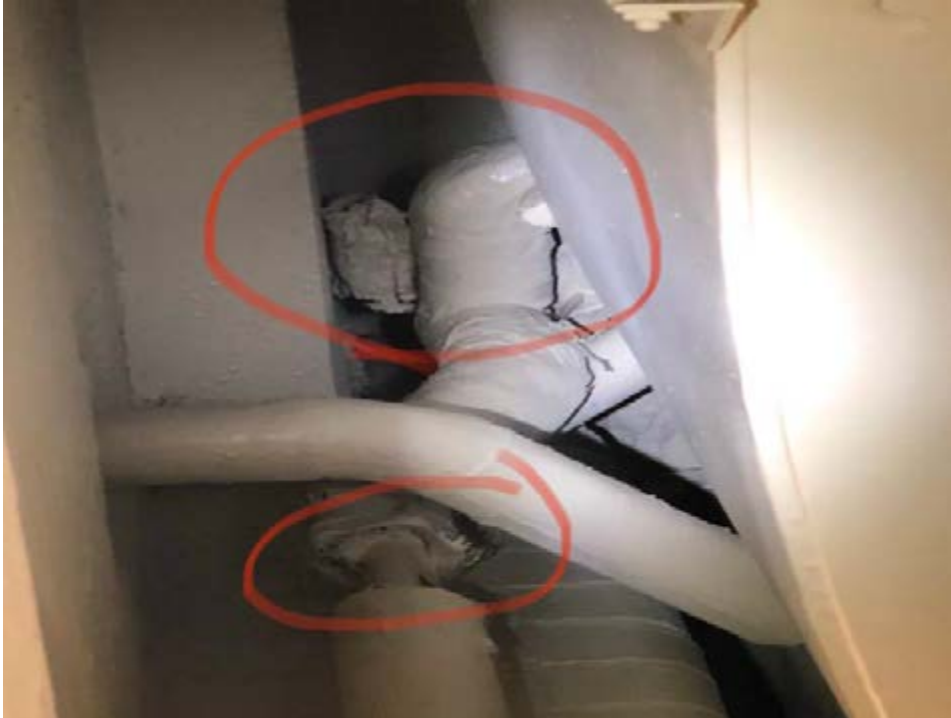
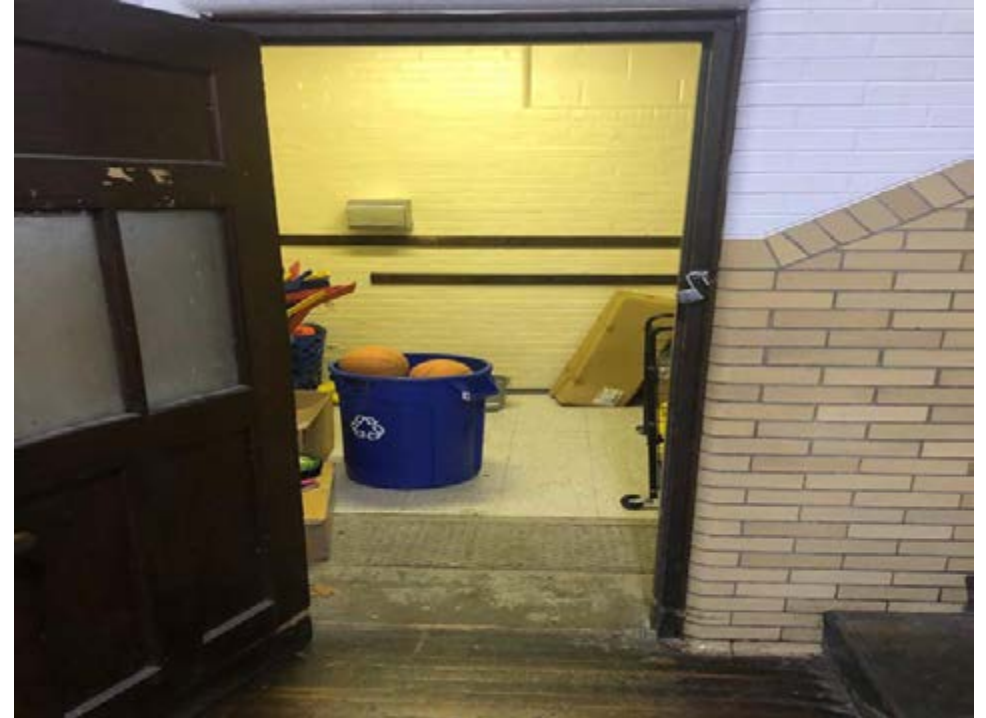
Asbestos Design Data Collection (DDC) 10242019

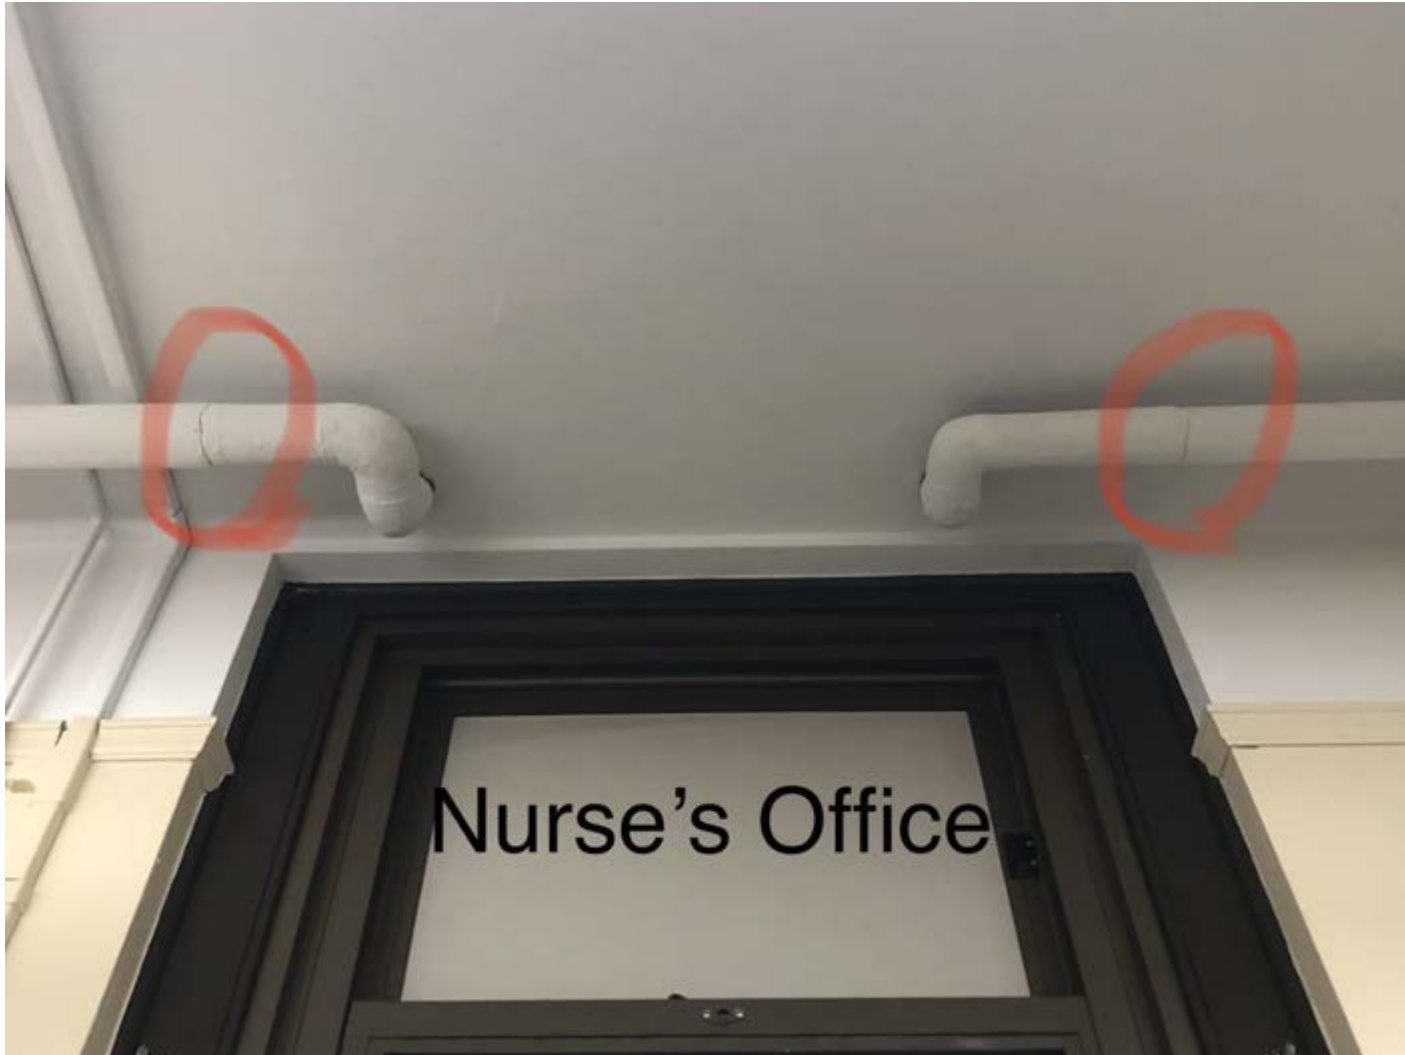
Asbestos Design Data Collection (DDC) 10242019

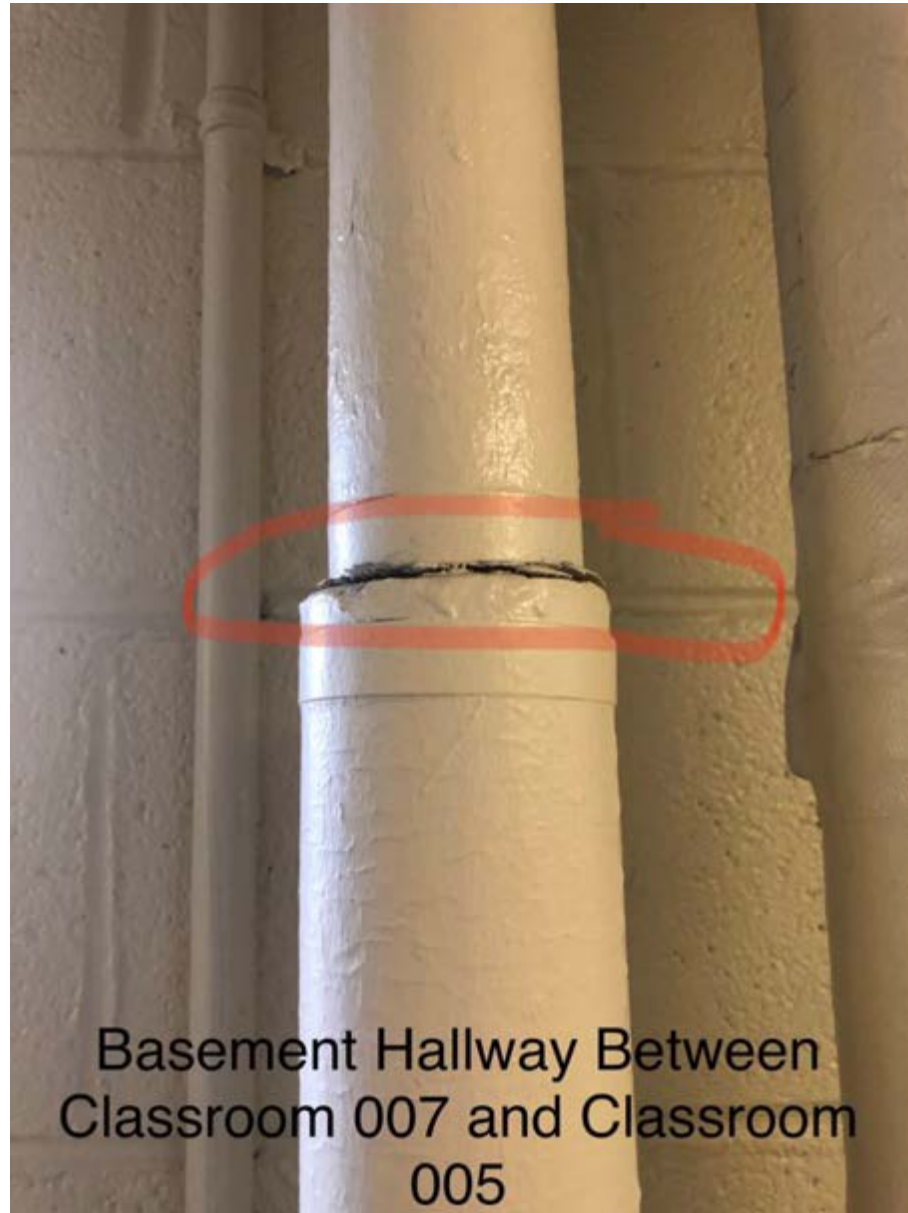
Asbestos Design Data Collection (DDC) 10242019

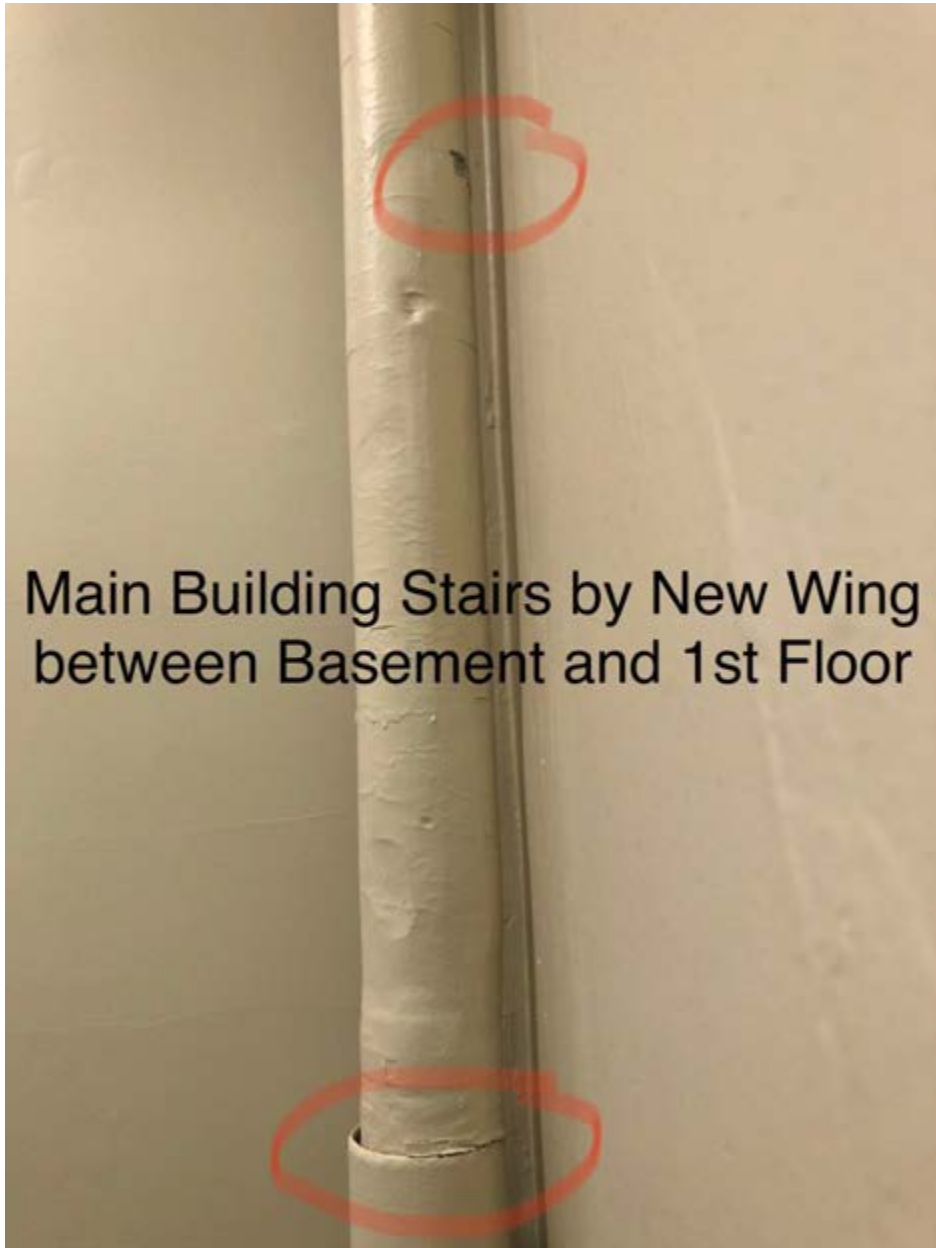
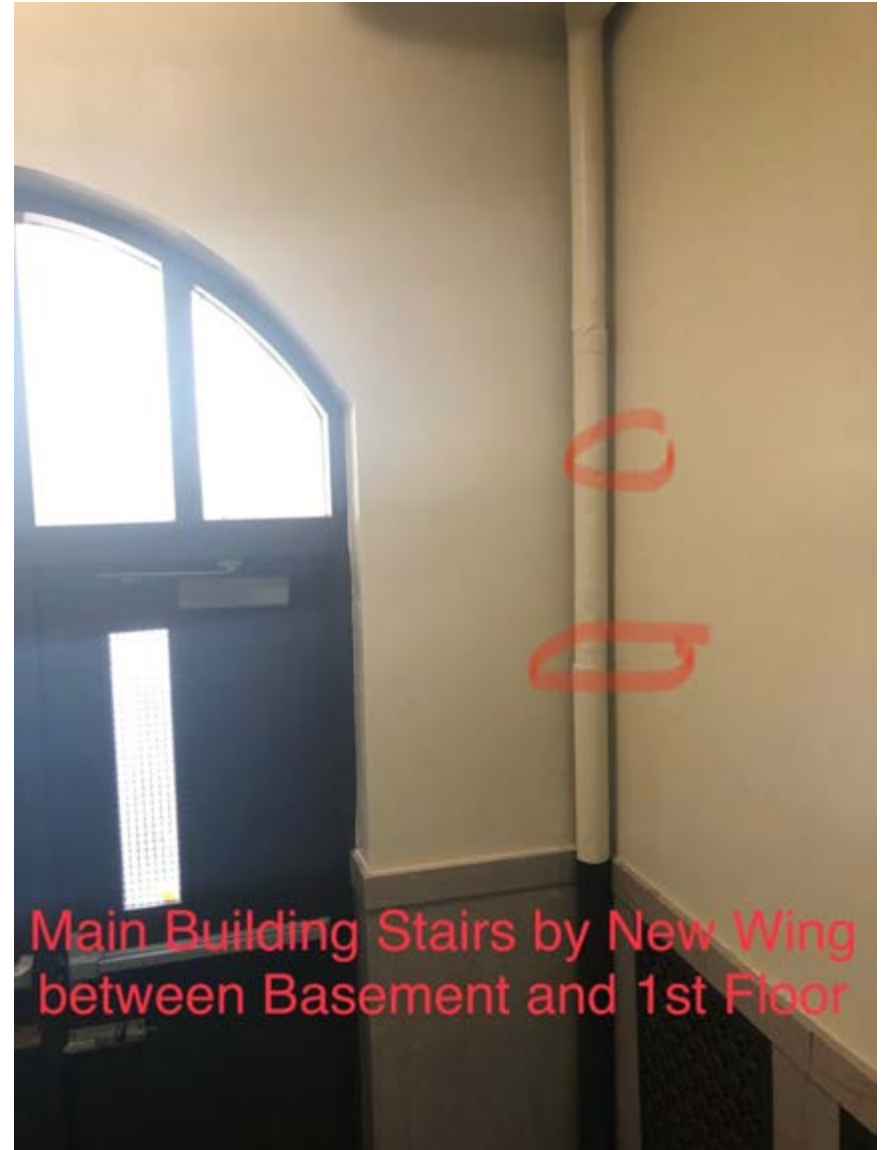
Asbestos Design Data Collection (DDC) 10242019

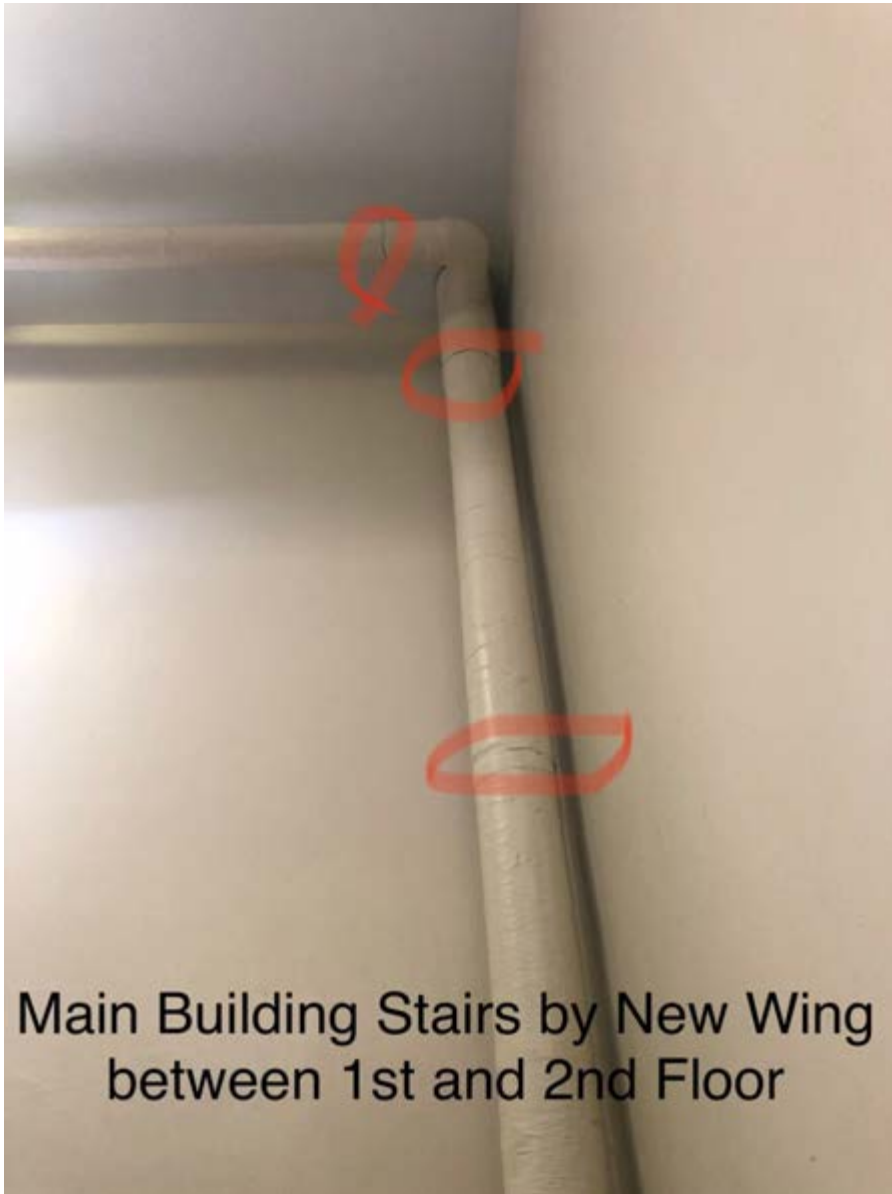
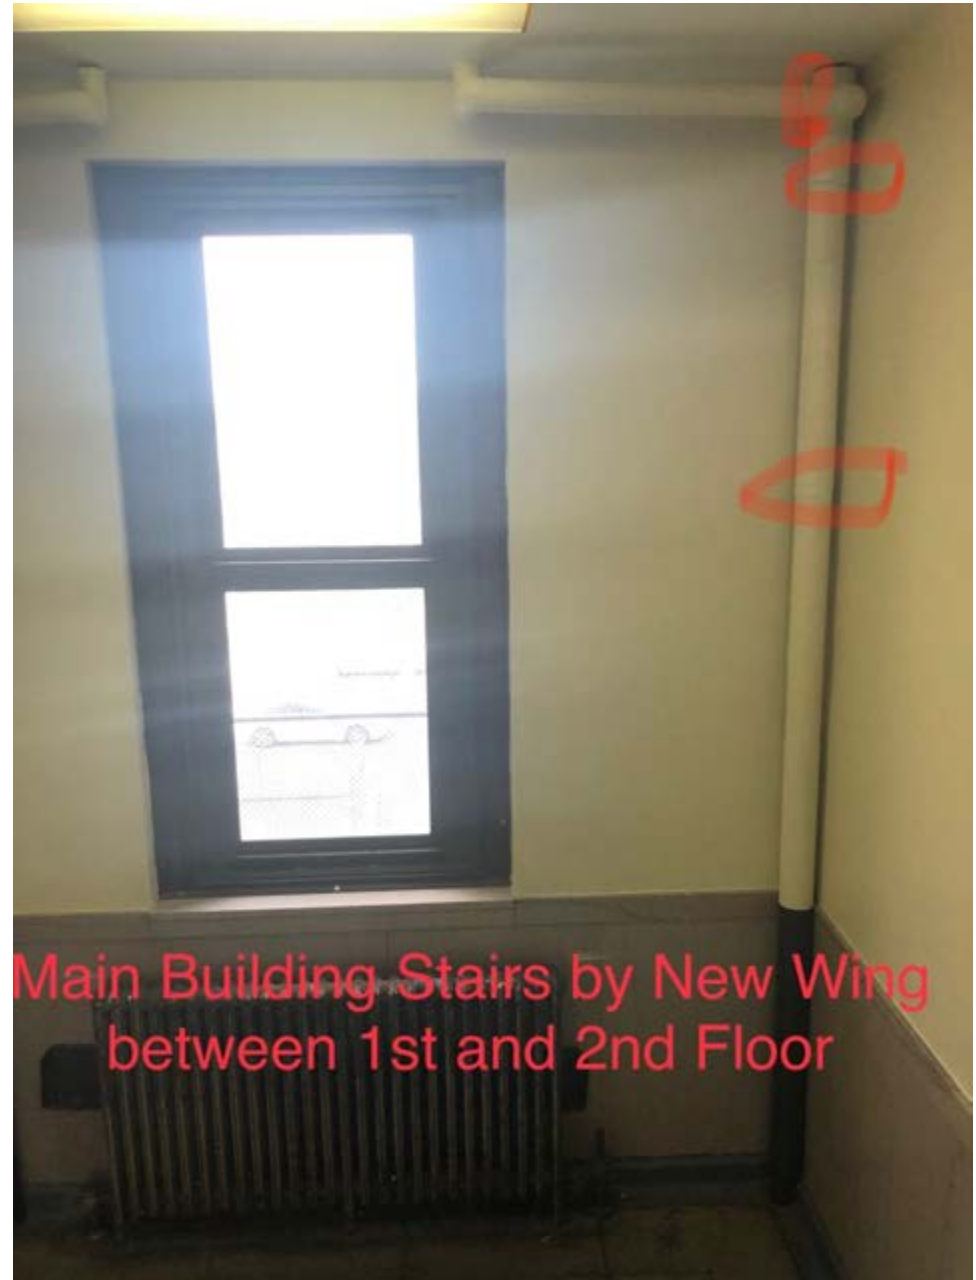
Asbestos Design Data Collection (DDC) 10242019

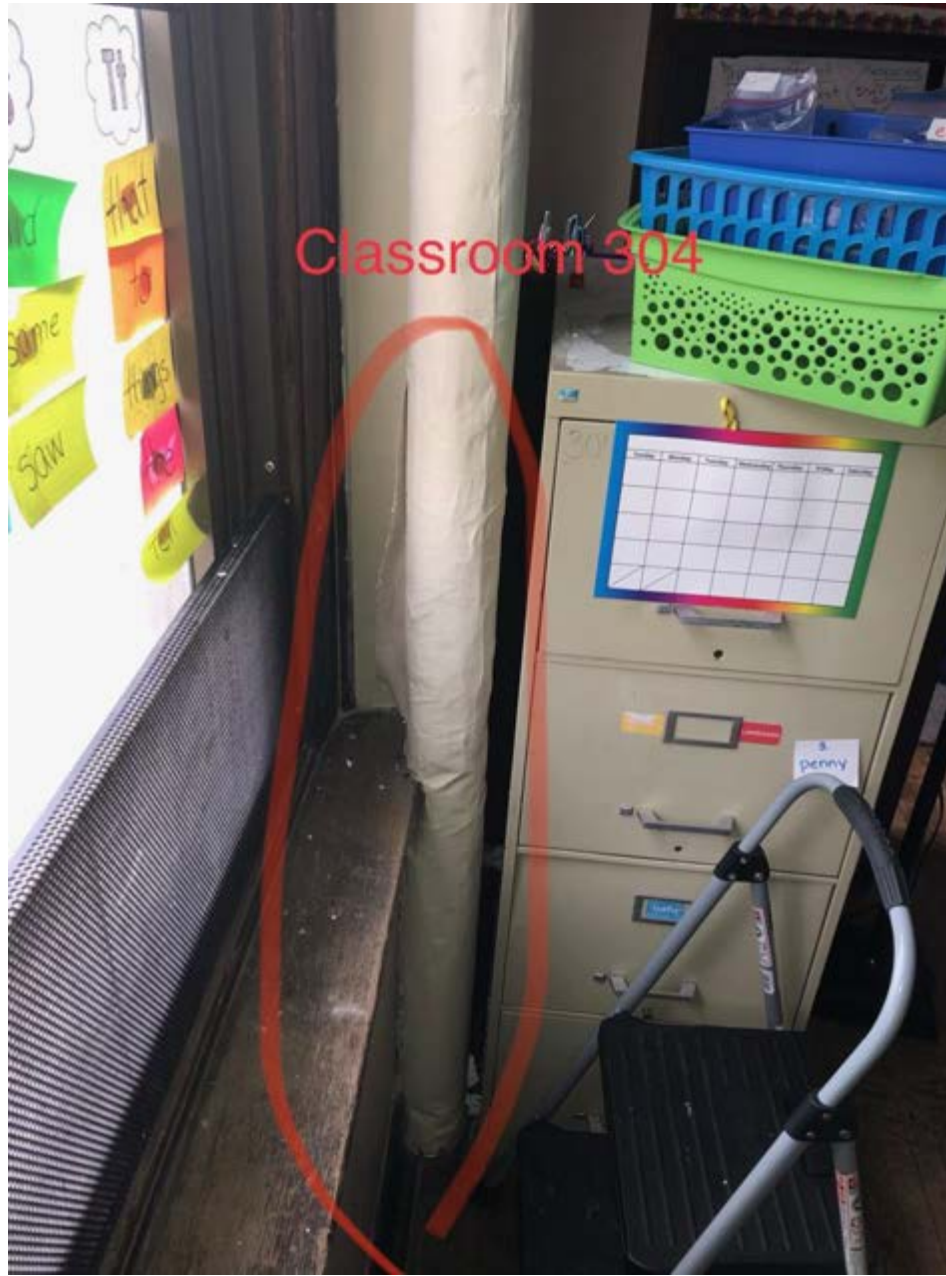
Asbestos Design Data Collection (DDC) 10242019

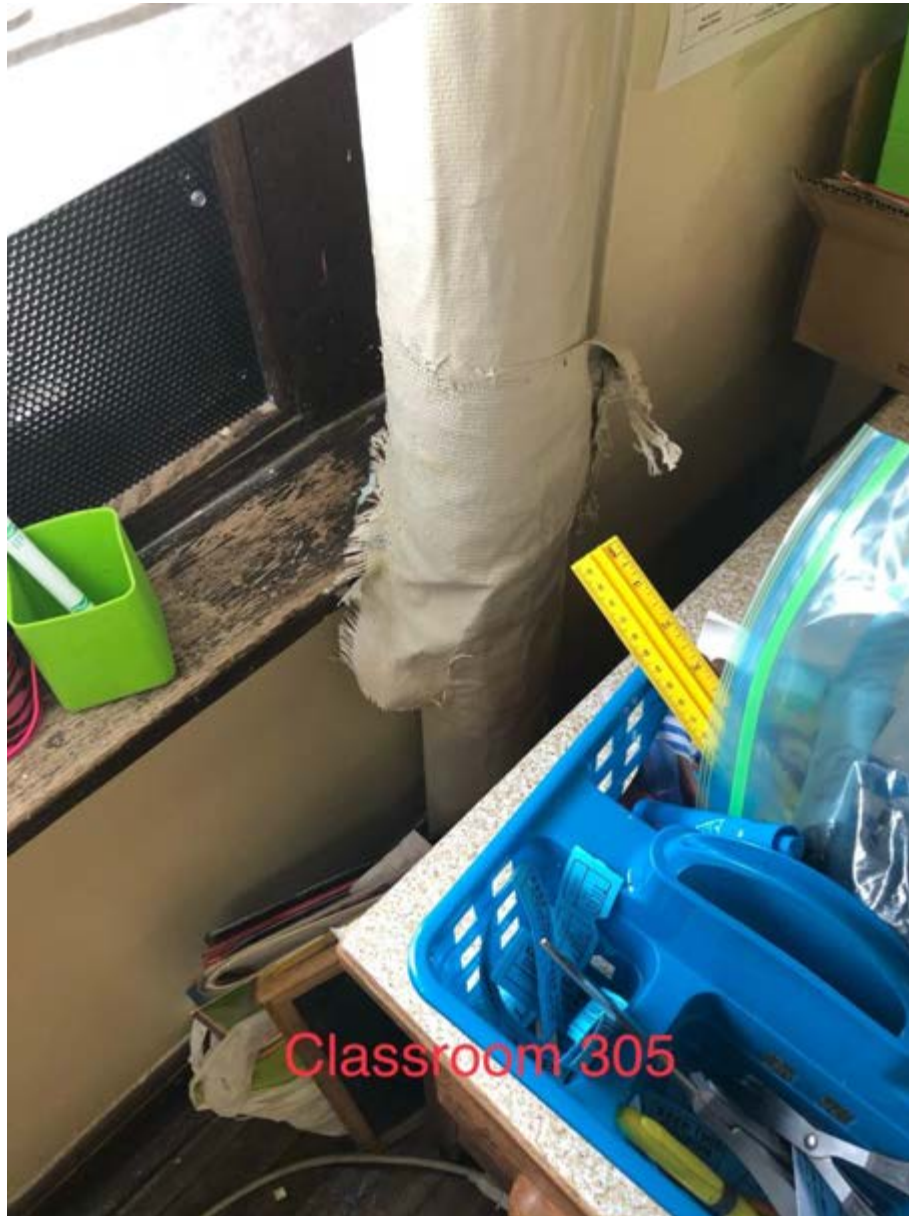
Asbestos Design Data Collection (DDC) 10242019

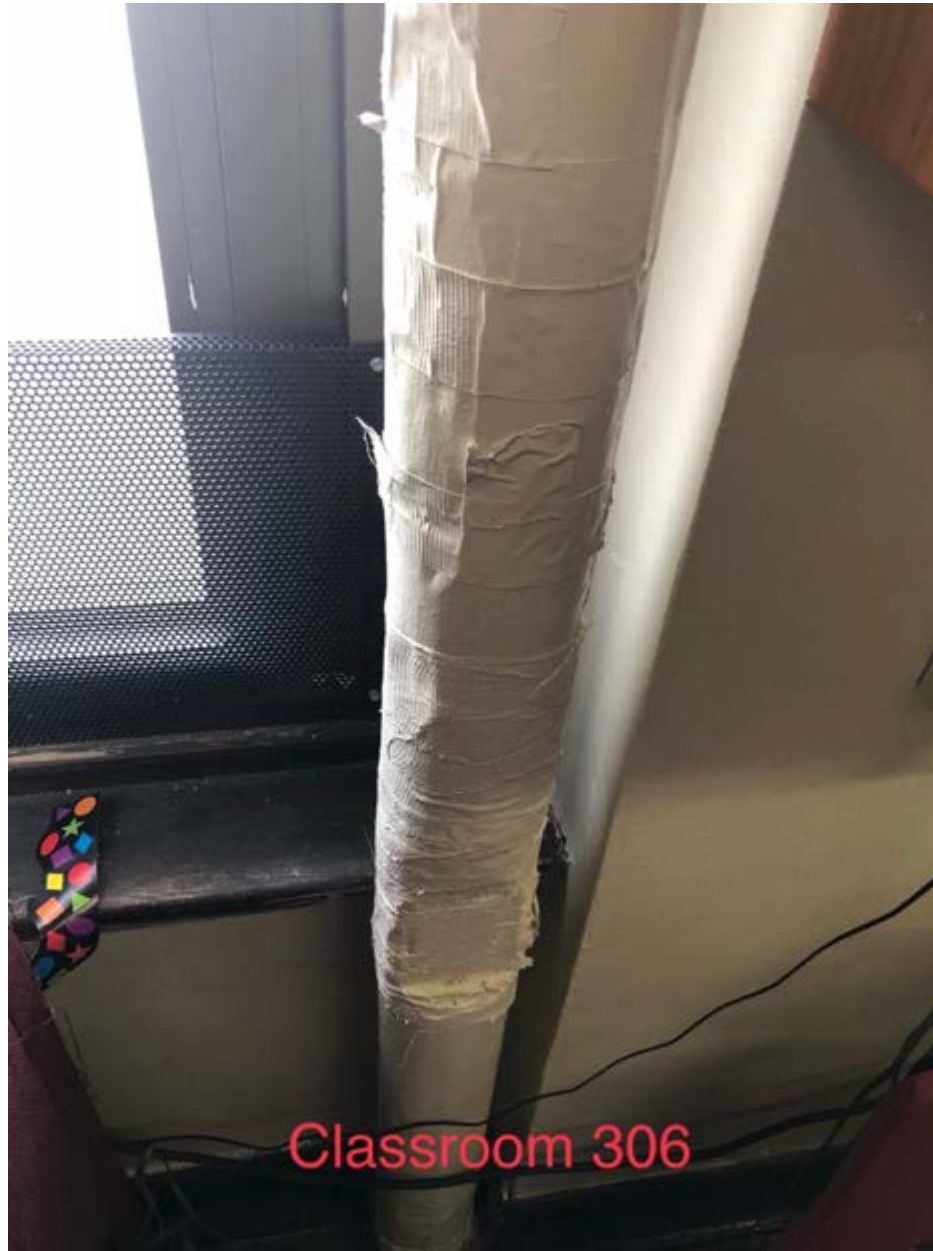
Asbestos Design Data Collection (DDC) 10242019

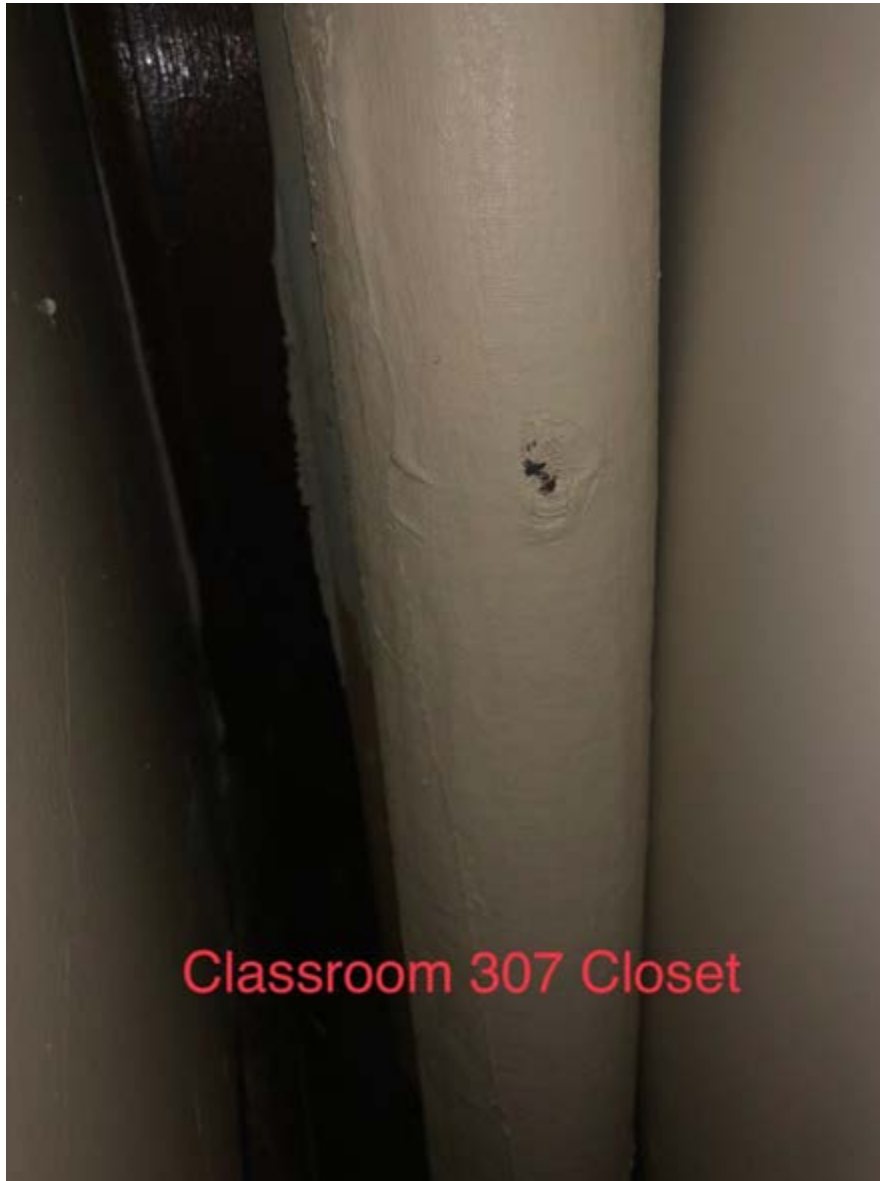
Asbestos Design Data Collection (DDC) 10242019

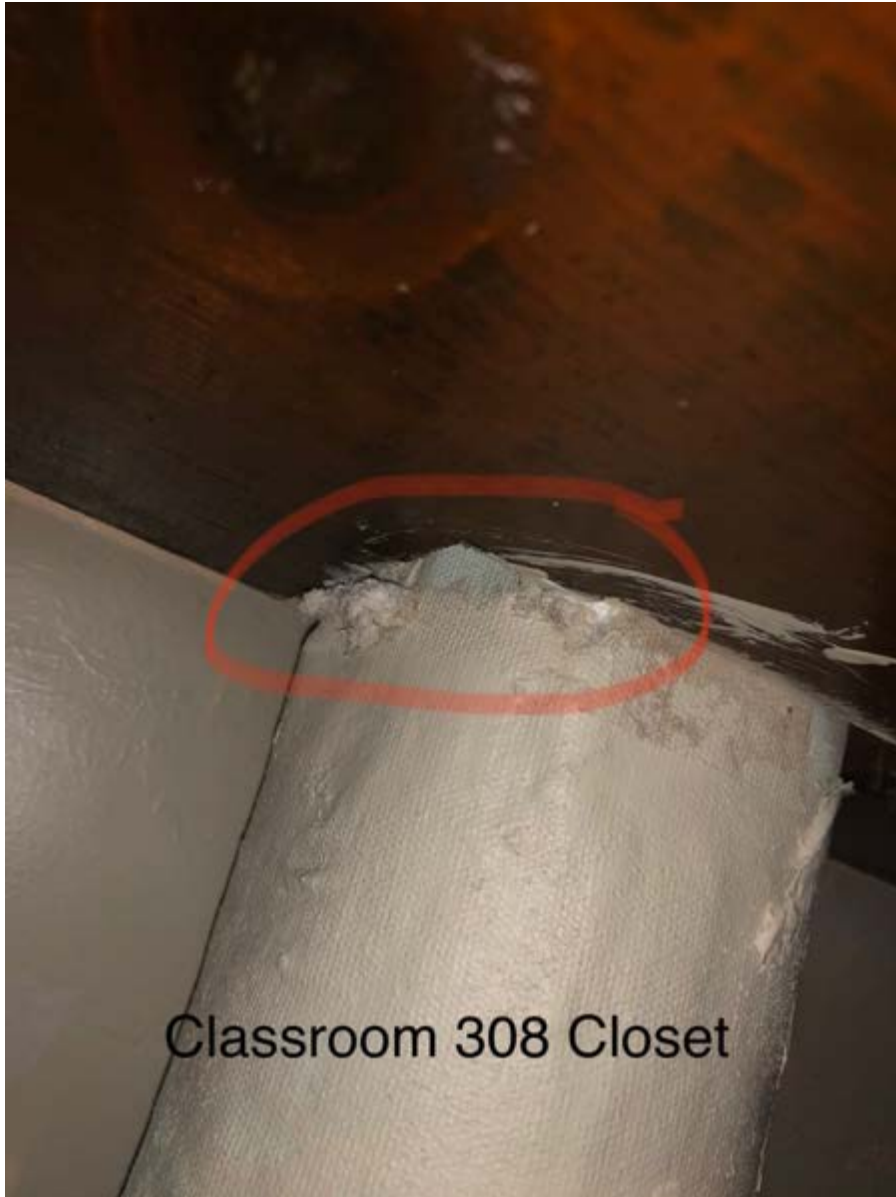
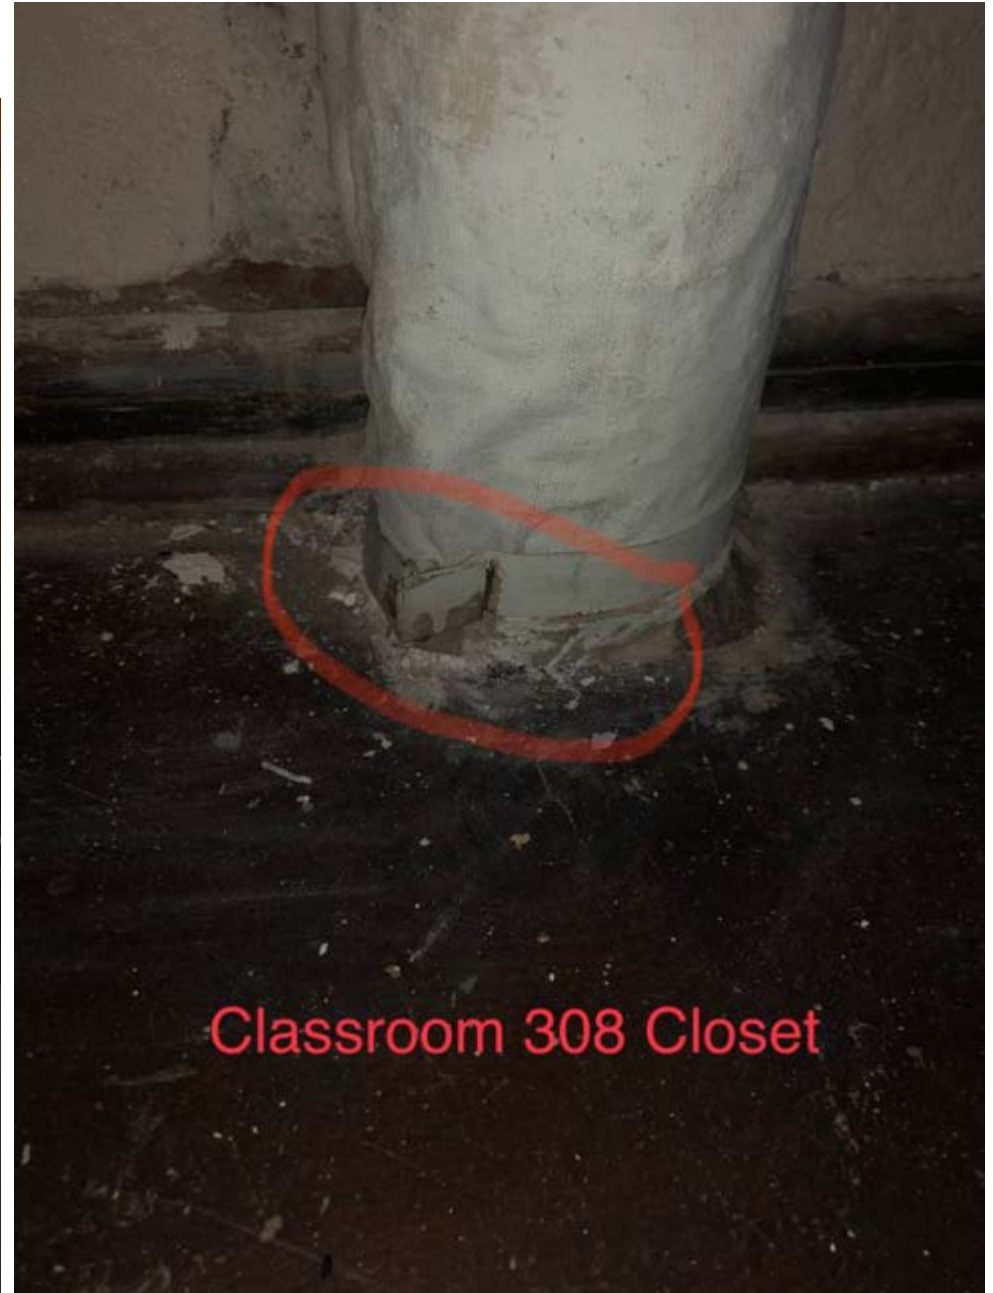
Classroom 308 Closet

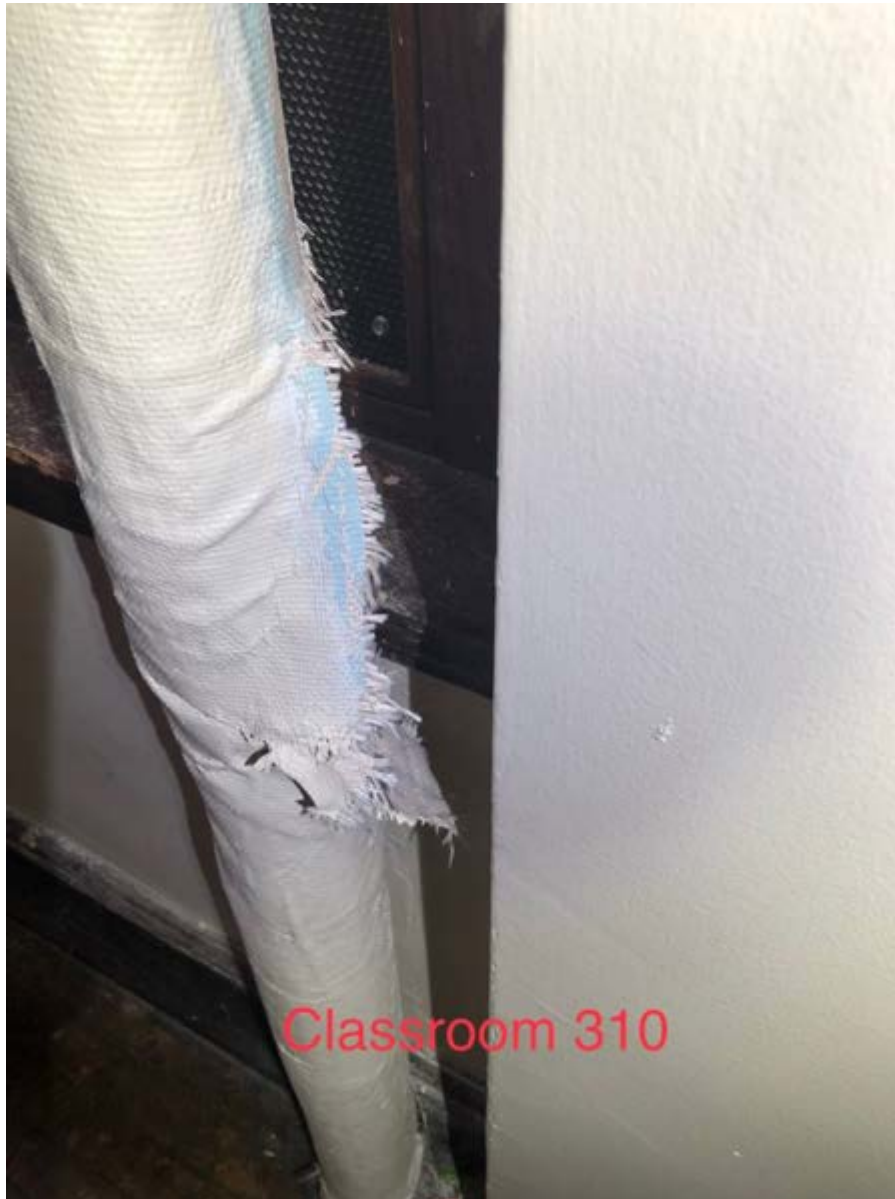
Asbestos Design Data Collection (DDC) 10242019

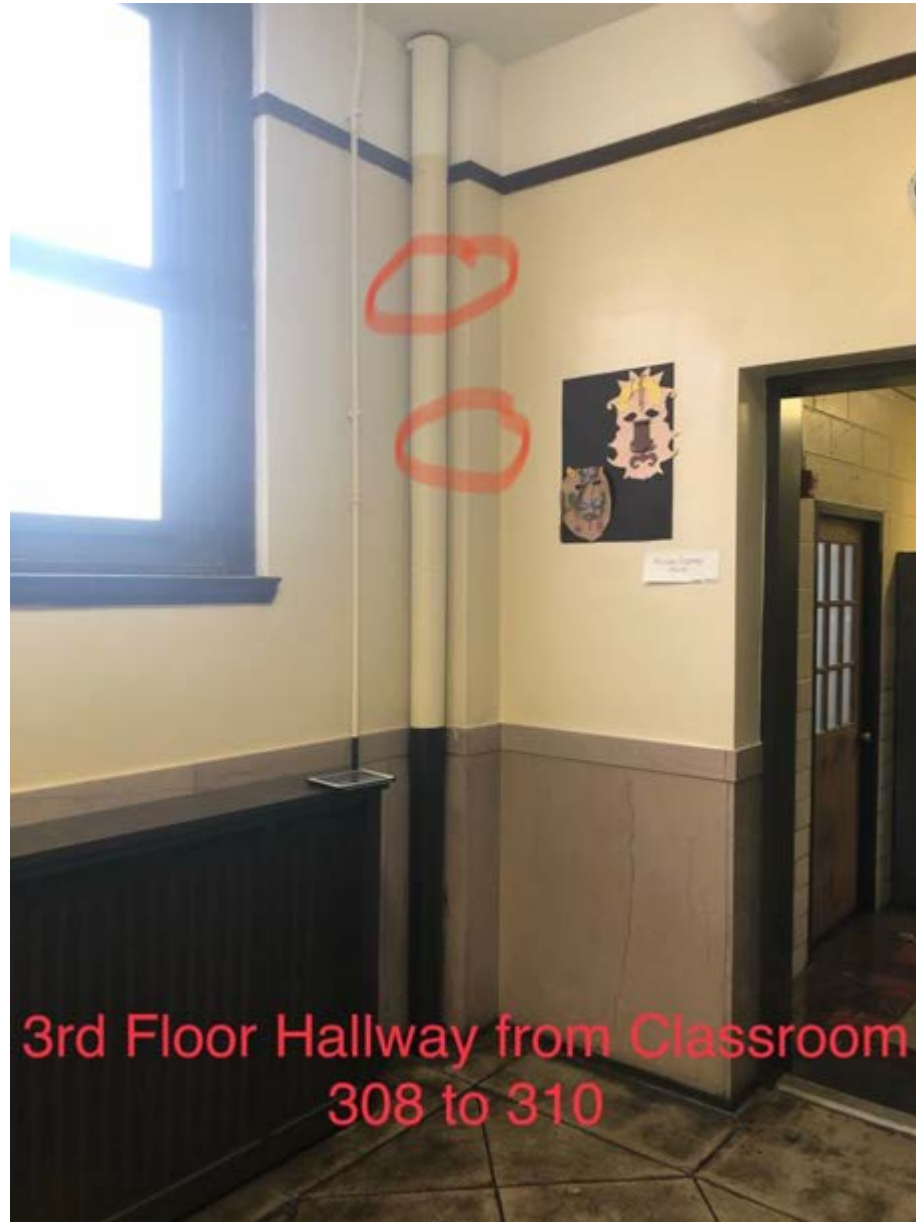
Asbestos Design Data Collection (DDC) 10242019

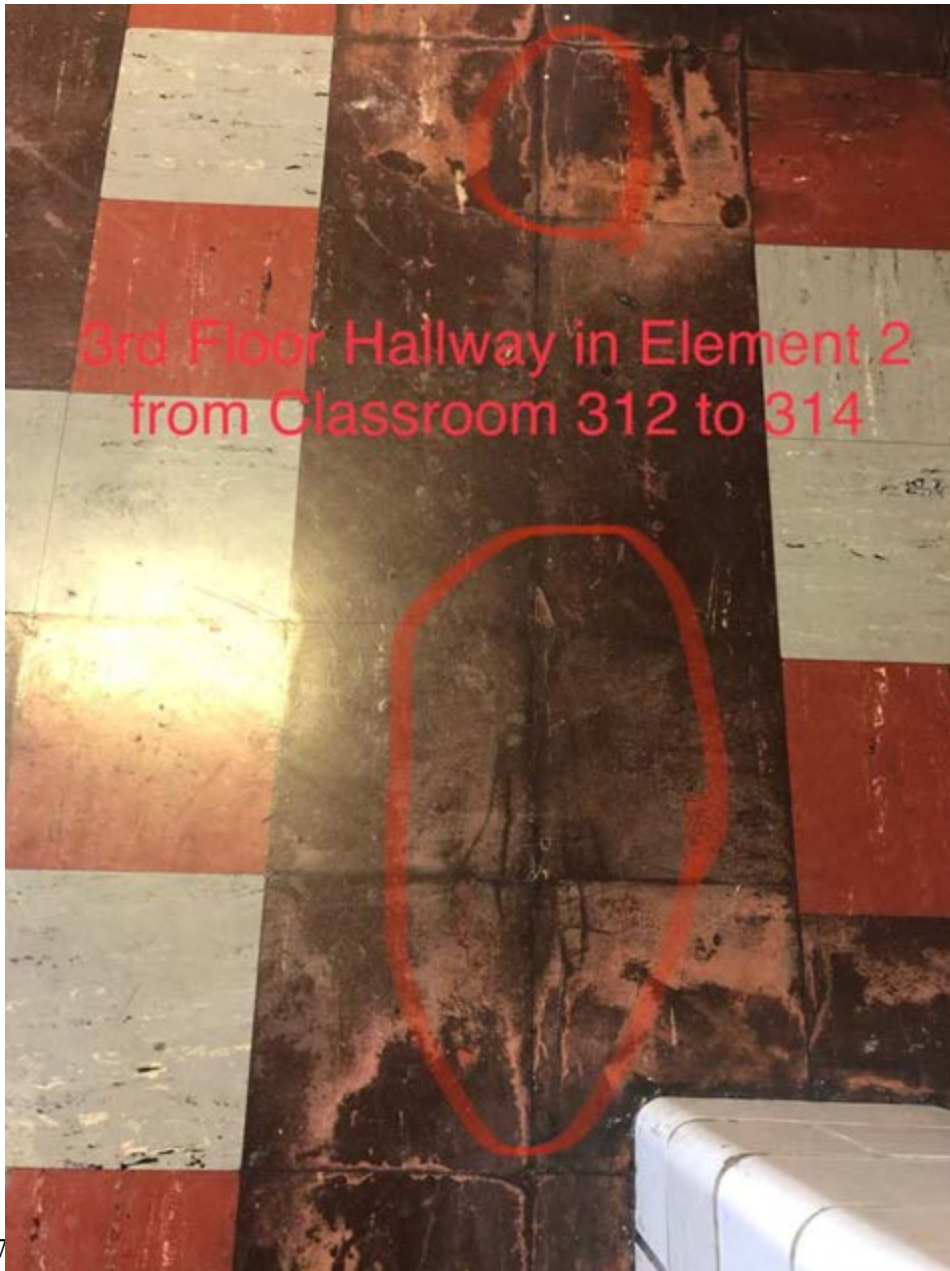
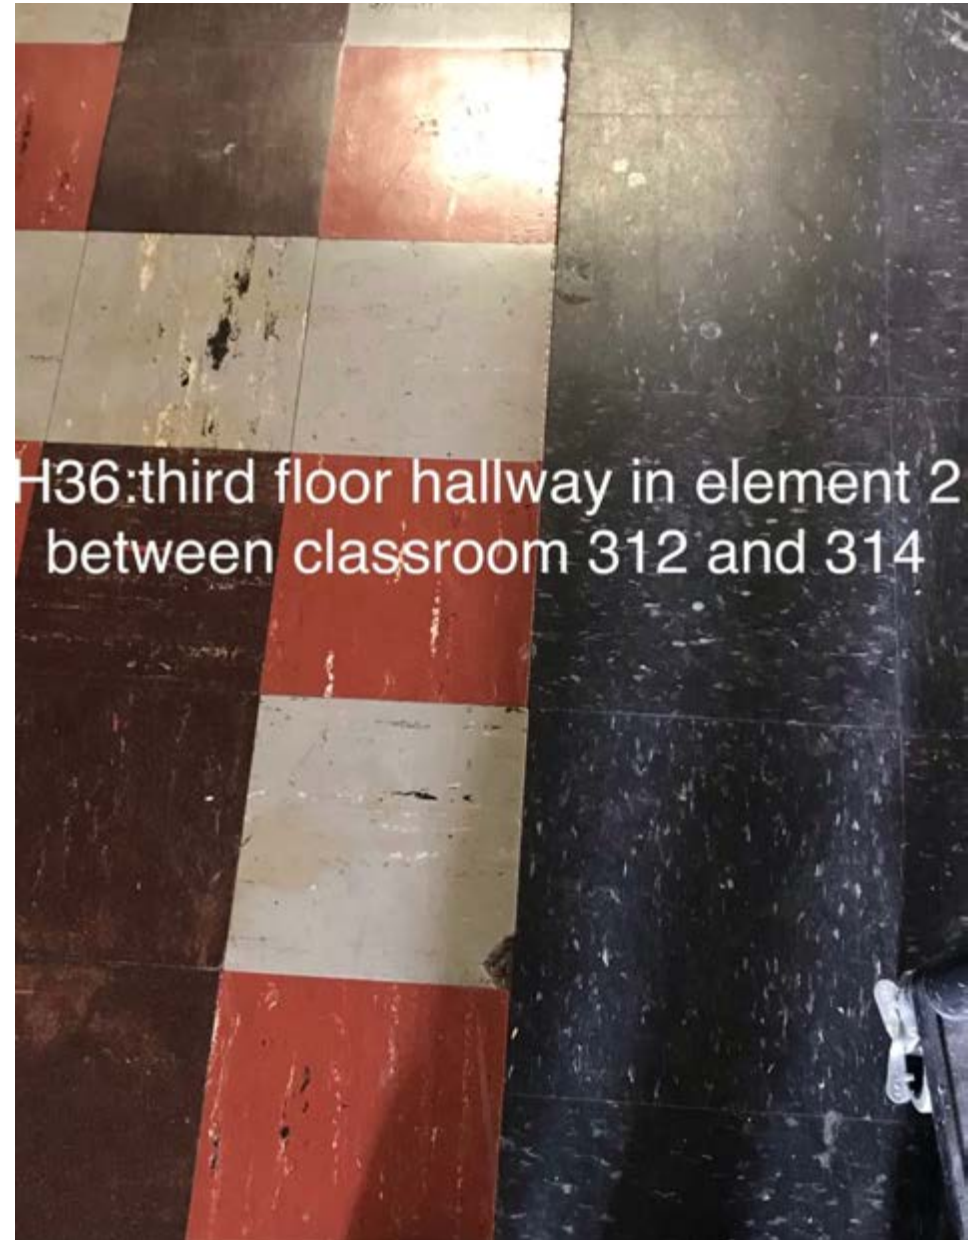
Asbestos Design Data Collection (DDC) 10242019

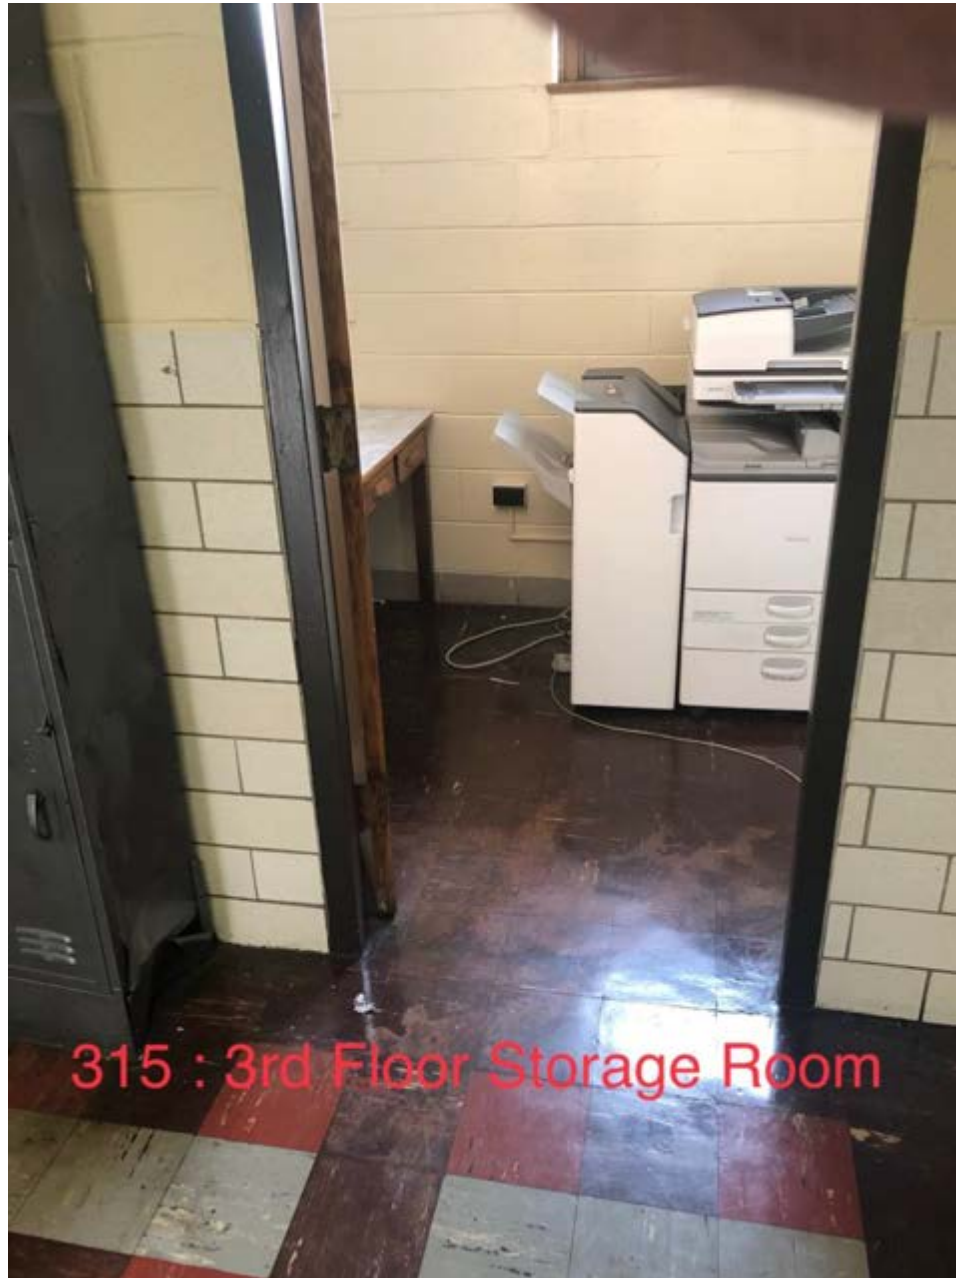
Asbestos Design Data Collection (DDC) 10242019

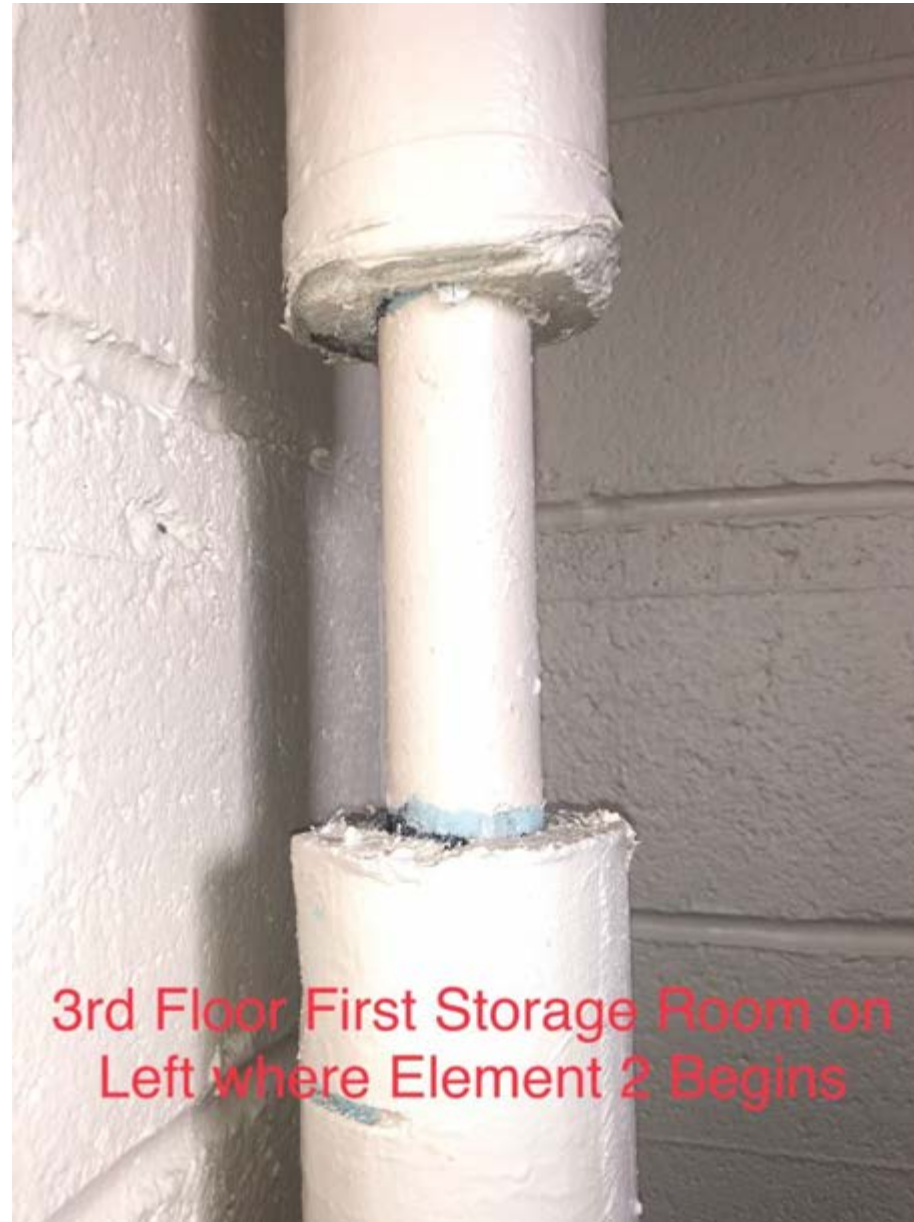
Asbestos Design Data Collection (DDC) 10242019
