Asbestos Design Data Collection (DDC) 10242019

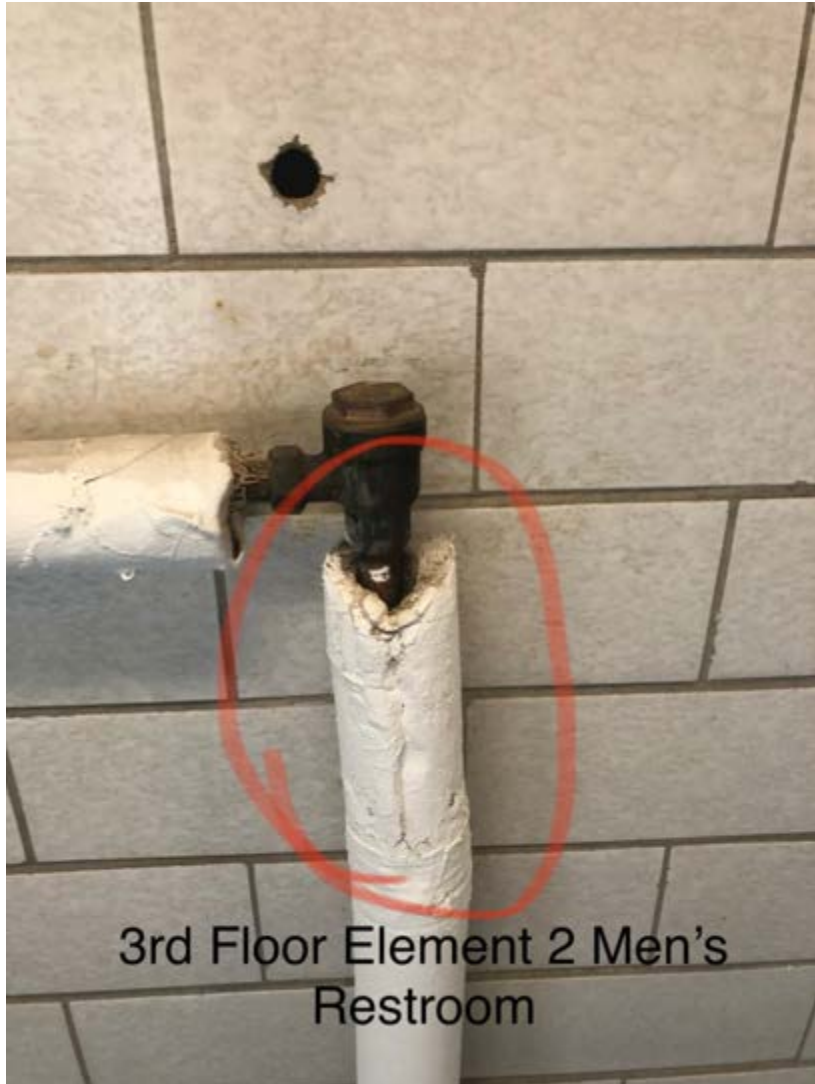
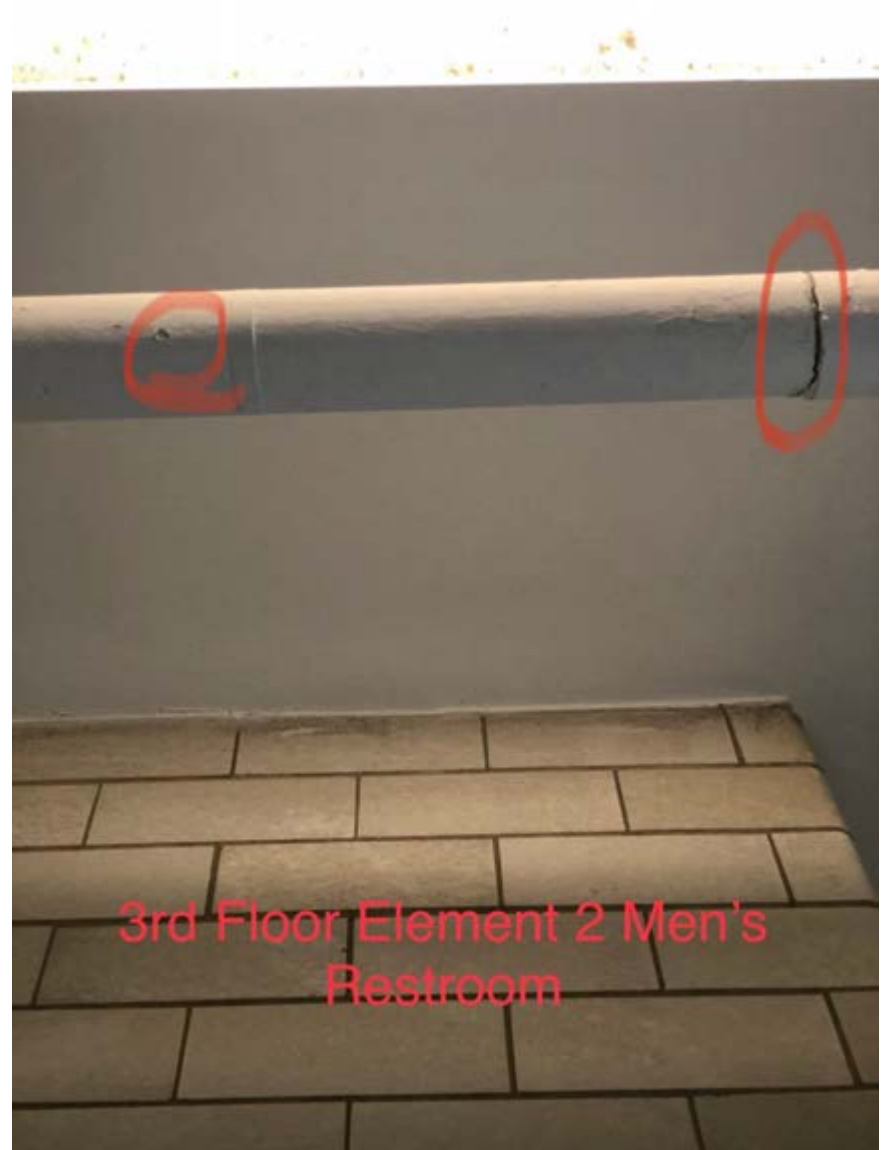
Asbestos Design Data Collection (DDC) 10242019

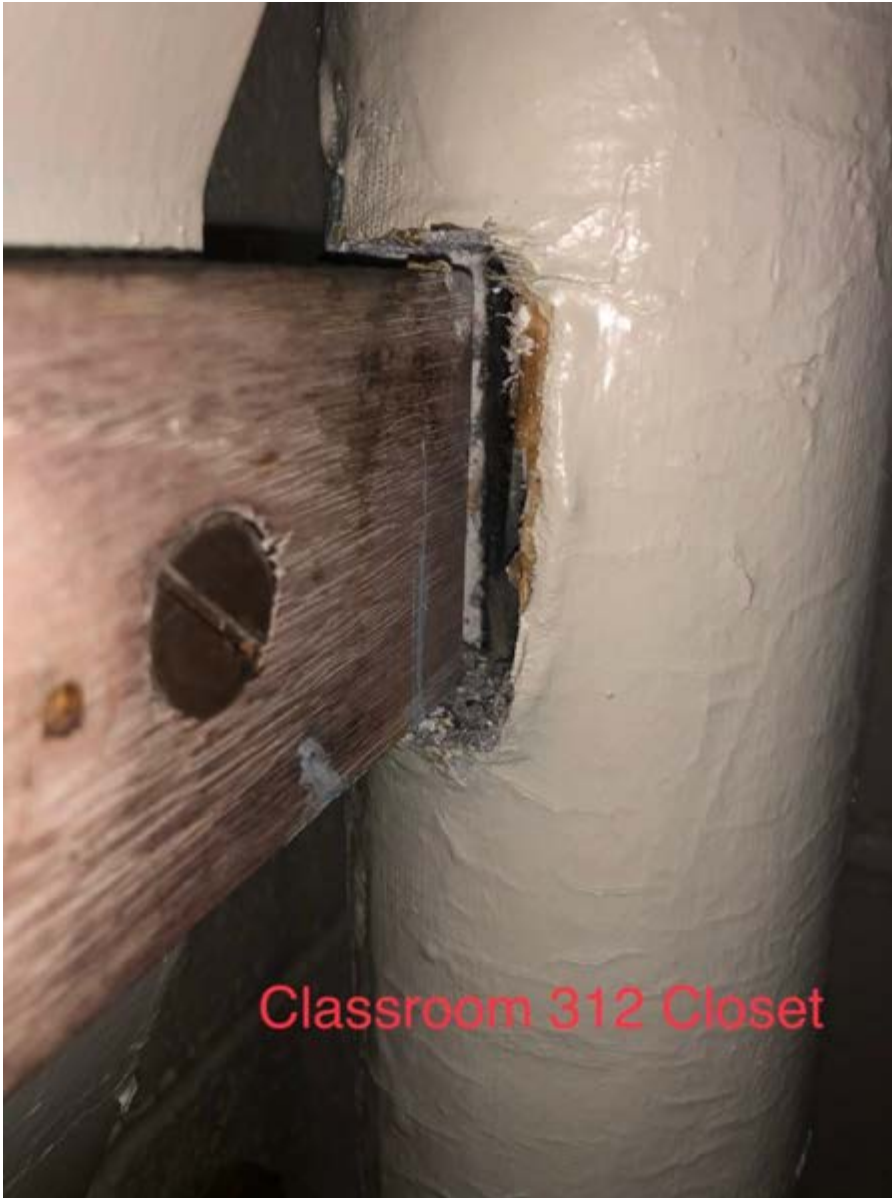
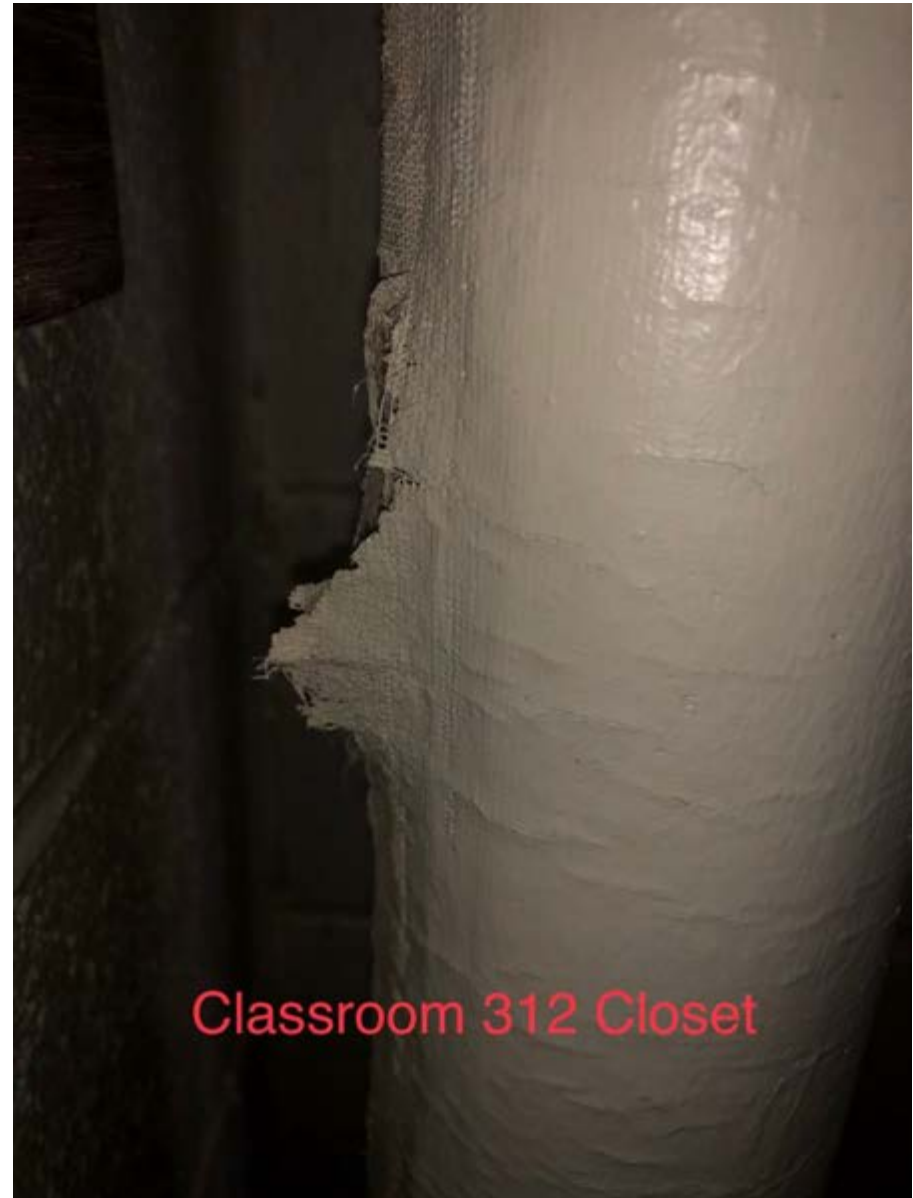
Asbestos Design Data Collection (DDC) 10242019

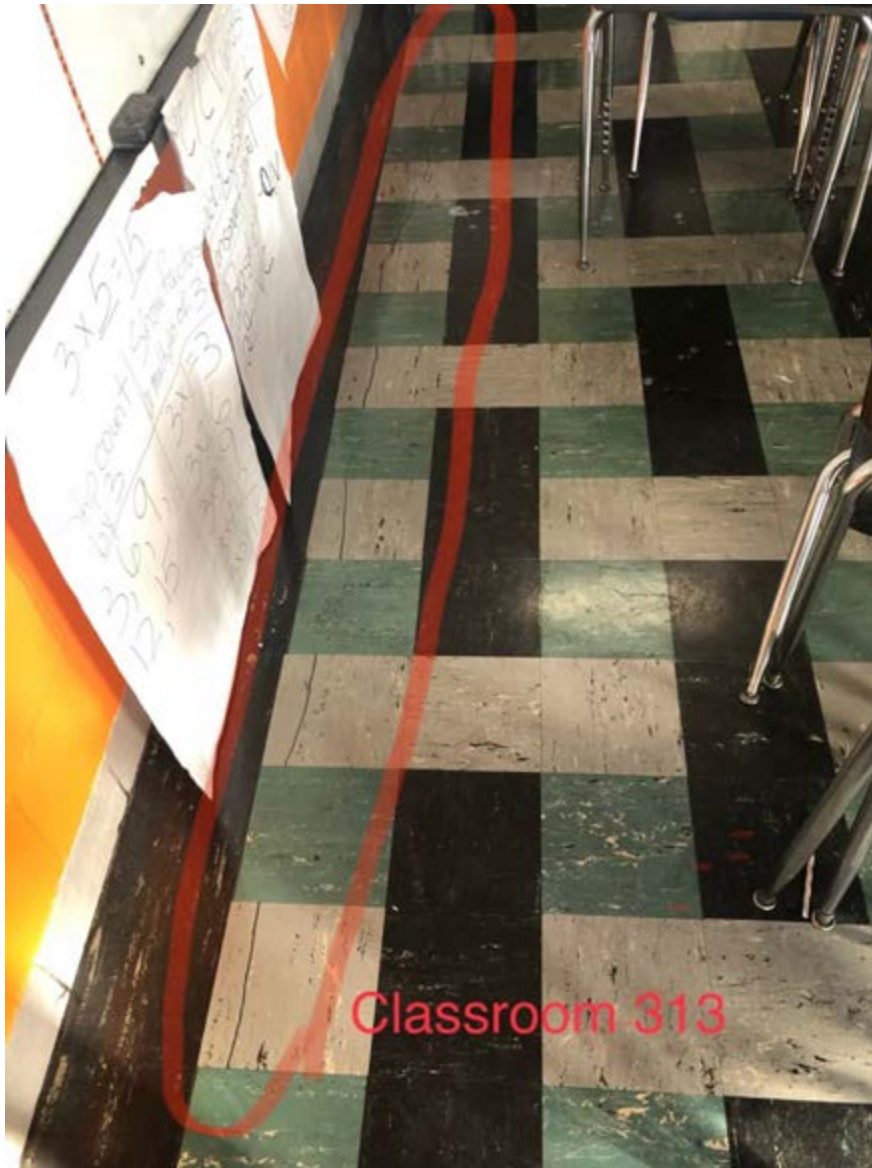
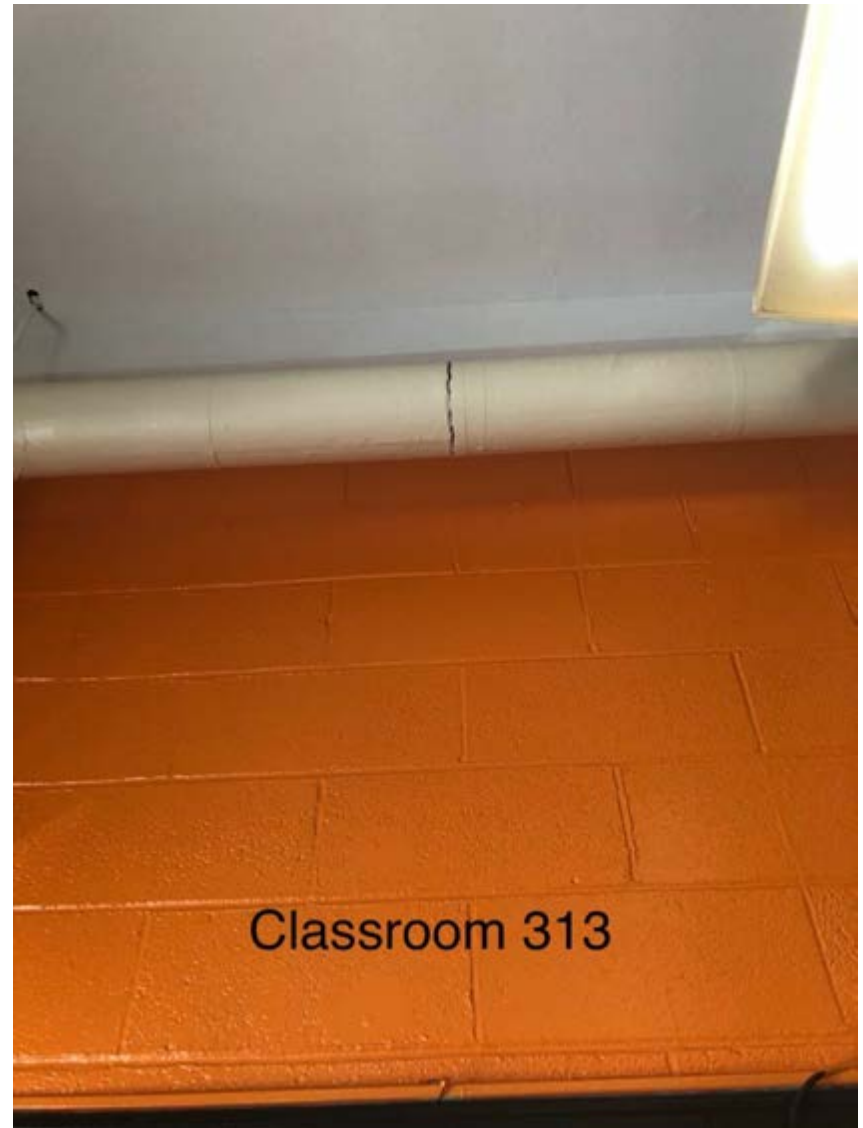
Asbestos Design Data Collection (DDC) 10242019

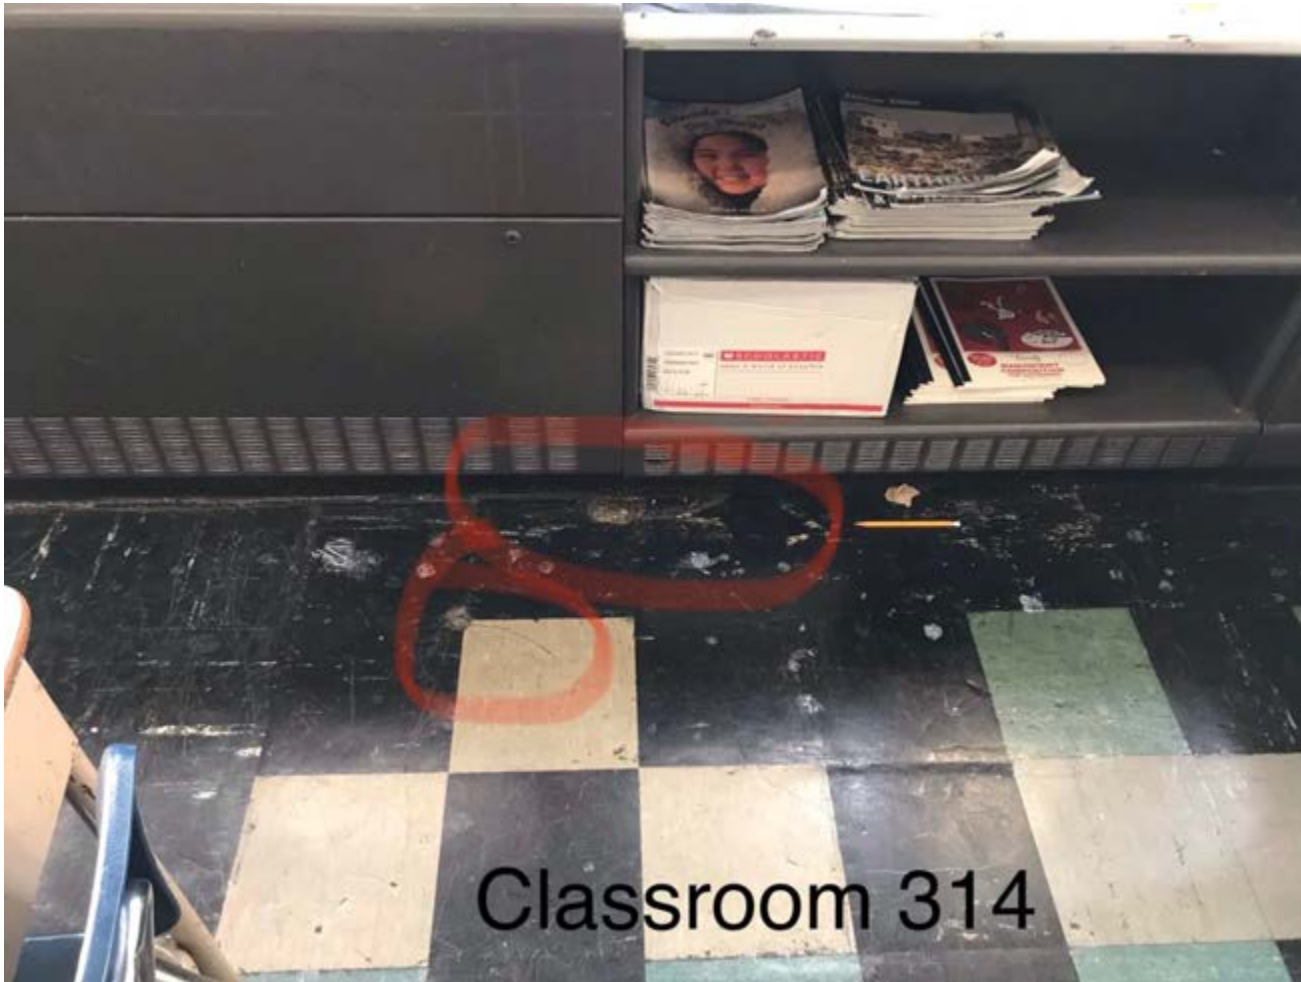
Asbestos Design Data Collection (DDC) 10242019

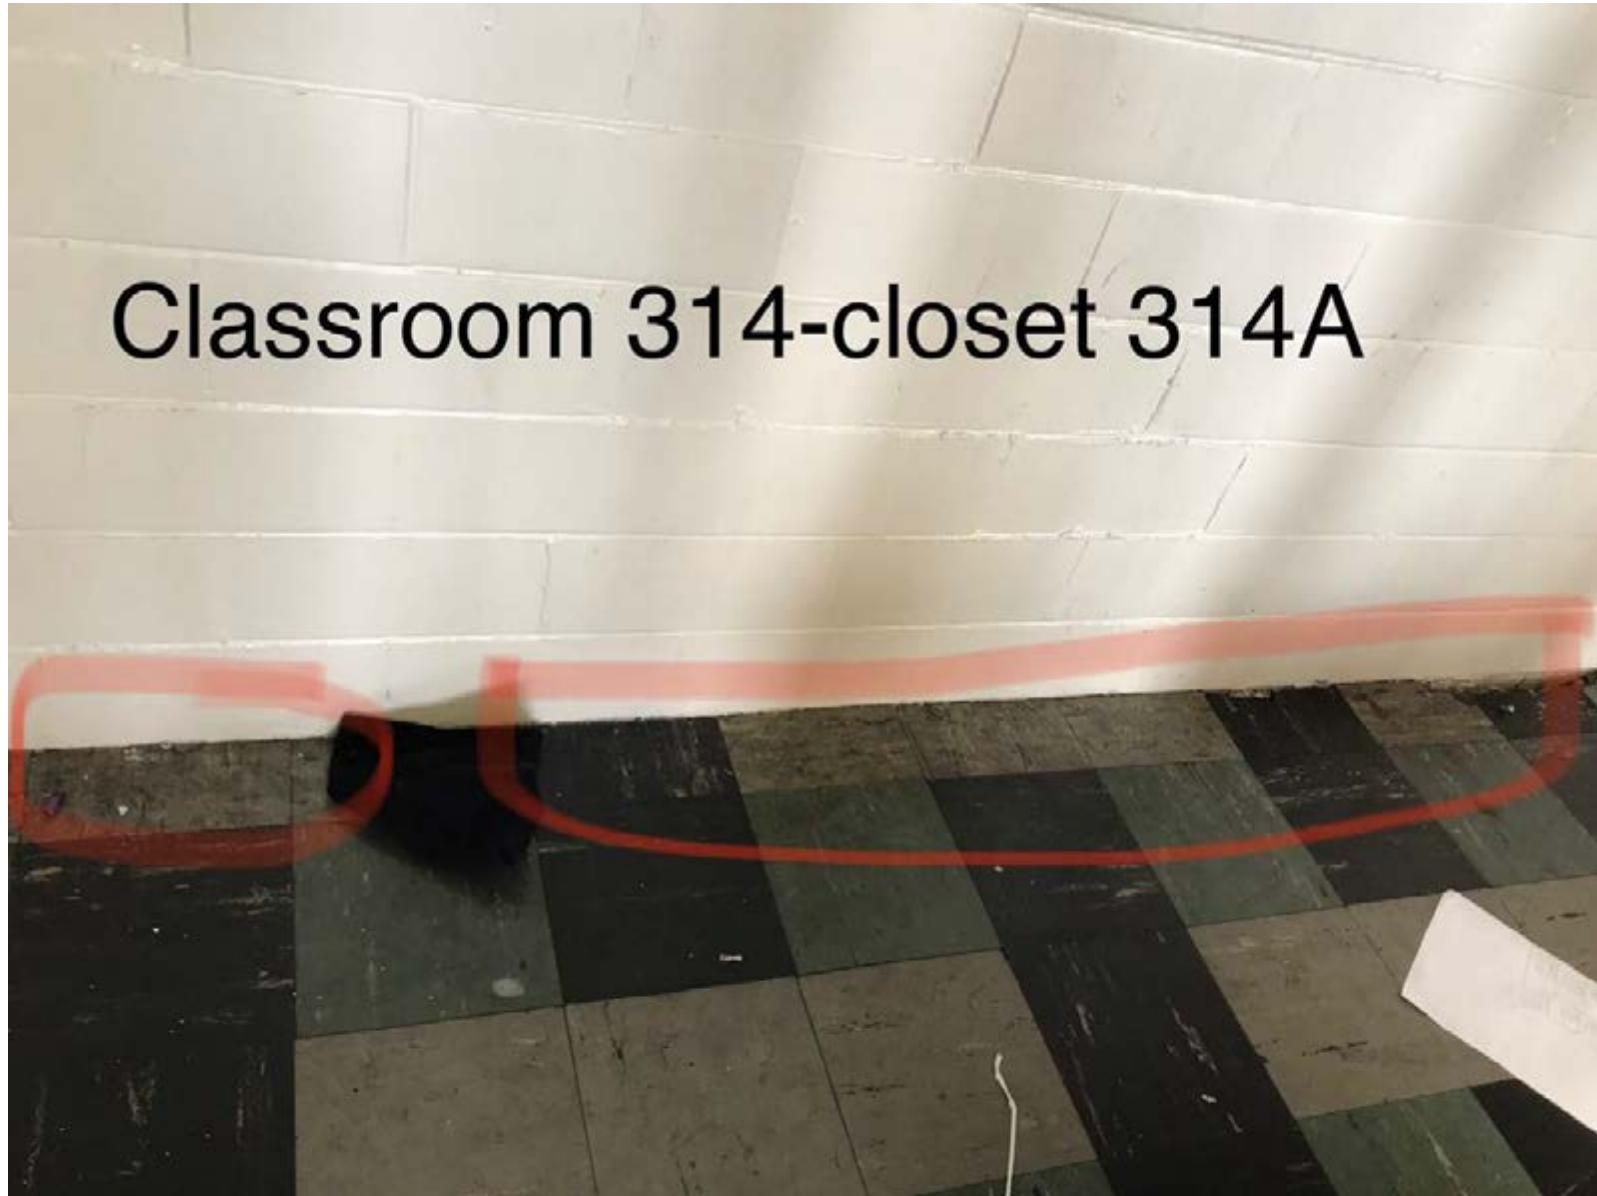
Asbestos Design Data Collection (DDC) 10242019

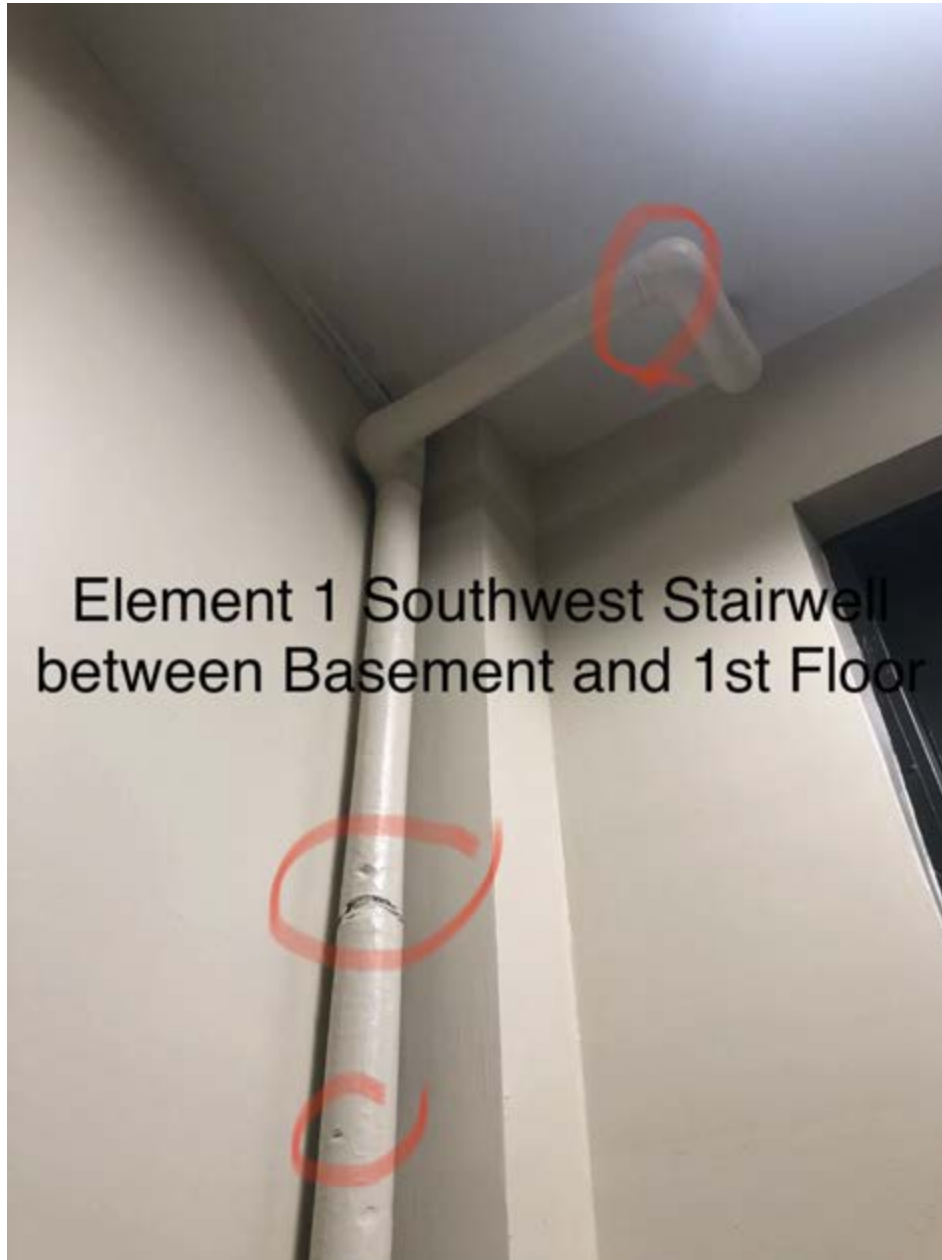
Asbestos Design Data Collection (DDC) 10242019

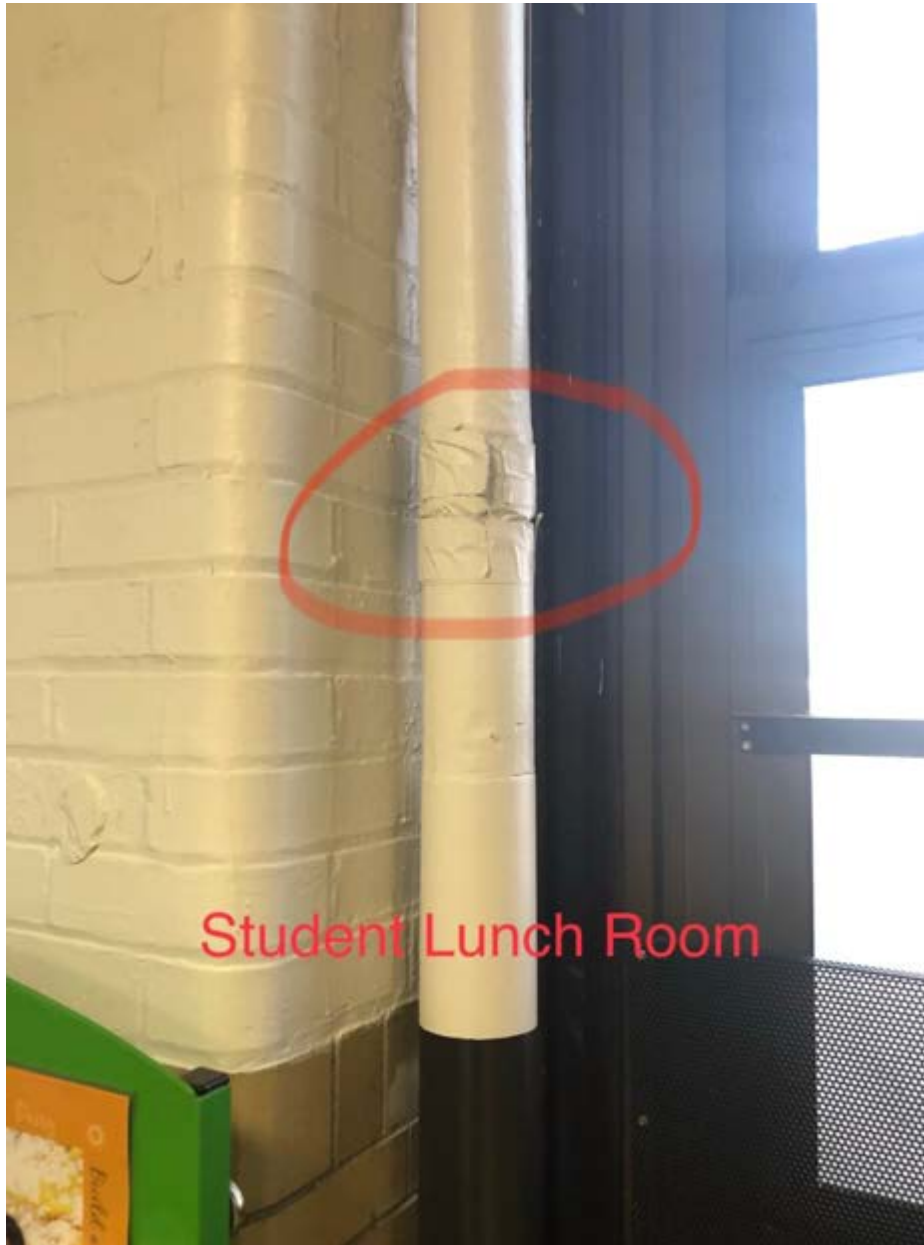
Asbestos Design Data Collection (DDC) 10242019

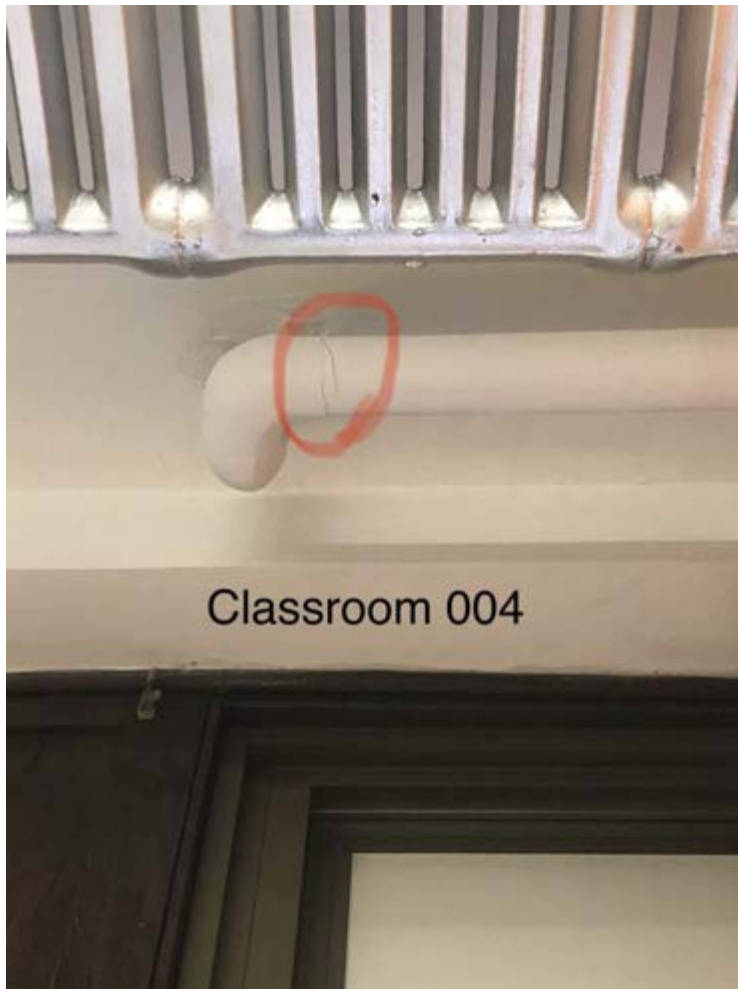
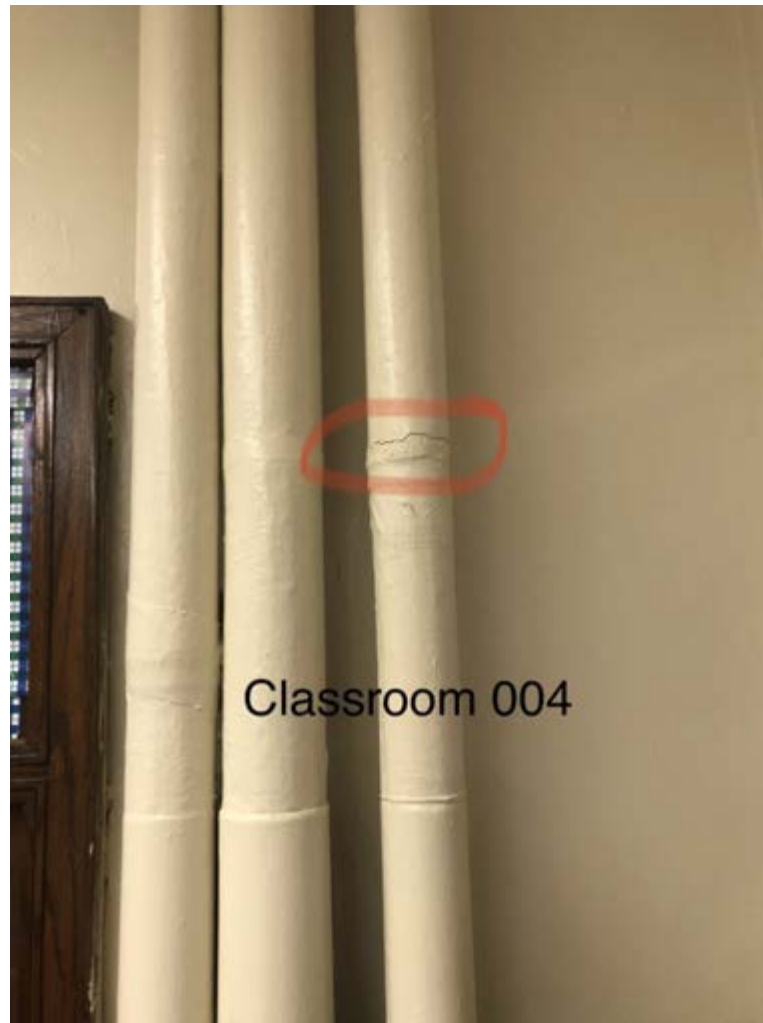
Asbestos Design Data Collection (DDC) 10242019

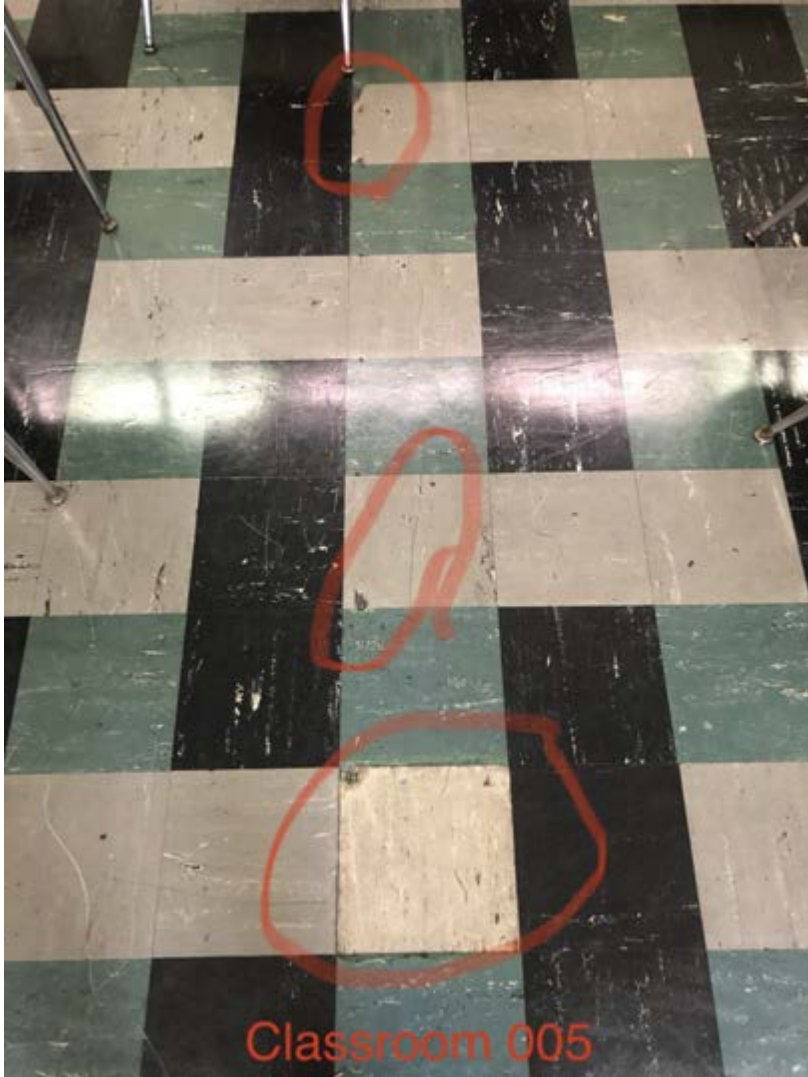
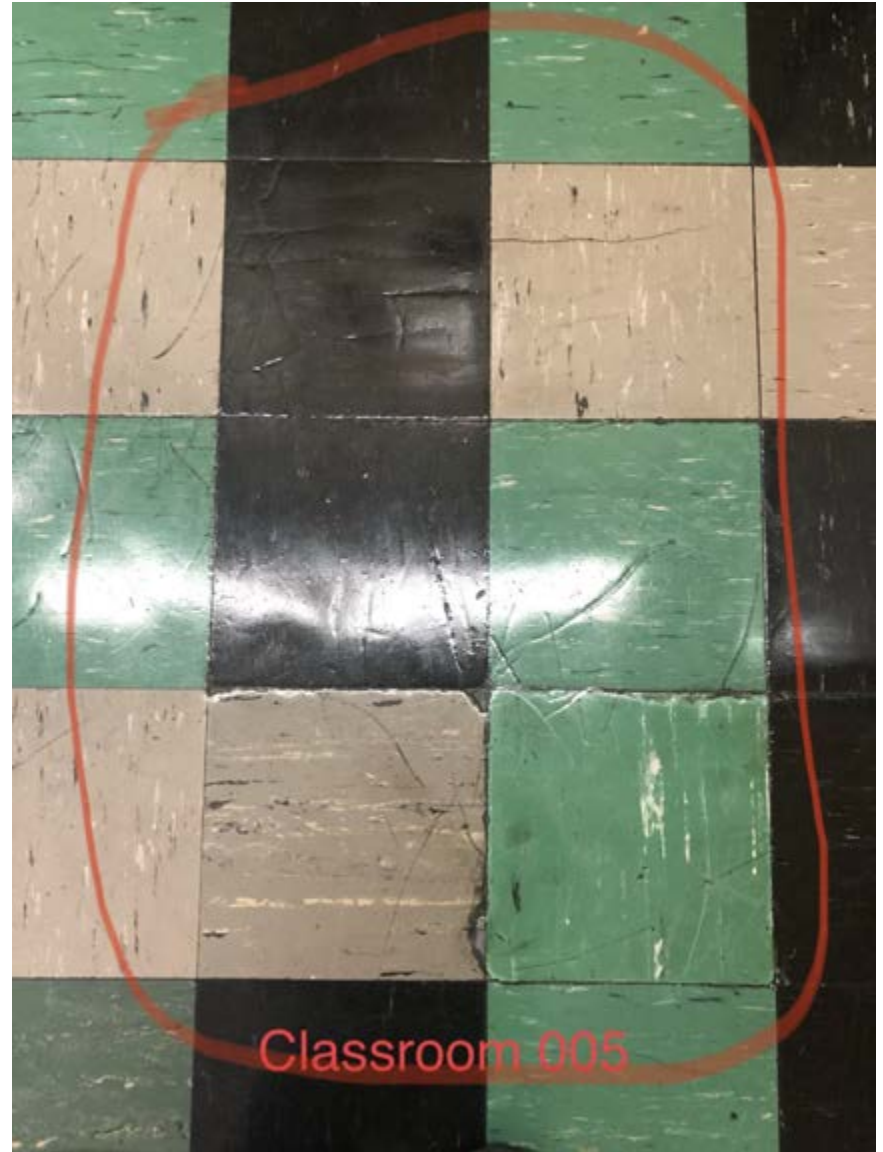
Asbestos Design Data Collection (DDC) 10242019

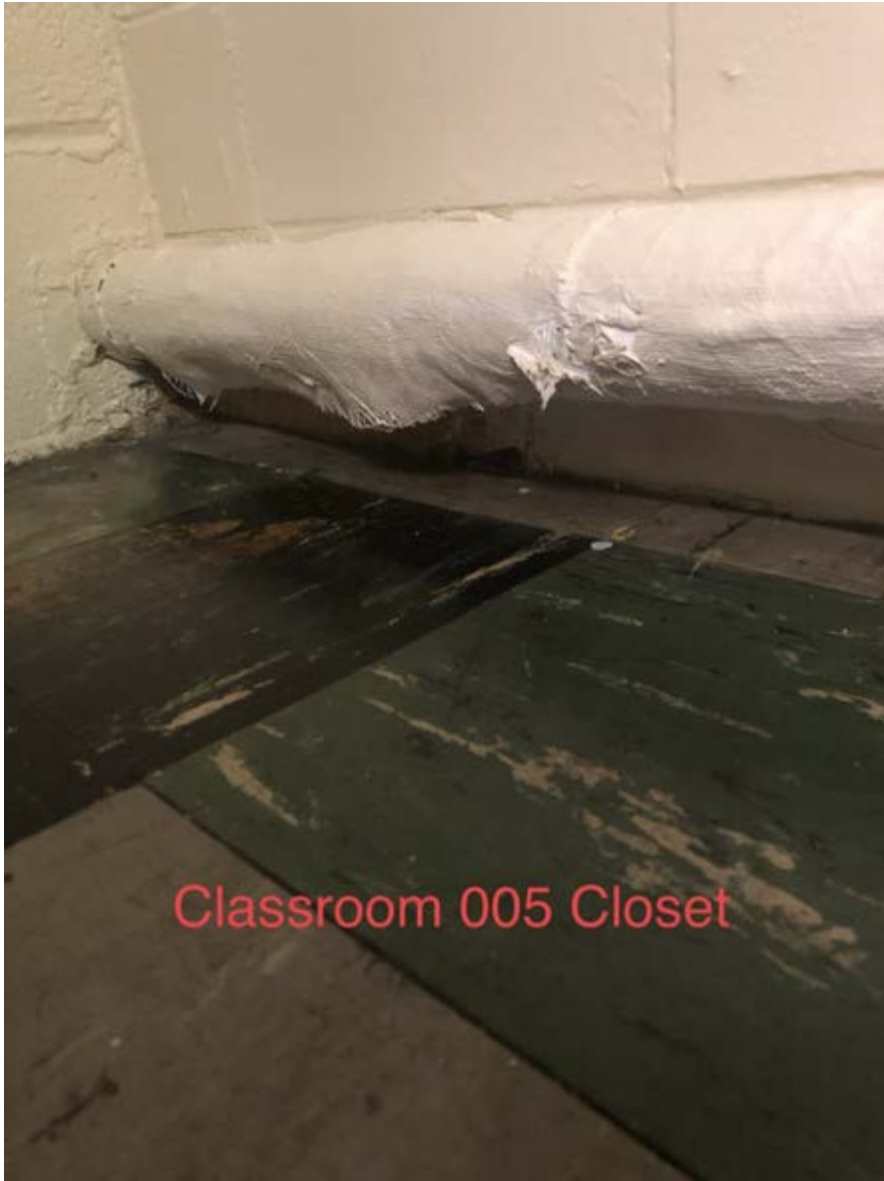
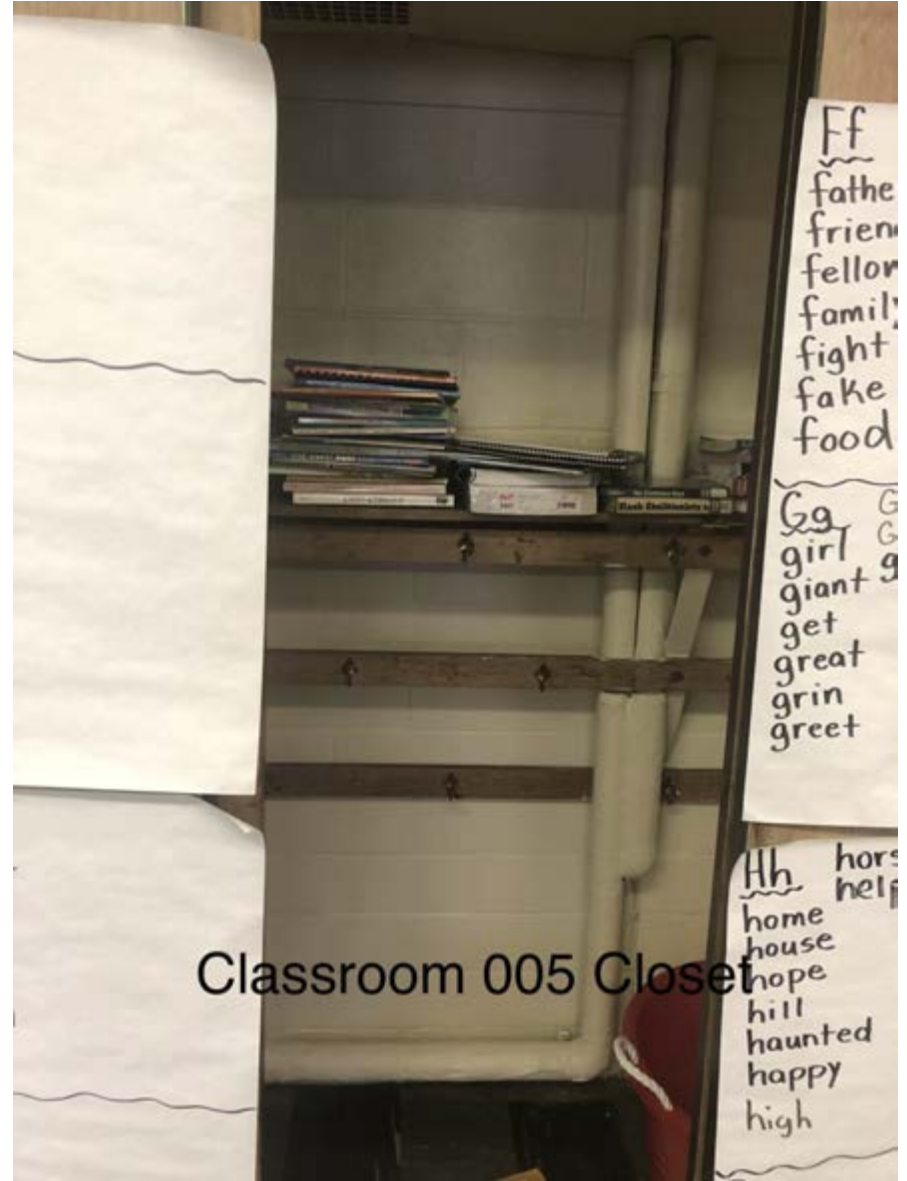
Asbestos Design Data Collection (DDC) 10242019

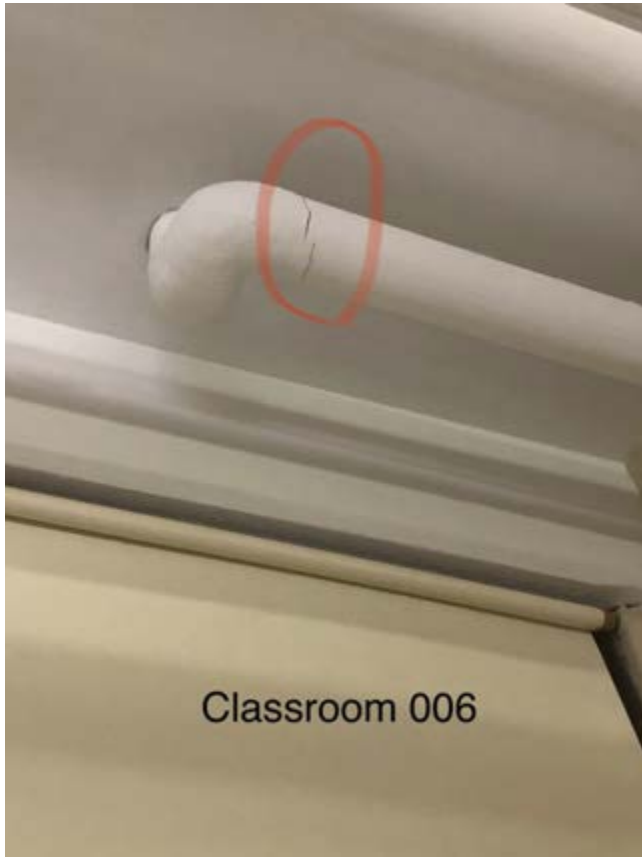
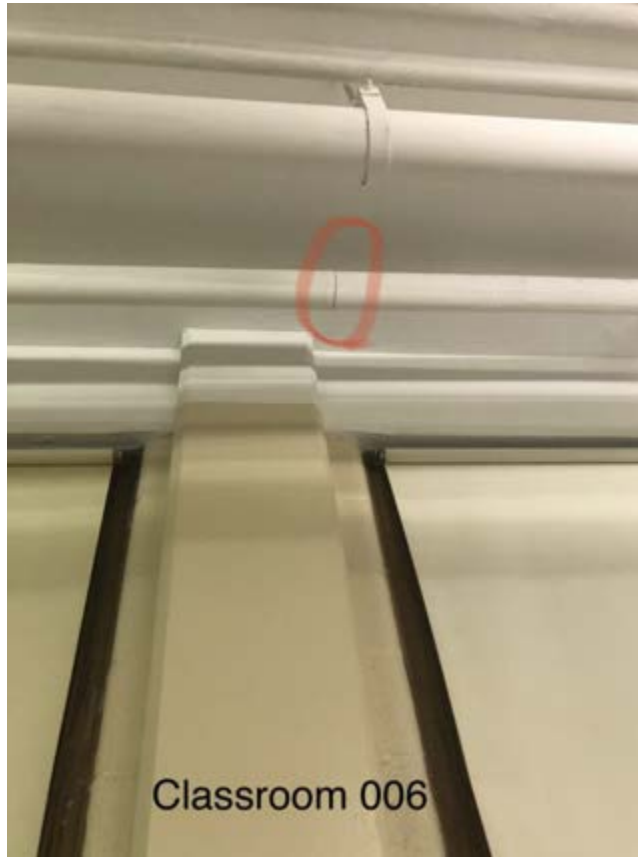
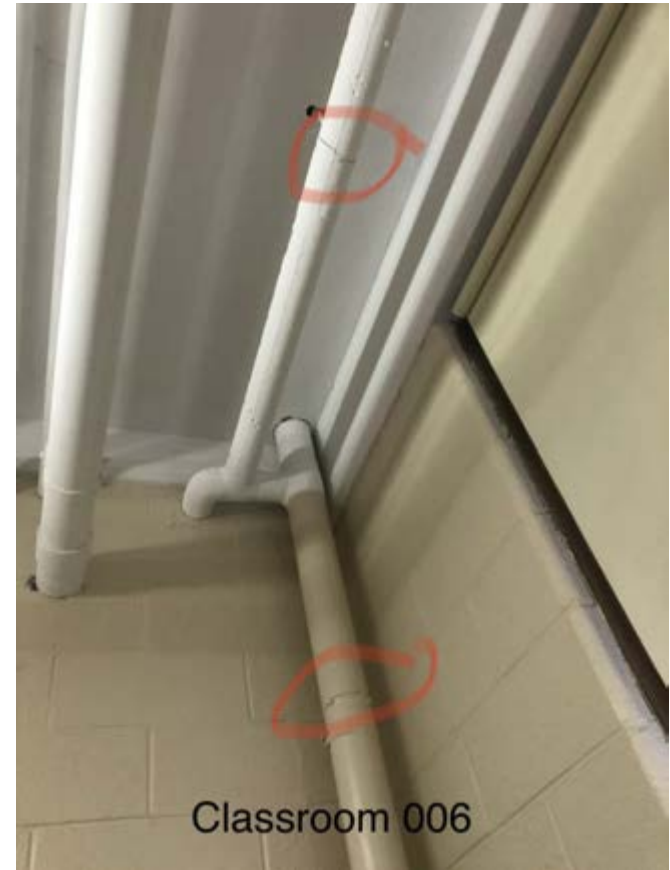
Asbestos Design Data Collection (DDC) 10242019

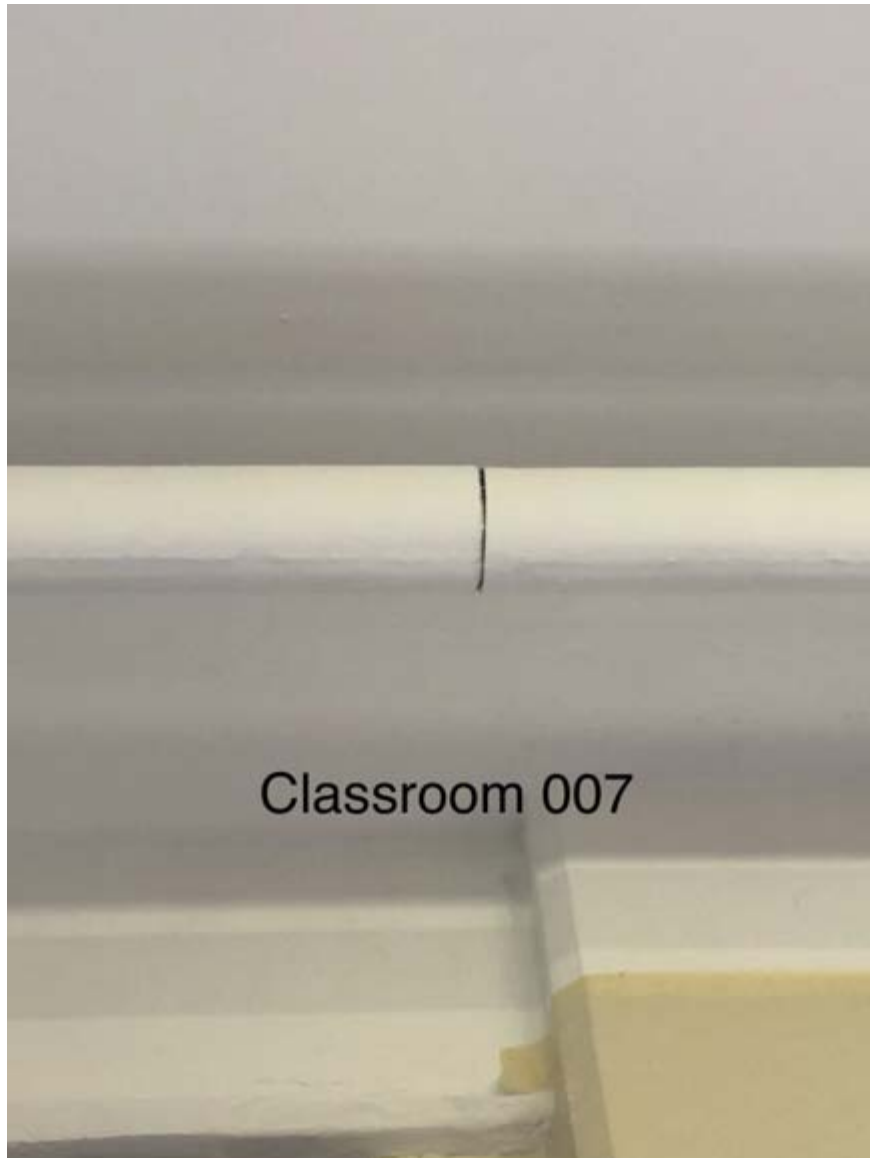
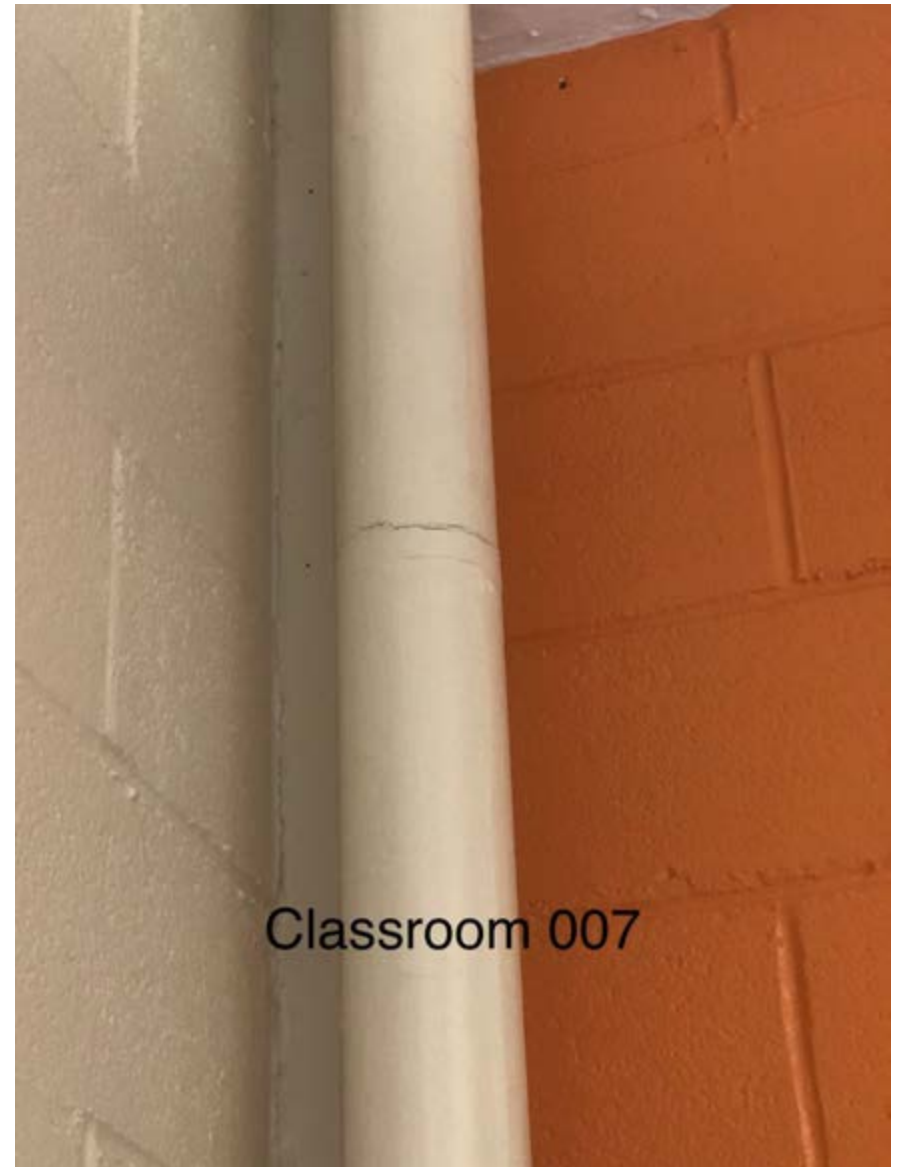
Asbestos Design Data Collection (DDC) 10242019

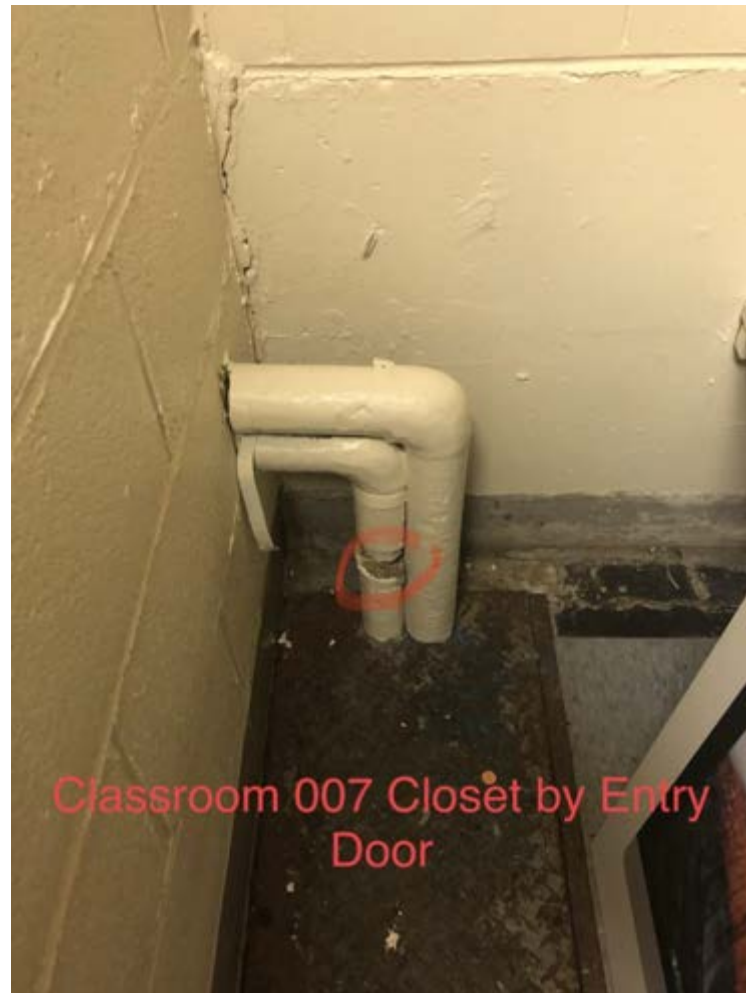
Asbestos Design Data Collection (DDC) 10242019

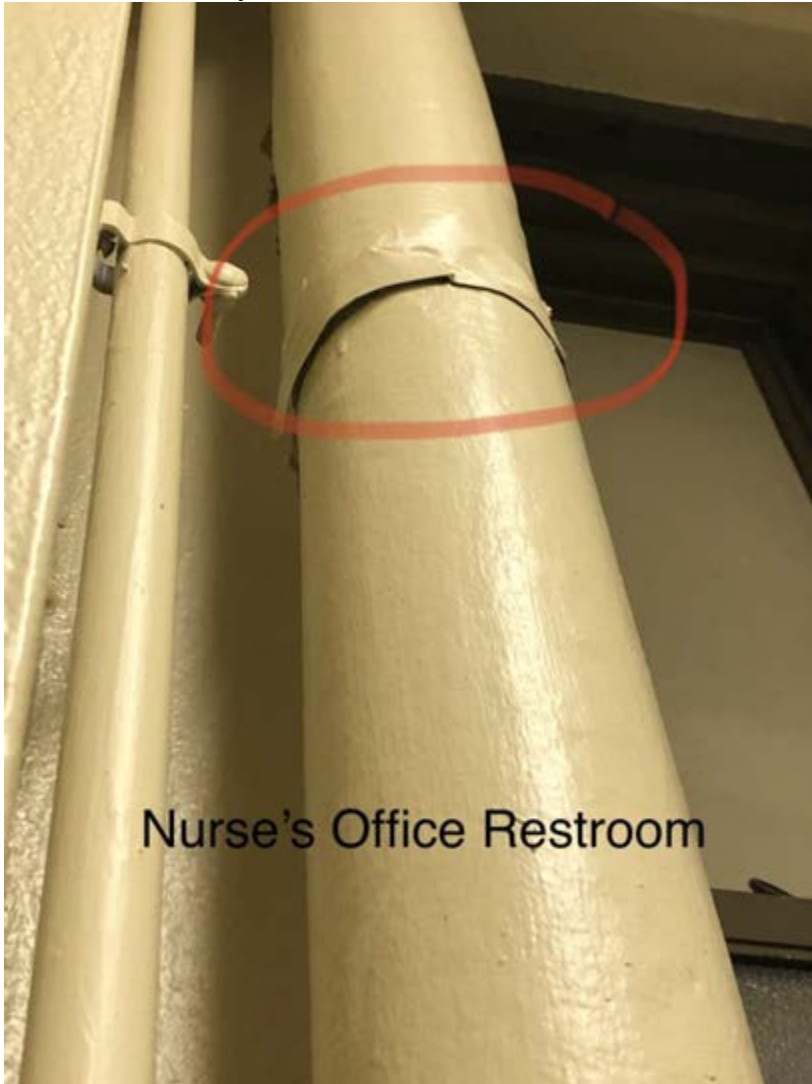
Asbestos Design Data Collection (DDC) 10242019
