Asbestos Design Data Collection (DDC) 10242019

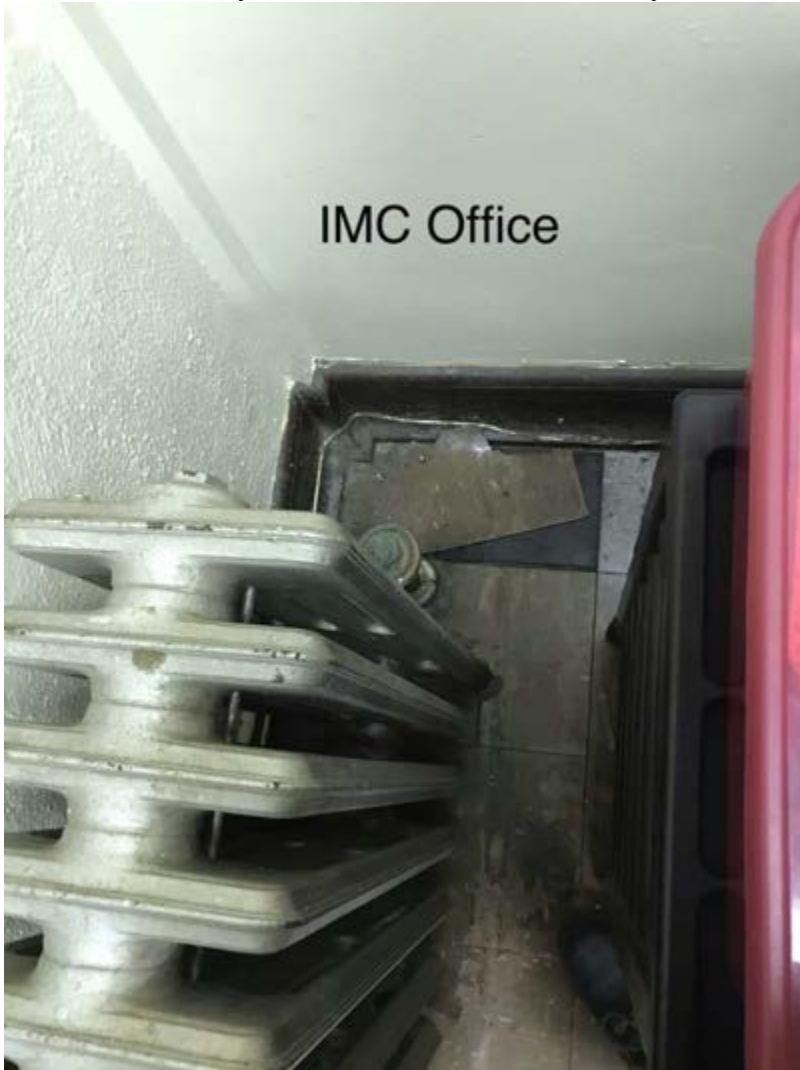
Asbestos Design Data Collection (DDC) 10242019

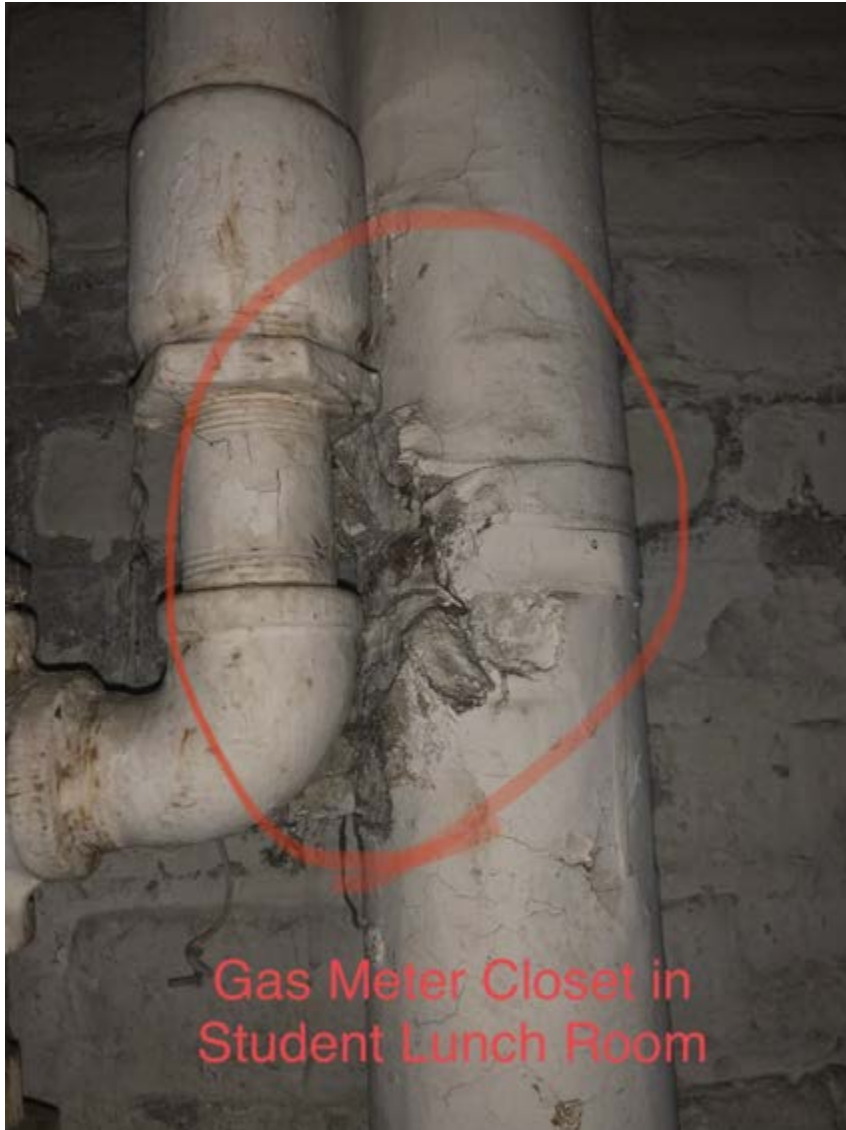
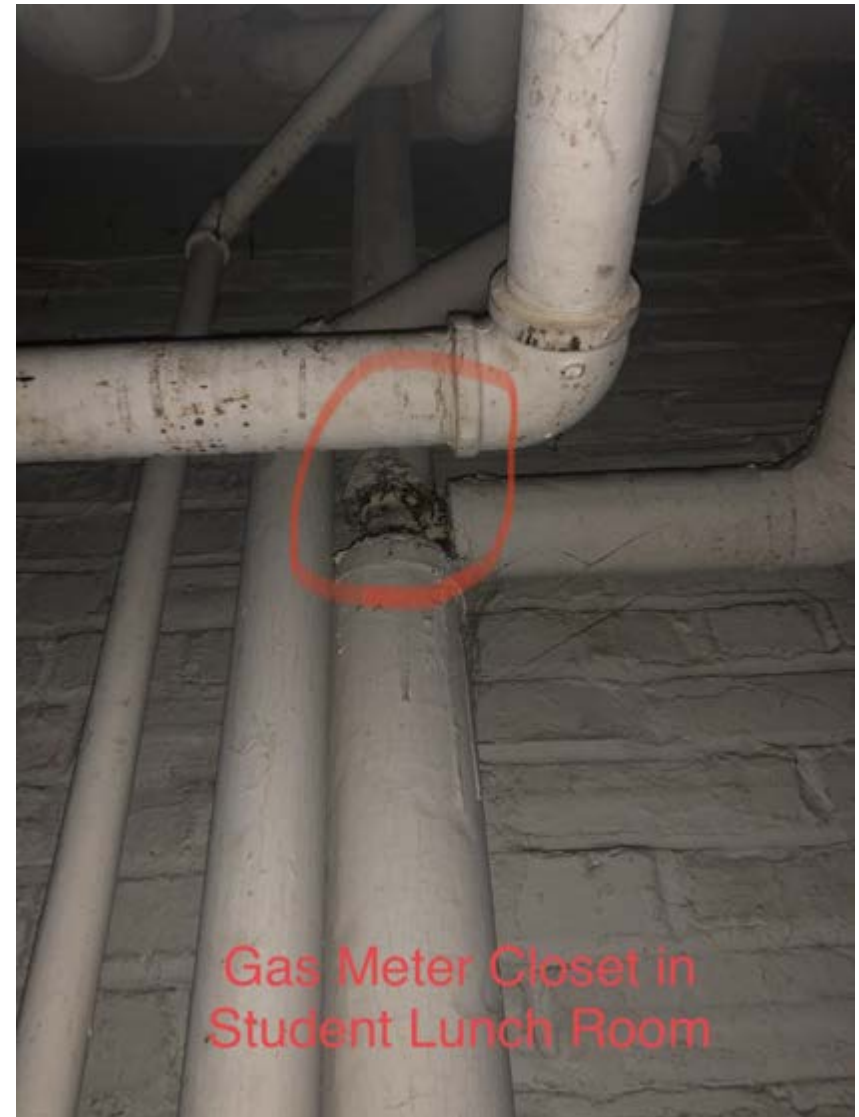
Asbestos Design Data Collection (DDC) 10242019

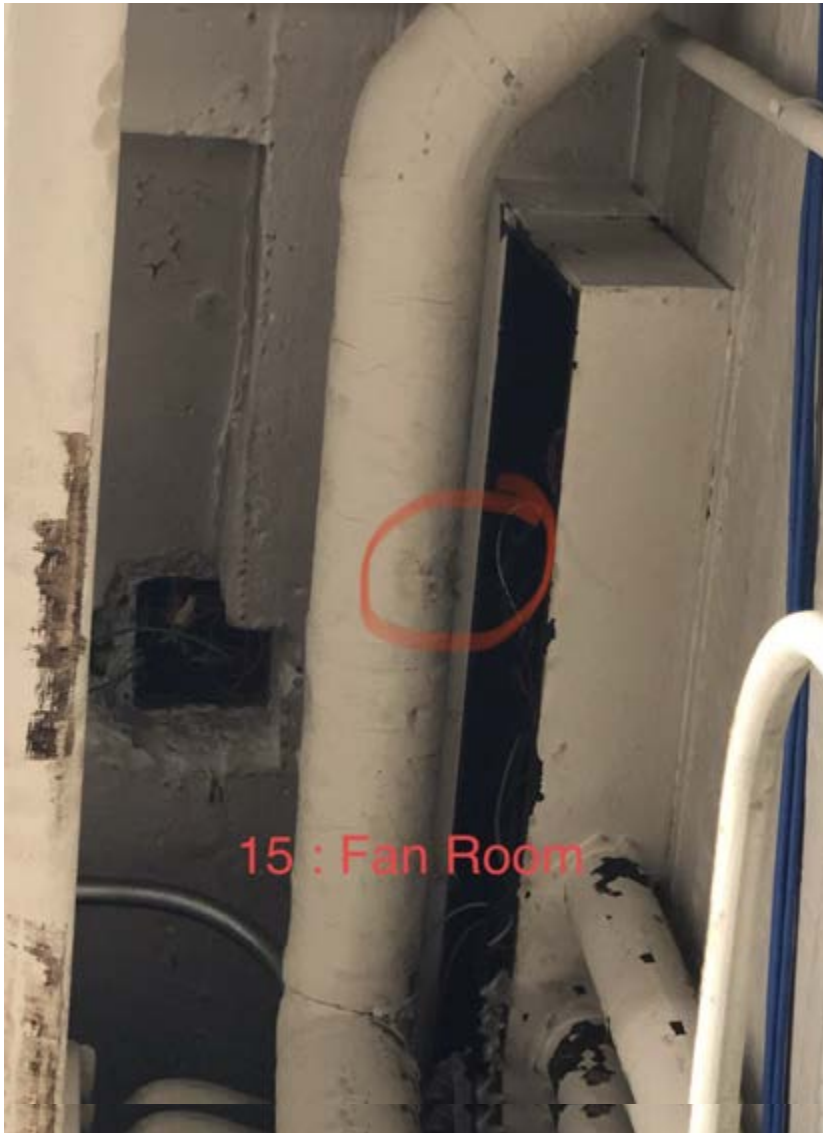
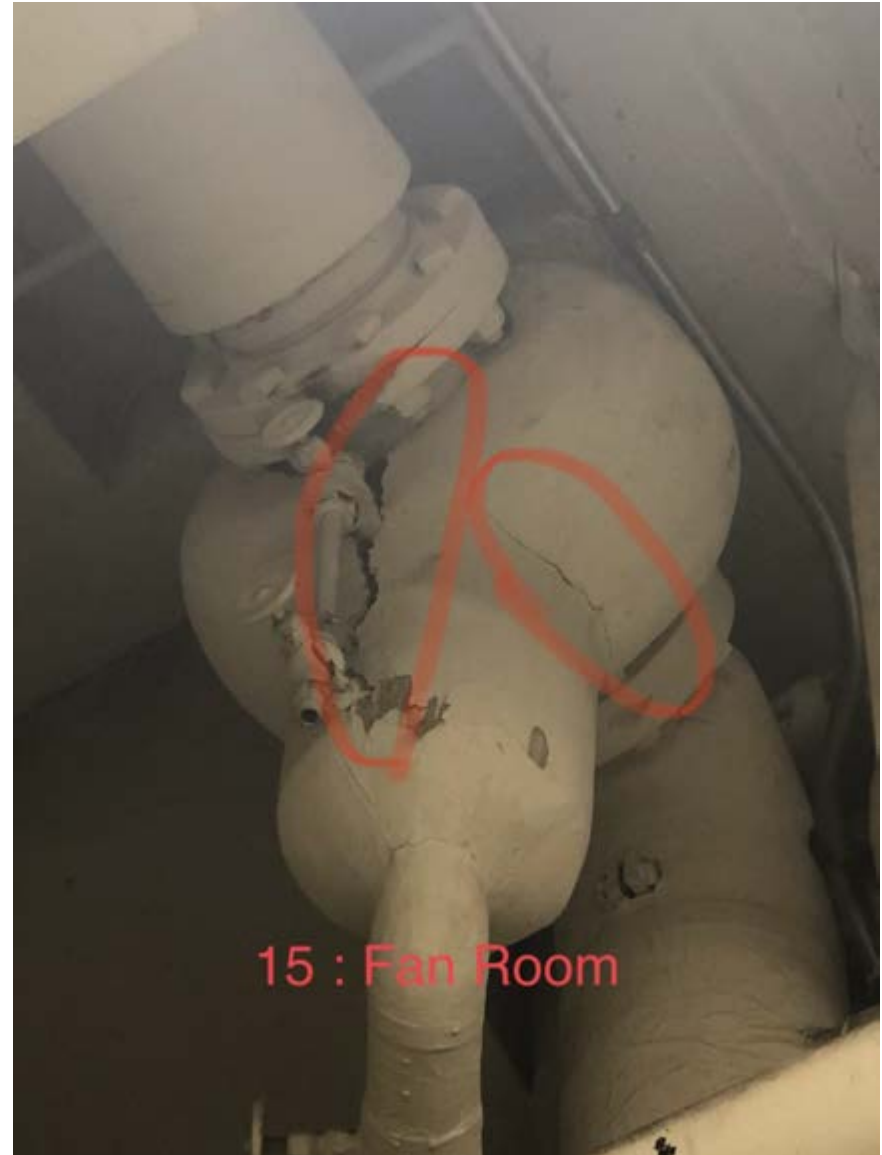
Asbestos Design Data Collection (DDC) 10242019

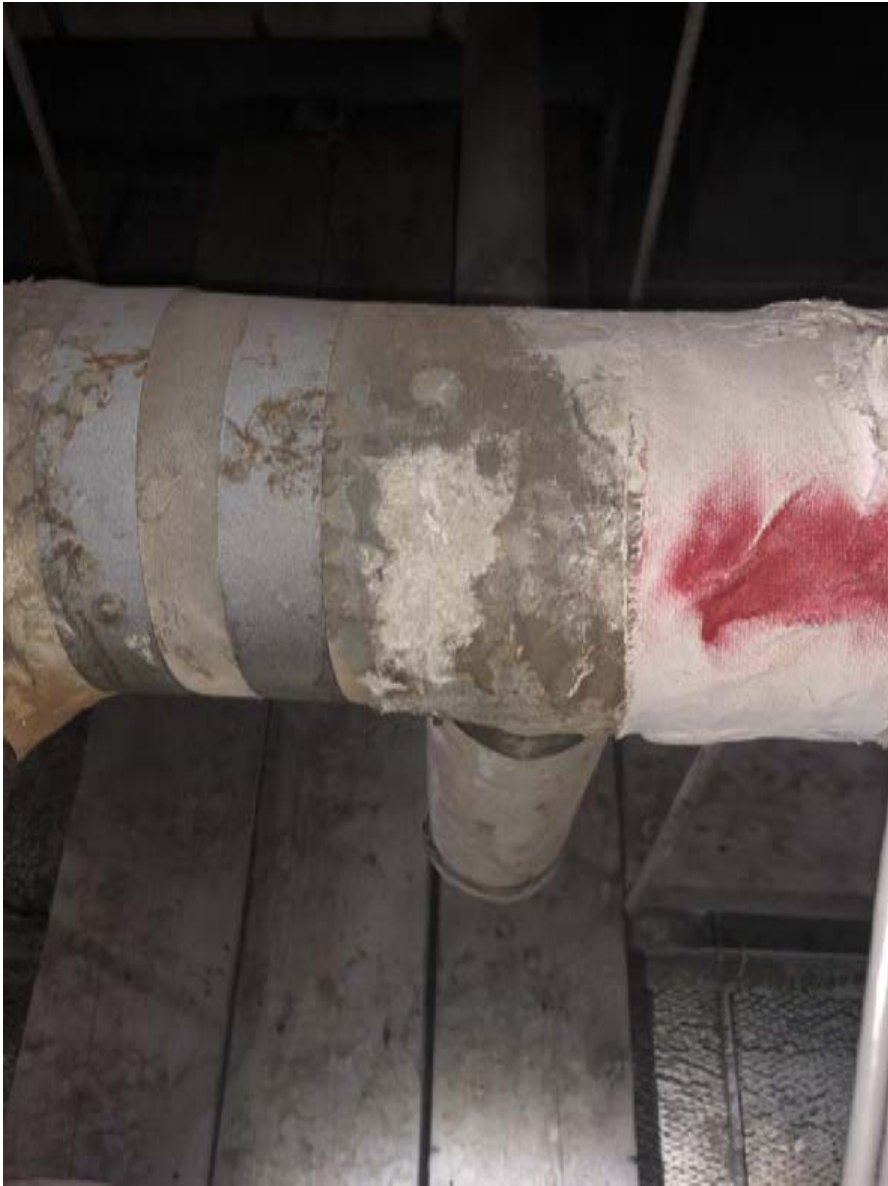
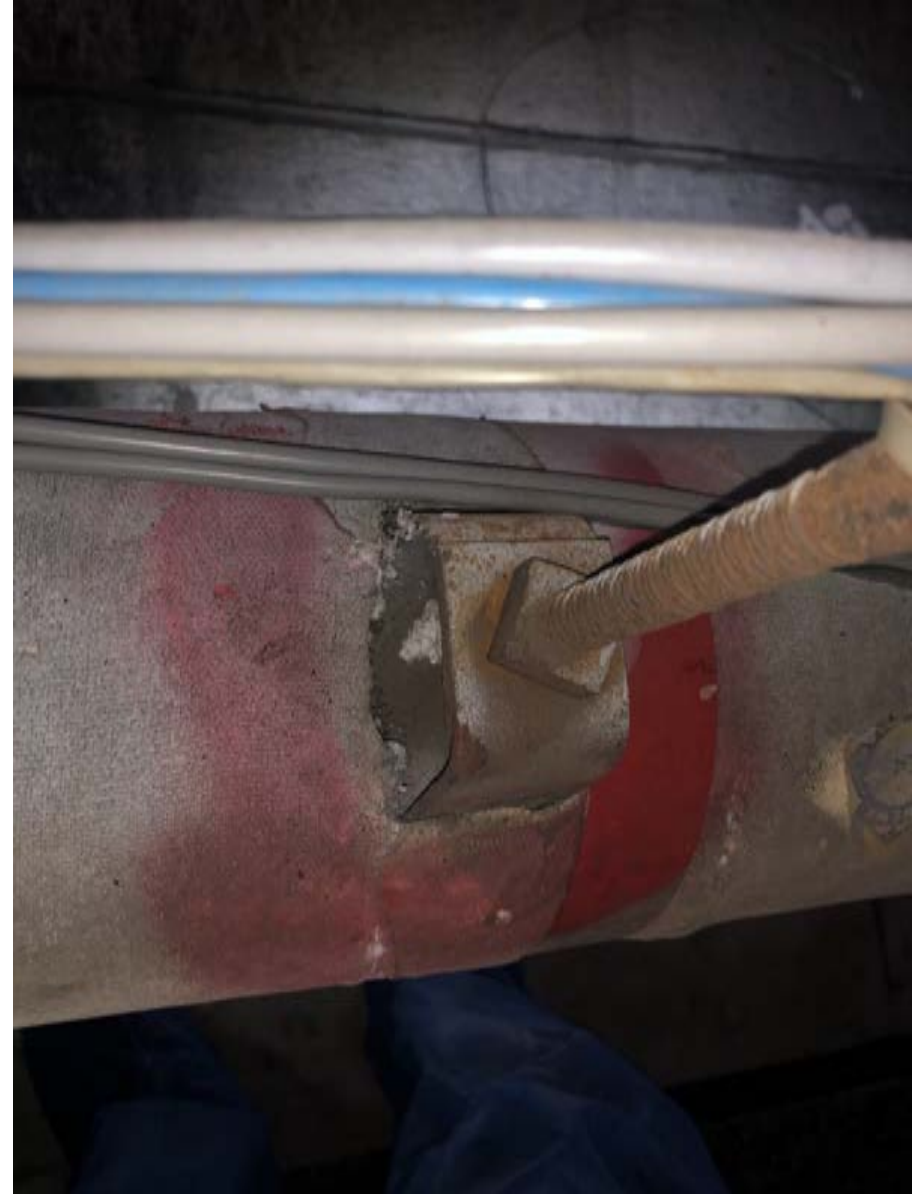
Asbestos Design Data Collection (DDC) 10242019
